# OREGON CITY

## Type I Site Plan and Design Review

Project Description: oak & WALNUT TREE REMOVALS - HAZARD

# Arborist Report

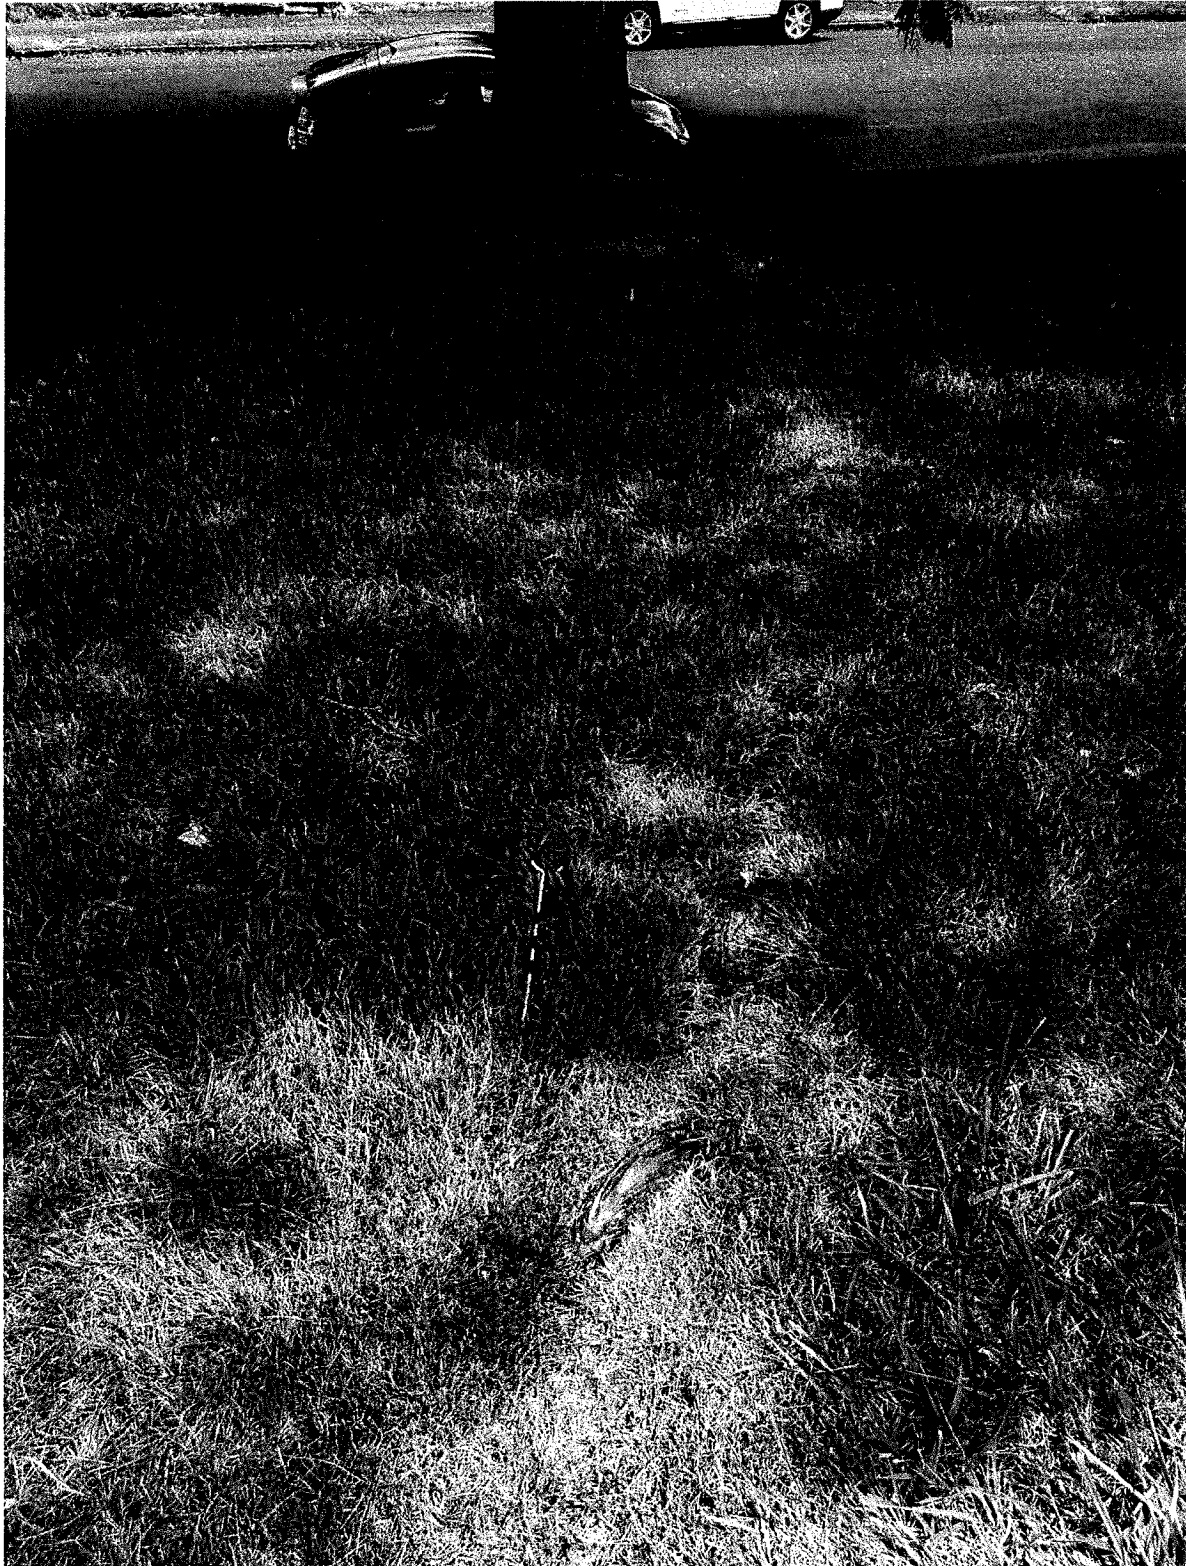
The tree has one trunk wound that is sealing, and one surface root in the lawn that has had mower damage. The health and structure of the roots, trunk, scaffold branches, and foliage is good.

Photo 2. Surface root in lawn
