Tree #2

TERAGAN
& ASSOCIATES, INC.
ARBORICULTURAL CONSULTANTS

RE: Tree Risk Assessment of 37-inch Oregon white oak (*Quercus garryana*) east of Mt. Pleasant Apartments, 1208 Linn Avenue, Oregon City 97045.

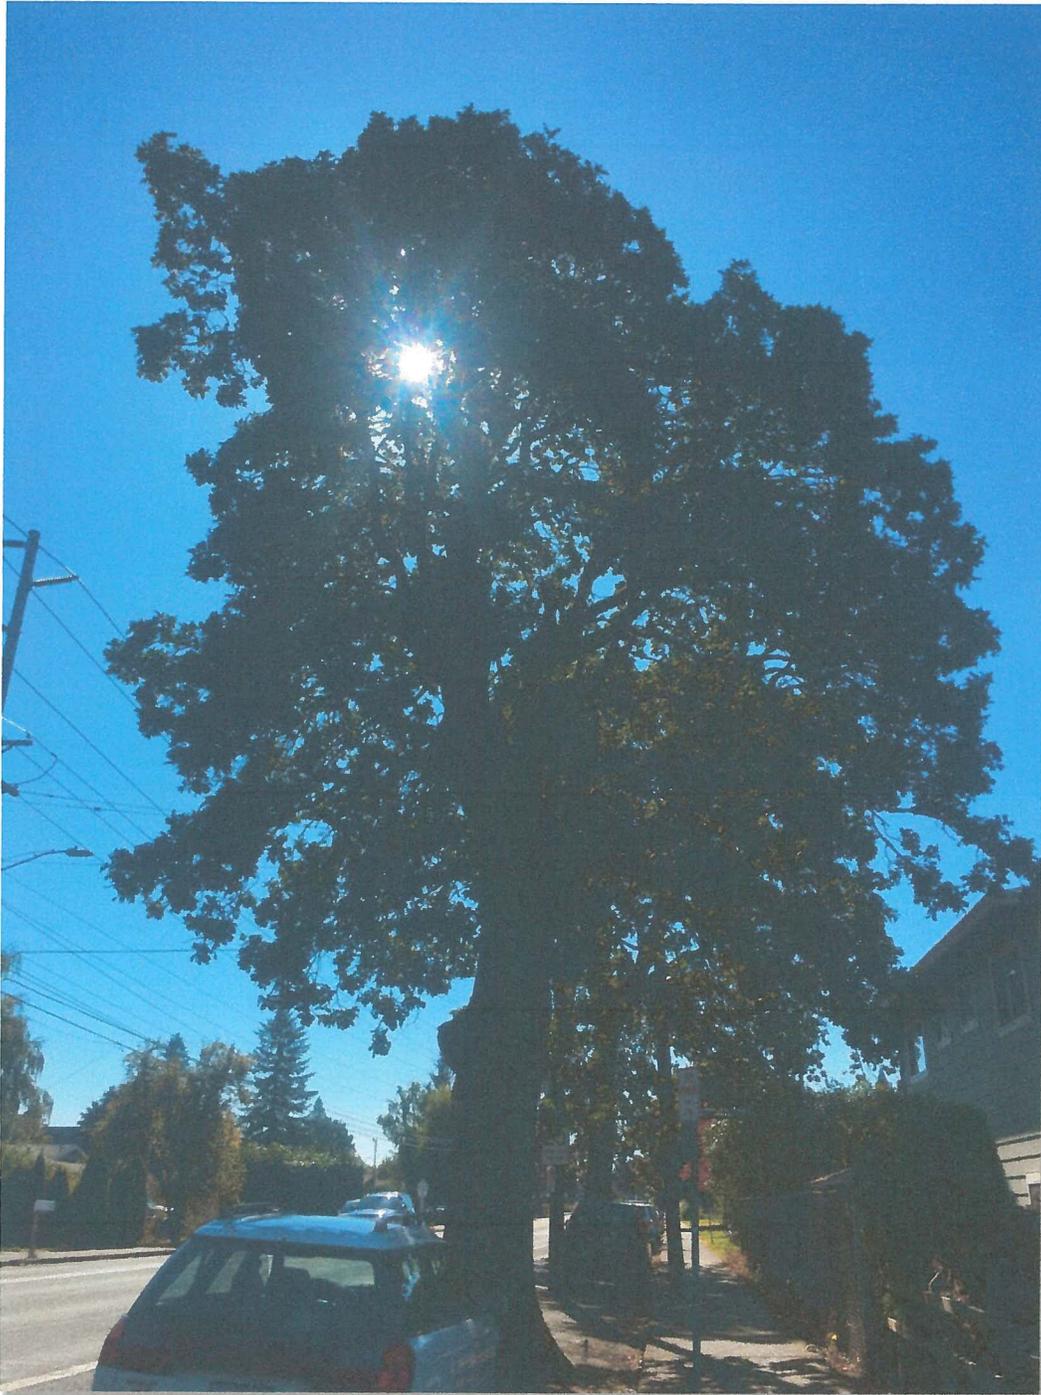
The assessed tree is a 37-inch diameter Oregon white oak (*Quercus garryana*), approximately 40-feet in height (see Figure 1). It is in a parking strip between the sidewalk and bike lane. Asphalt is paved on all sides of the trunk at varying distances; 15-inches on the east side, between 8 and 26-inches on the south side, 10 to 16-inches on the west, and 12 to 16-inches on the north side. The oak visually appears to be in fair health and is of poor structural condition. The tree's health is rated fair as the tree's crown is exhibiting signs of stress such as smaller off-colored leaves and short internodal growth, however there is limited die-back. The tree's structure is rated as poor as the crown appears to have been topped at least two times many years ago, with topping cuts appearing to be large, 6-inches in diameter and greater (see Figure 2). The resulting crown has many large diameter dead stubs, many crowded branches originating from the same point, and upright growing branches (water sprouts) that are likely to be poorly attached. When viewed from the east, the crown is balanced, only slightly heavier to the south. The north portion of the crown is taller to the east, but appears to be weight balanced to the east and west.

Figure 1. View from the north.

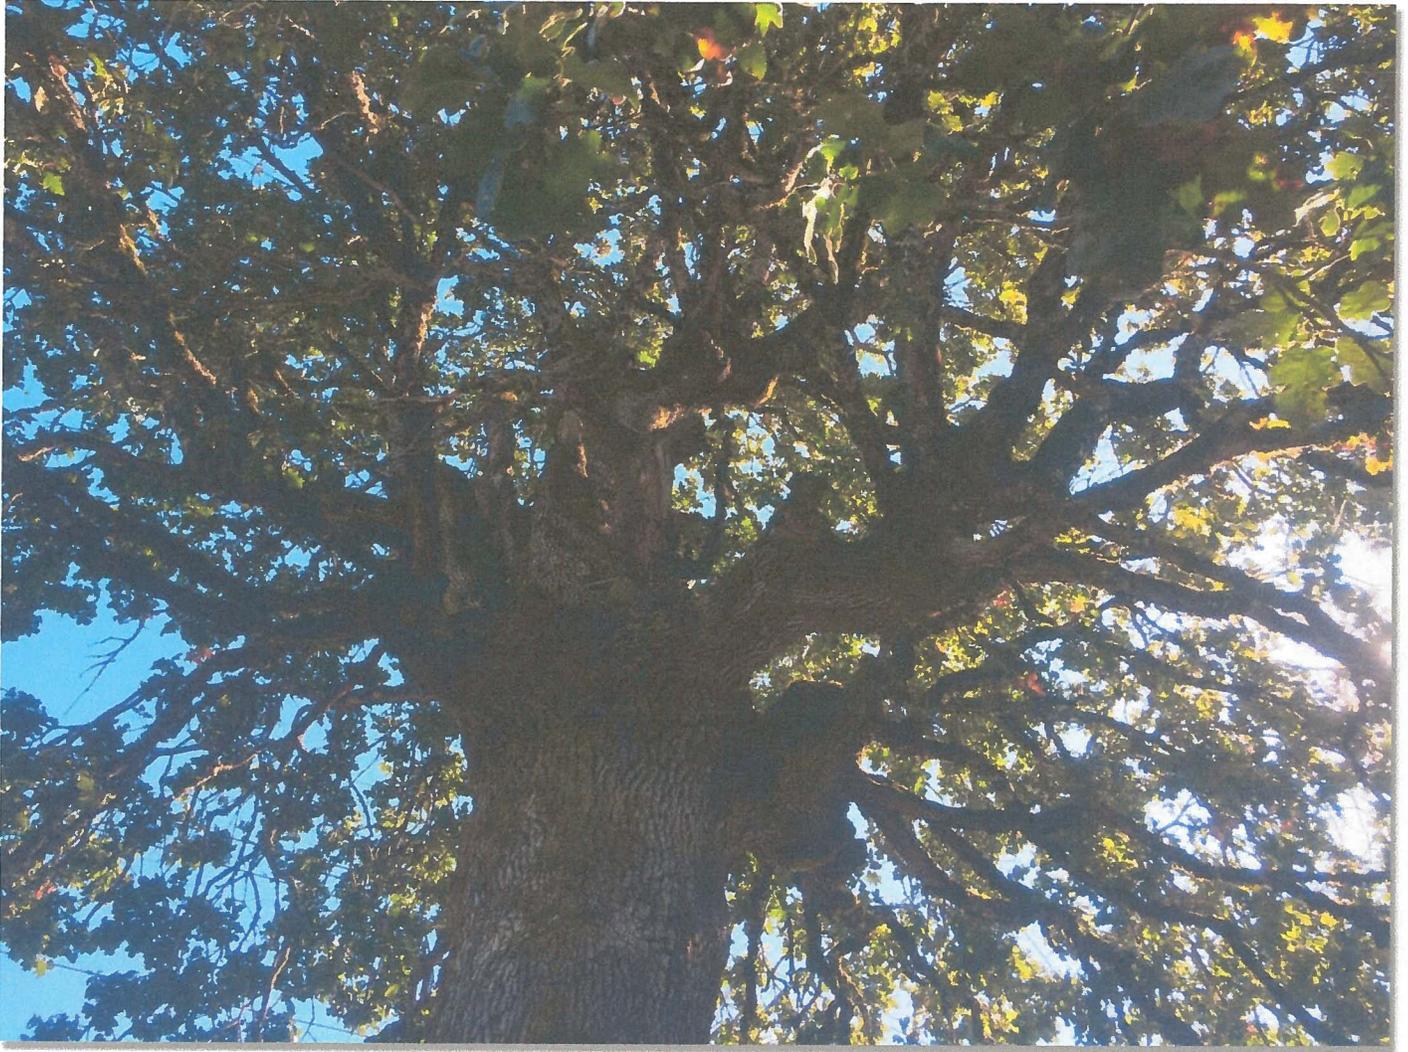
The likelihood of failure of any of the multiple possibly poorly attached branches resulting from the at least two prior topping events over a one-year period is **possible** due to the suspected decay commonly associated with topping at the branch unions that may have penetrated the trunk wood and the branch's weak attachment points. All the targets mentioned above are of concern, with the likelihood of impact being **high**. The consequence of failure is **severe** as topping occurred many years ago, resulting in considerable upright growth and therefore weight that would likely strike the targets of concern. The risk rating of the failure of any of the branches post-topping is **moderate**.

Figure 2. Crown view of topping points.

To assess the need to mitigate the moderate risk associated with this type of branch failure, I recommend a climbing arborist inspect the topping points to determine the presence and extent of decay. Depending on the results of this inspection, pruning and cabling may be options to utilize in addressing the strength of branch attachment.

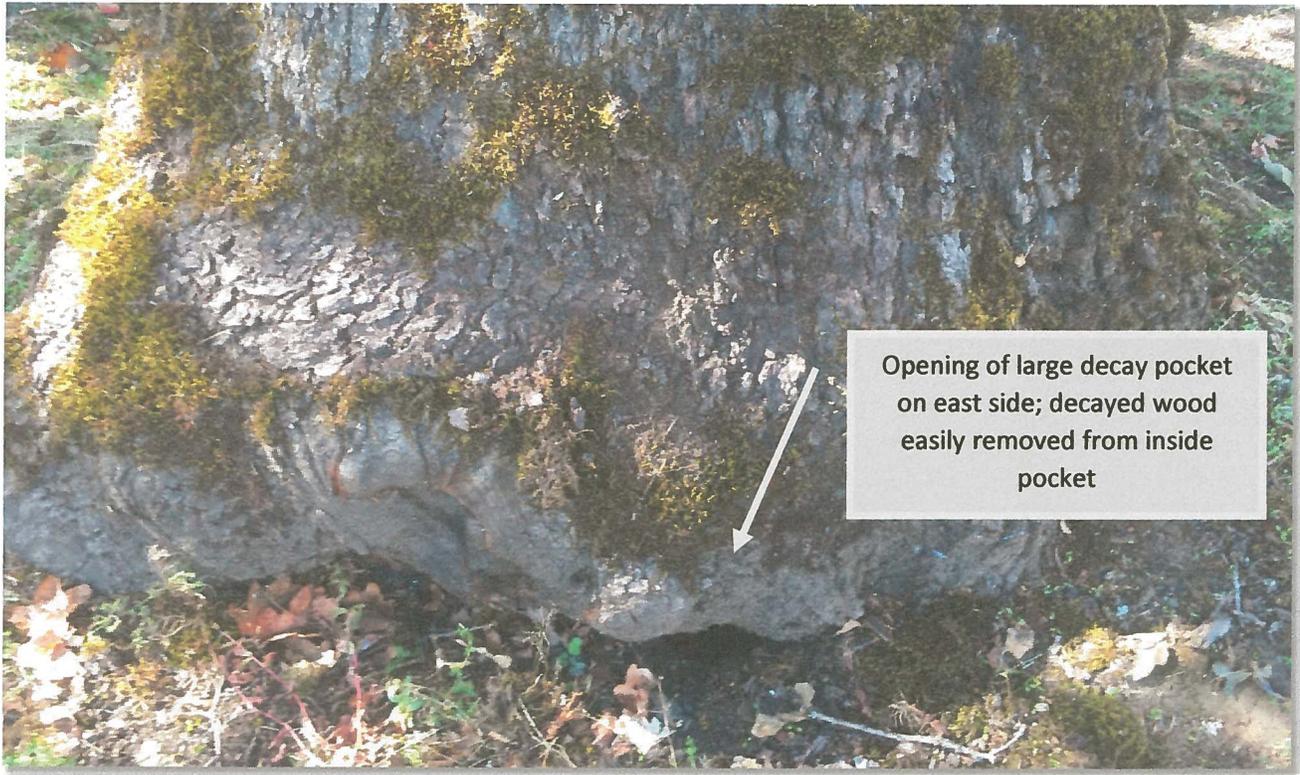
Figures 3 and 4. Image above (3) is decay pocket opening on east side. Image below (4) is ground-level image of same decay pocket beneath tree.

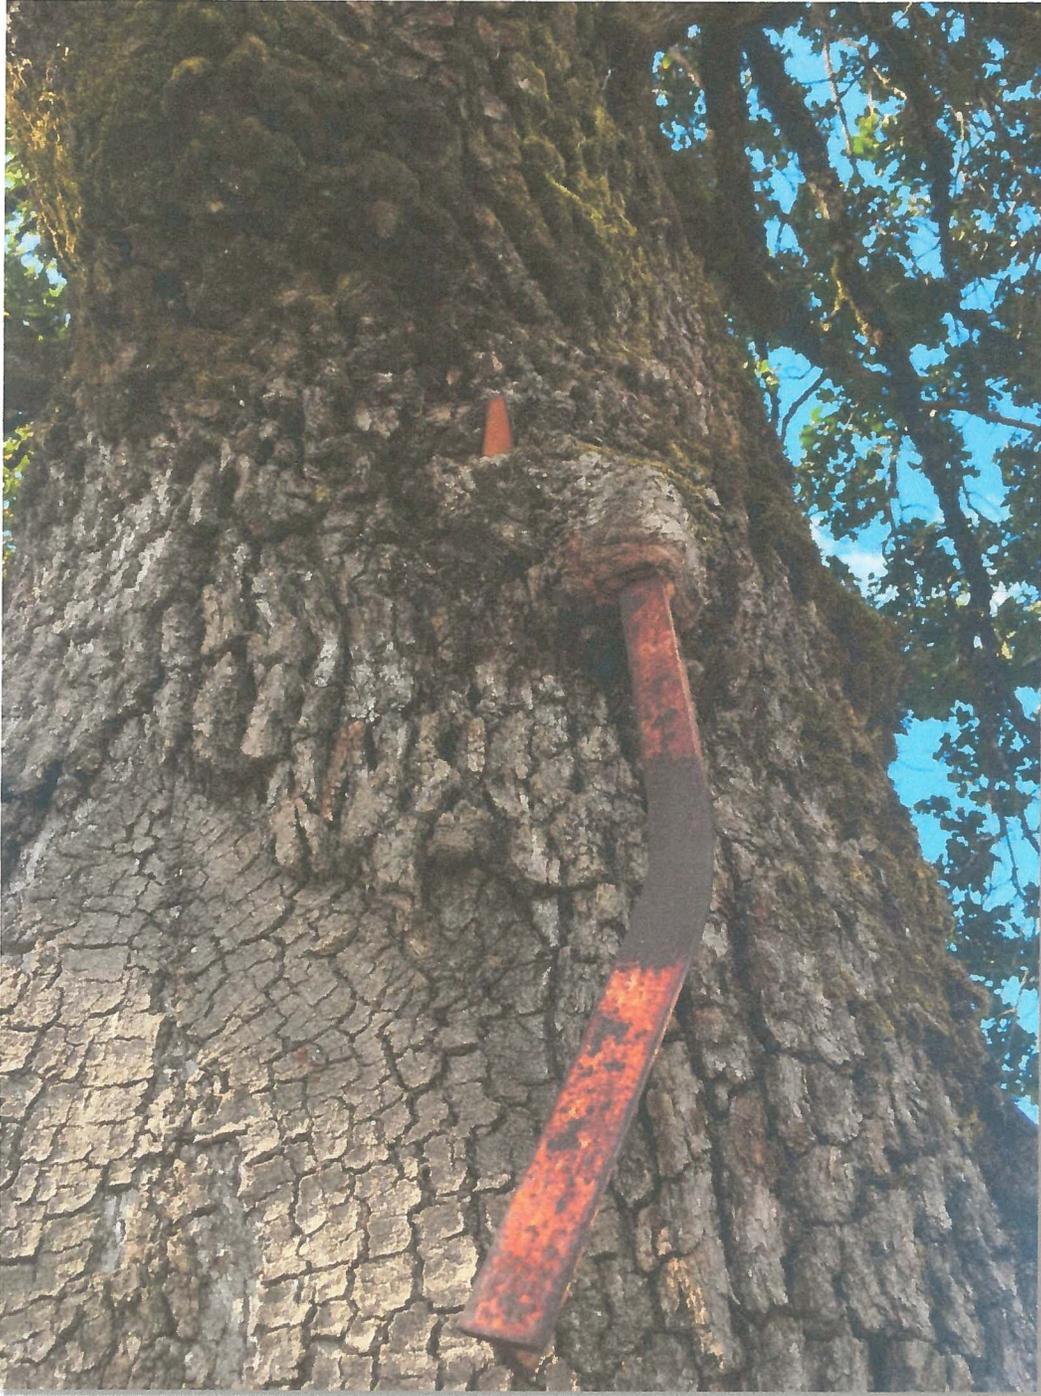
Figure 4. T-post at 10-feet on east side.

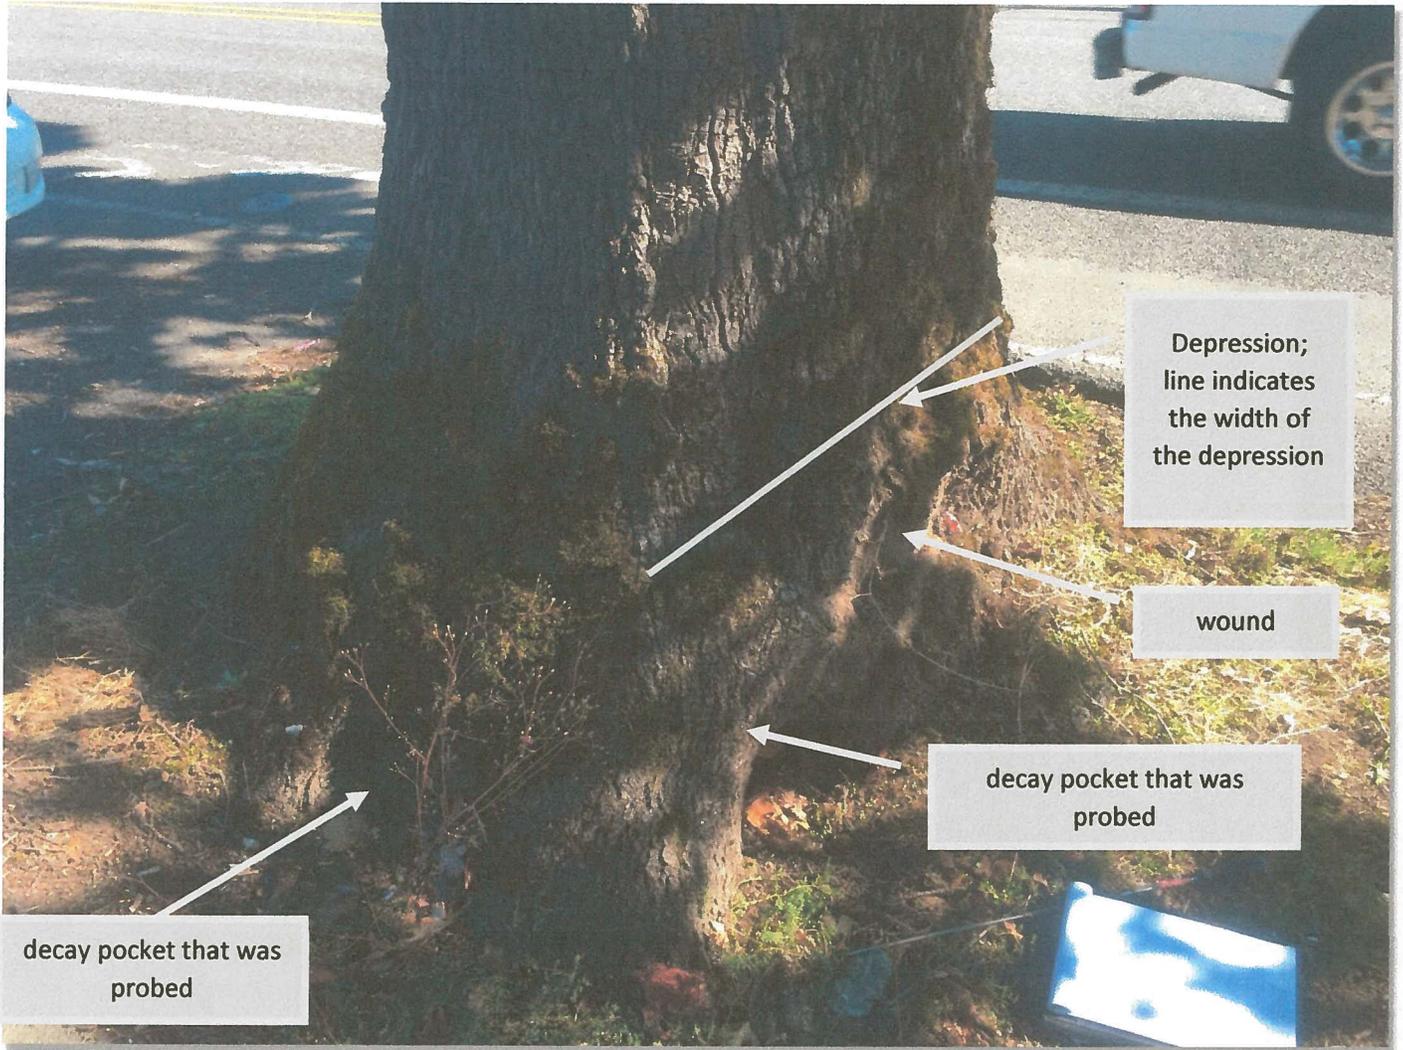
The visible presence of decay on the north, east, south and west sides of the buttress coupled with the ability of the metal probe to penetrate where structural roots were likely located and the basal trunk depressions (see Figure 6) on the north, east and south sides, indicates extensive decay in critical structural components. This is compounded by the likely root suffocation and therefore death of roots when the parking area was created. This likelihood is supported by the minimal sidewalk and road damage caused by the oak that recently failed to the south that was growing in similar conditions. The failed oak's root wad revealed highly decayed structural roots.

The likelihood of whole tree failure in one year is **probable**. The possible targets of failure are the apartments, parking, and two lanes of traffic possibly including power lines. The presence of basal decay on many sides of the tree makes predicting failure patterns difficult. The likelihood of impact is **high** as winds from the south/southwest could cause the tree to fall to the north where the occupancy rate of the apartments is more stable than traffic and pedestrian usage. The consequences of whole tree failure would be **severe**. The risk rating of whole tree failure due to possible root damage and decay of the 37-inch Oregon white oak is **high**.

Figure 6. Trunk buttress. Depression at base of entire south side.

Recommendation: Given the **high** risk of whole tree failure, this tree should be removed.

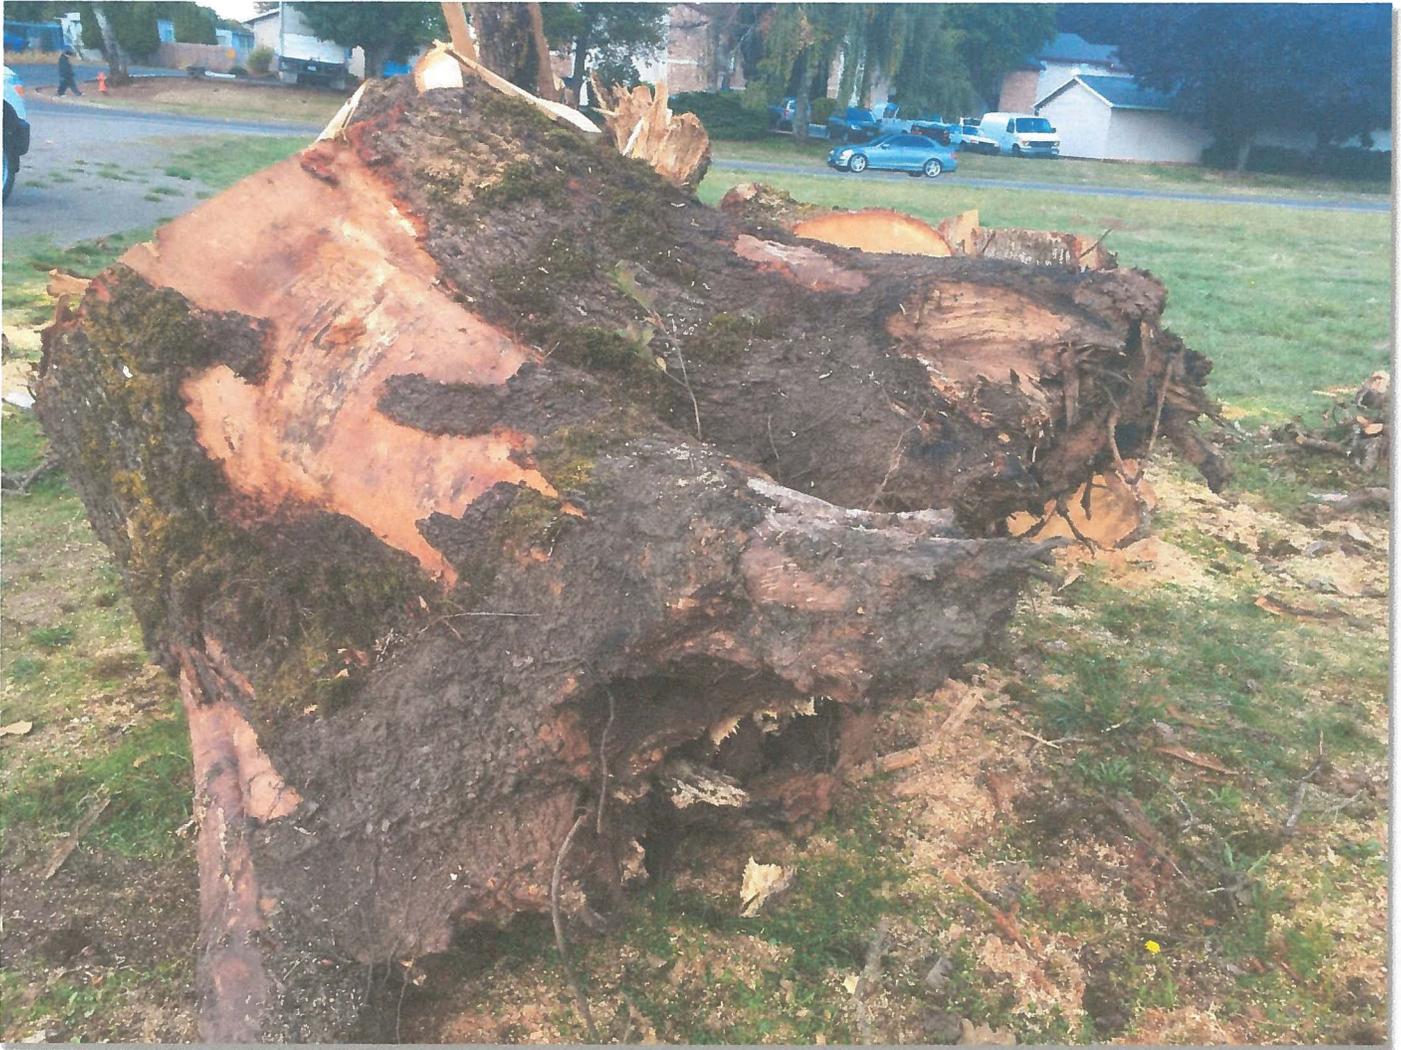
The largest of the three oaks failed near 1:30am on September 19th, 2017. The previous day, 0.45-inches of rain fell. Just before the reporting of tree failure, there was a 9mph wind gust that came from the south/southwest, with wind gusts not exceeding 15mph during the hour prior. These low wind gusts are not typically associated with tree failure which occurs when forces applied to a tree exceed its strength.

Figure 7. Failed root wad; extensive decay of structural roots.
