Preliminary Geotechnical Engineering Report

The Cove Garden Apartments
Oregon City, Oregon

GeoPacific Engineering, Inc. Job No. 15-3719
May 12, 2015

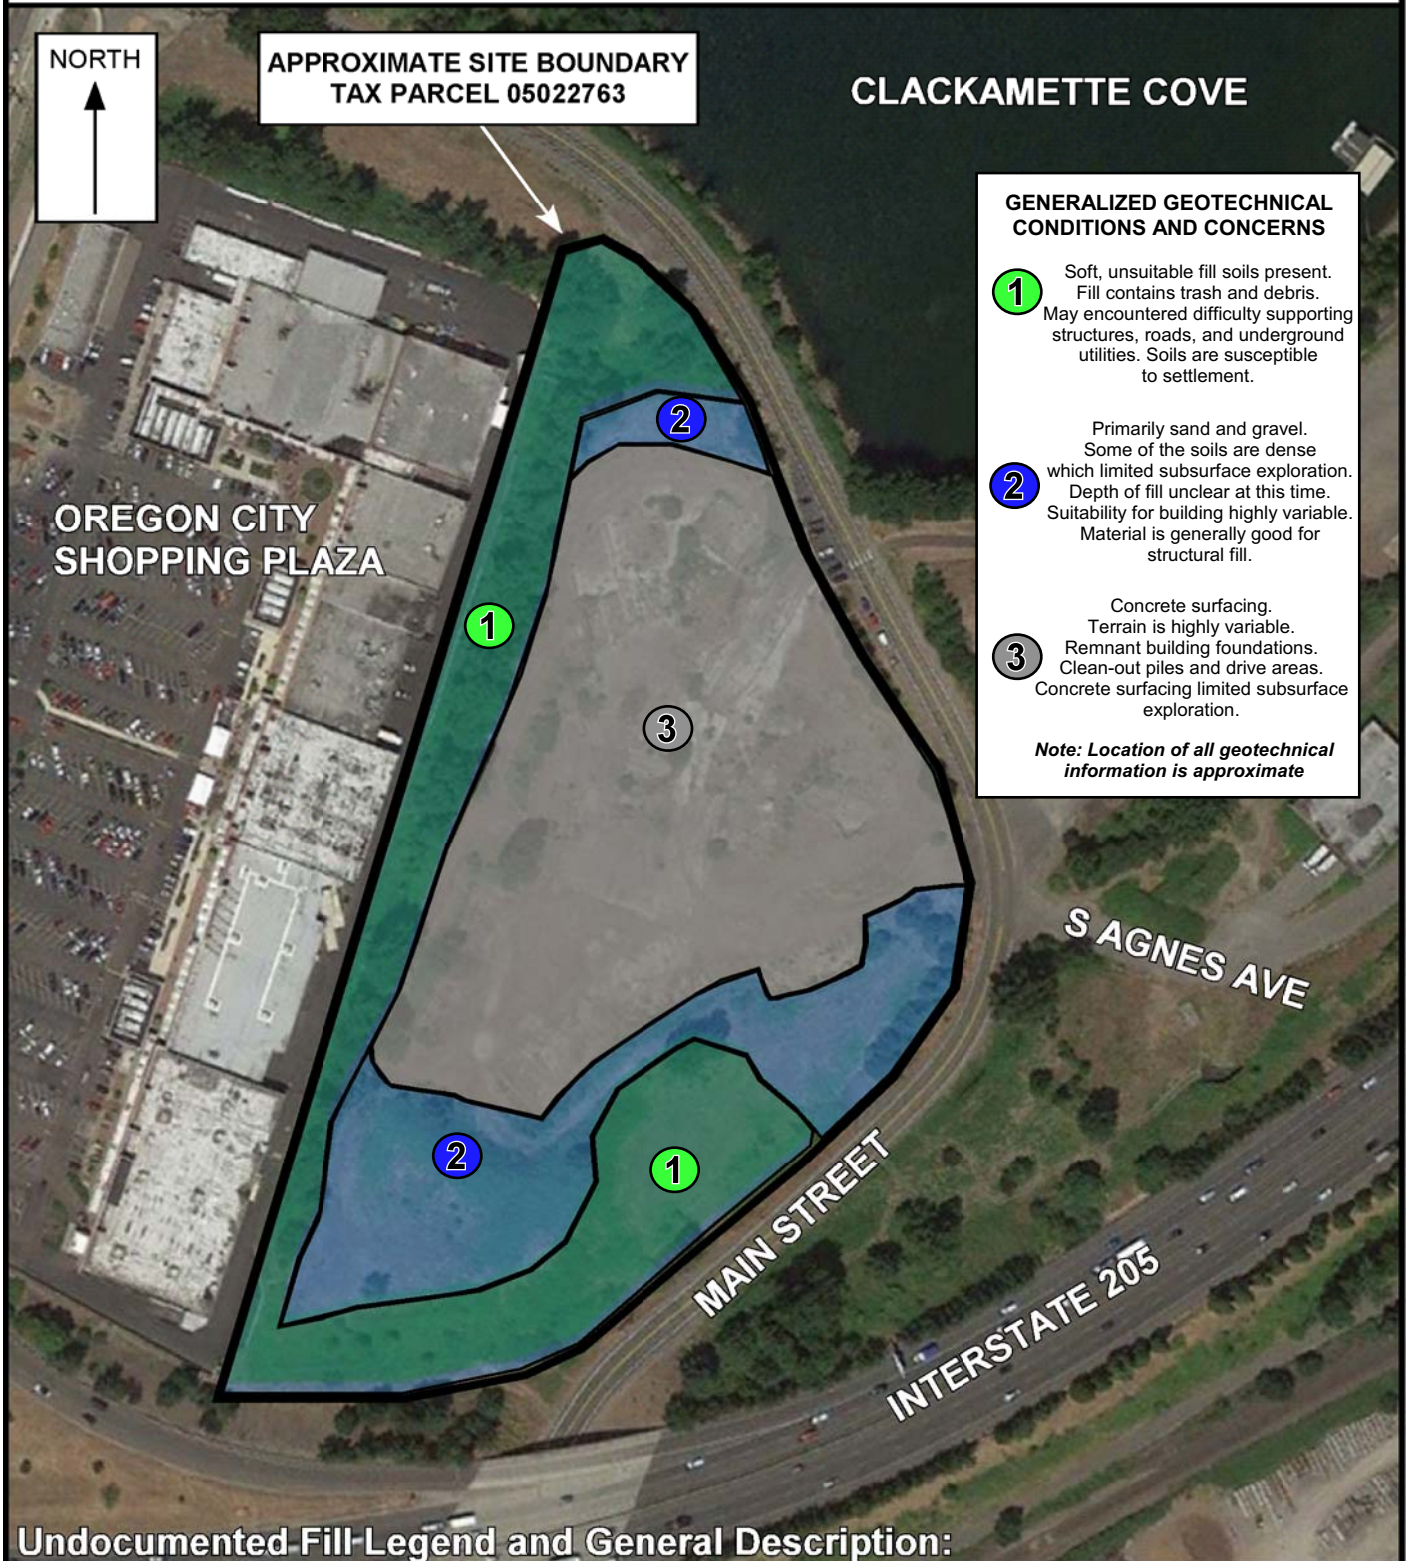
SITE AERIAL AND GENERALIZED UNDOCUMENTED FILL MAP

As indicated on Figure 3, the site contains areas of apparent remnant sand and gravel stockpiles. The gravels were observed to vary in density and gradation. As indicated on the attached test pit logs, some of the sand and gravel fill soils were observed to be very dense and caused refusal of exploration. Uncertainty exists as to the subsurface conditions below the depths explored. Additional subsurface exploration is recommended in the areas proposed for structures. It is possible that some of the sand and gravel deposits may remain in place, particularly in areas where proposed fill depths are greater than 10 feet. In areas where less than 10 feet of fill has been proposed, soils may need to be excavated and the areas re-graded. The final extent of

- Fine-Grained Soil, Contains Debris
- Granular Fill, Sand and Gravel
- Concrete Surfacing, Concrete Fill

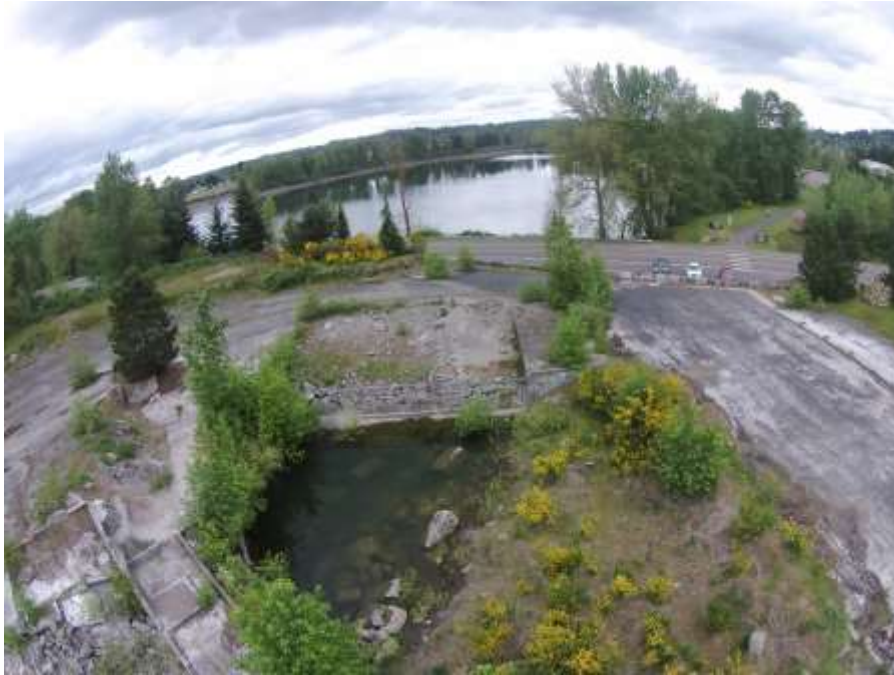
Aerial Photo, Showing Pond and Concrete Debris, North End of Site

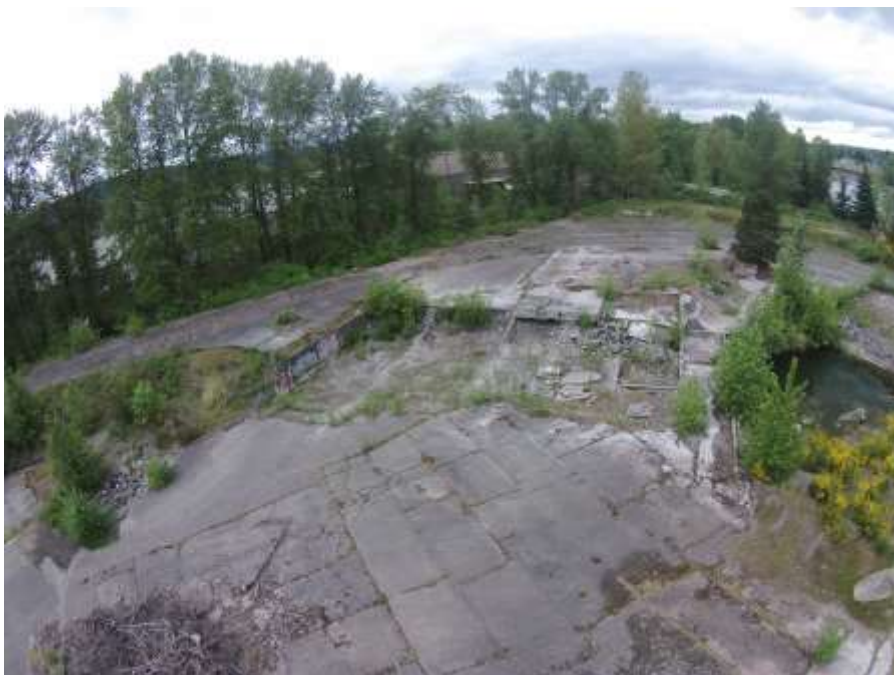
The north, east, and central portions of the site contain remnant building foundations and extensive layers of randomly poured concrete debris. It is our understanding that a concrete crusher will be utilized during site grading and that the recycled concrete will be used as engineered fill. We recommend that large excavators be utilized to remove the precast concrete debris in as much of the site as is feasible, thereby exposing as much of the underlying soil layers as possible. There may be portions of the site where it is feasible to leave some of the concrete in place, particularly areas where proposed fill depths are greater than 10 feet. The low elevation central portions of the site are surfaced with concrete that consisted of remnant building slabs and apparent drive areas. During our site investigation, excavation was not possible in these areas, however it appears that some of the area may be suitable placement of engineered fill. Based upon review of preliminary grading plans, it is our understanding that up to 15 feet of fill is planned in the noted areas. In order to determine whether or not the existing concrete is suitable for engineered fill placement, GeoPacific should conduct additional soil borings in the area to determine if voids or other unsuitable soil types are present which may be susceptible to settlement. In addition, settlement plates may be installed at the base elevation prior to engineered fill placement, and monitored for settlement for a period determined suitable by the geotechnical engineer.

Aerial Photo, Showing Old Building Foundations and Concrete Fill

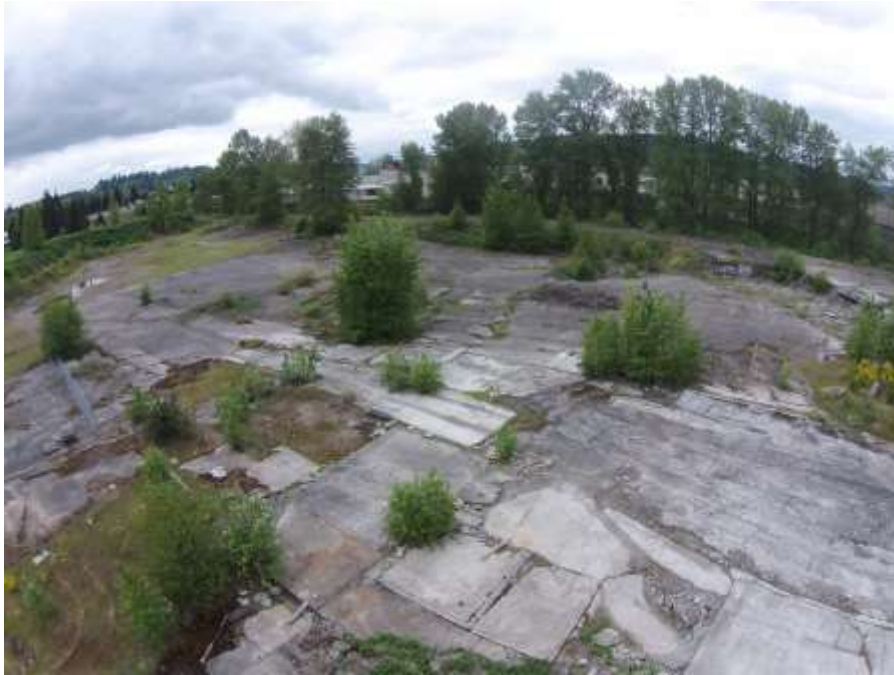
Aerial Photo, Facing West, Showing Concrete Fill

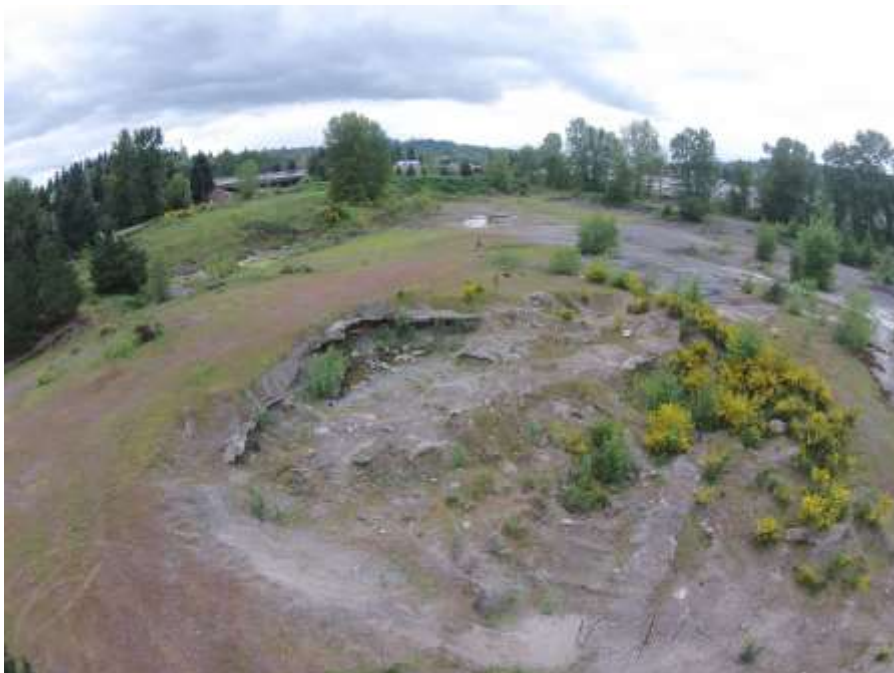
Aerial Photo, Facing West, Showing Concrete Fill

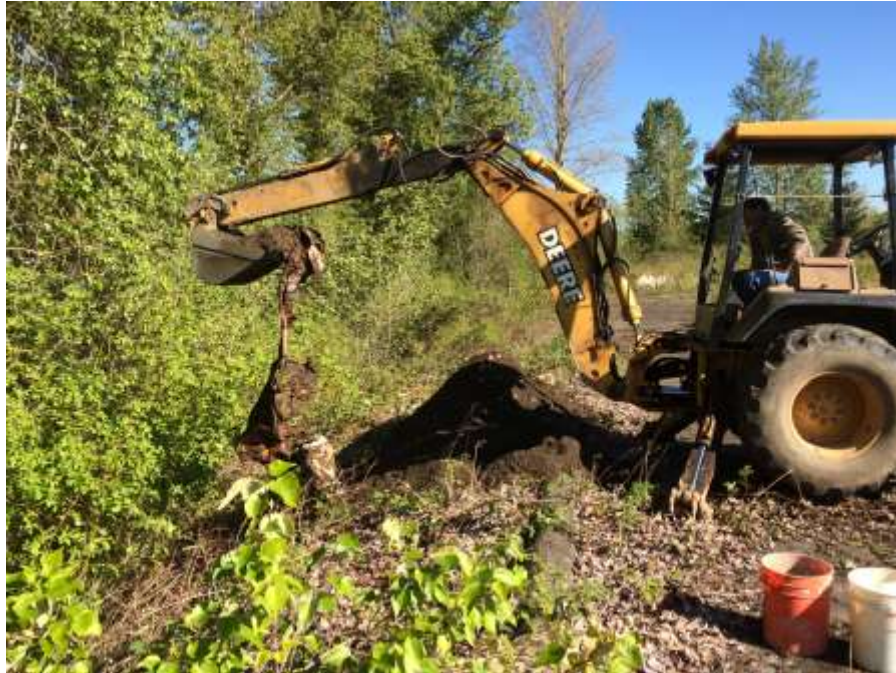
Facing North, Test Pit TP-3, Excavating Fill and Garbage

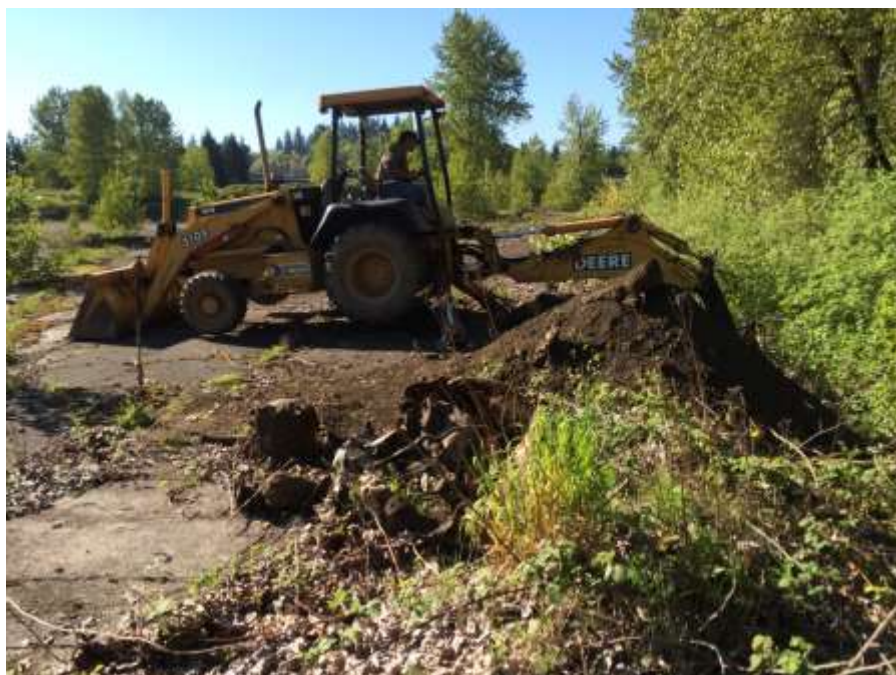
Facing South, Test Pit TP-3, Excavating Fill and Garbage

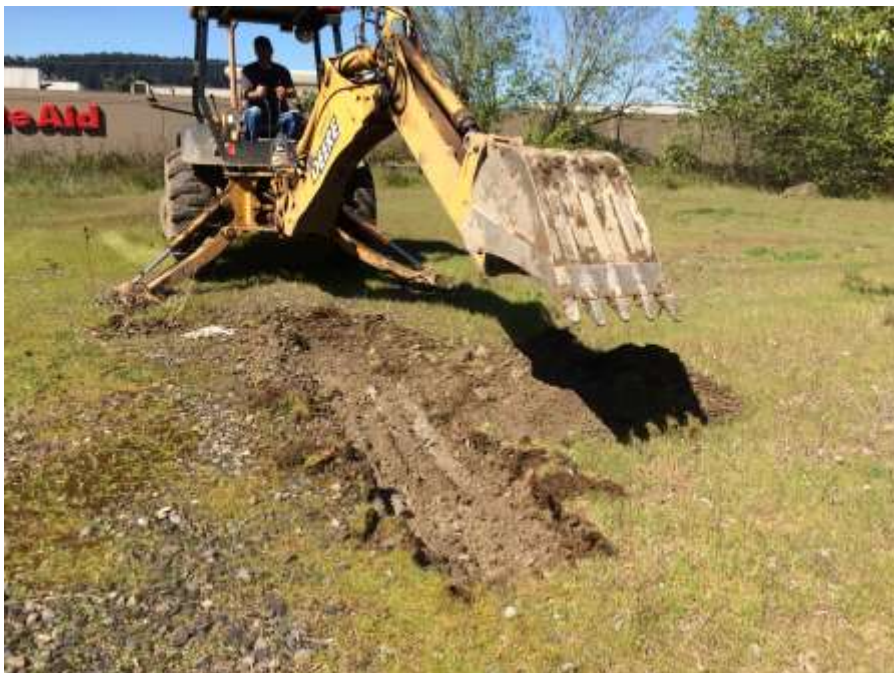
Soils tested from a depth of 12 feet at the location of test pit TP-9 indicated that soils consist of Clayey GRAVEL with Sand. Sieve analysis indicated approximately 46.7 percent by weight passing the No. 200 sieve, and an in-situ moisture content of 19.8 percent. Atterberg testing indicated a liquid limit of 47 and a plasticity index of 21. The soil type classified as GC, Clayey GRAVEL with Sand according to USCS specifications, and A-7-6(7) according to AASHTO specifications.

Facing West, Test Pit TP-9

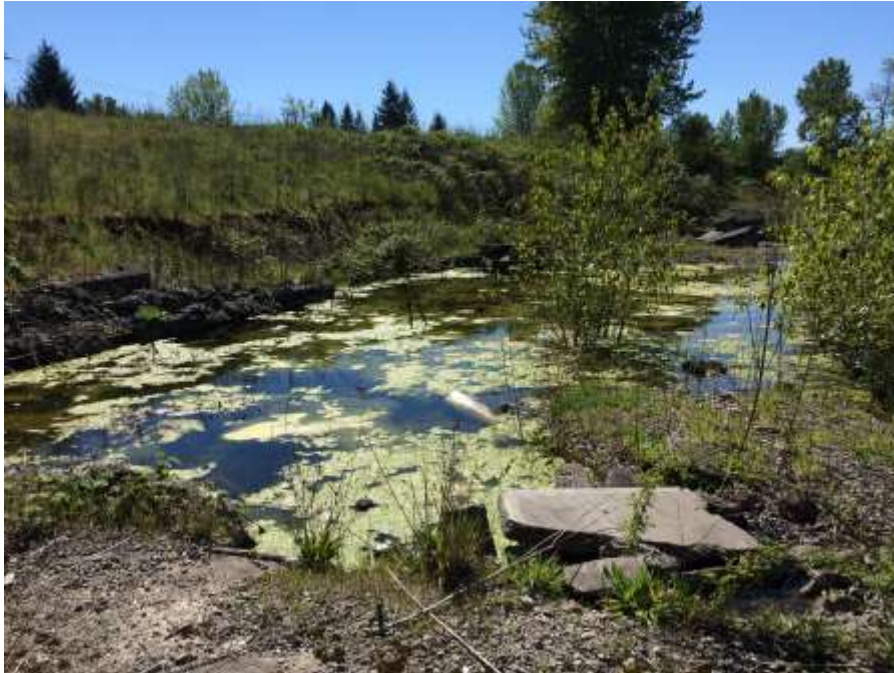
East Side of Site, Facing South, Pond with Concrete Debris

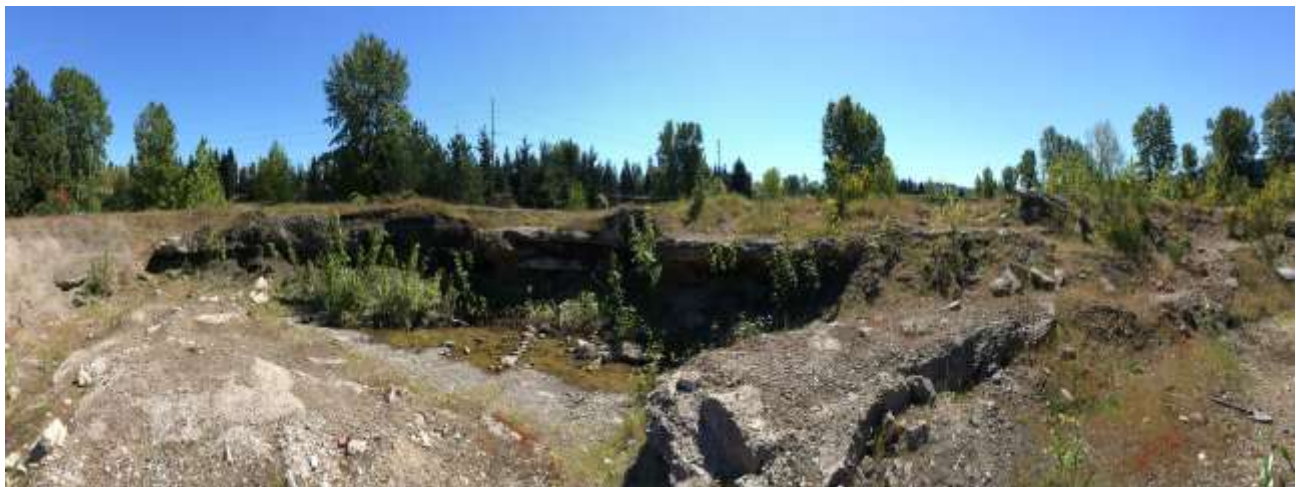
Northeast Portion of Site, Facing East, Showing Layering of Concrete Pours

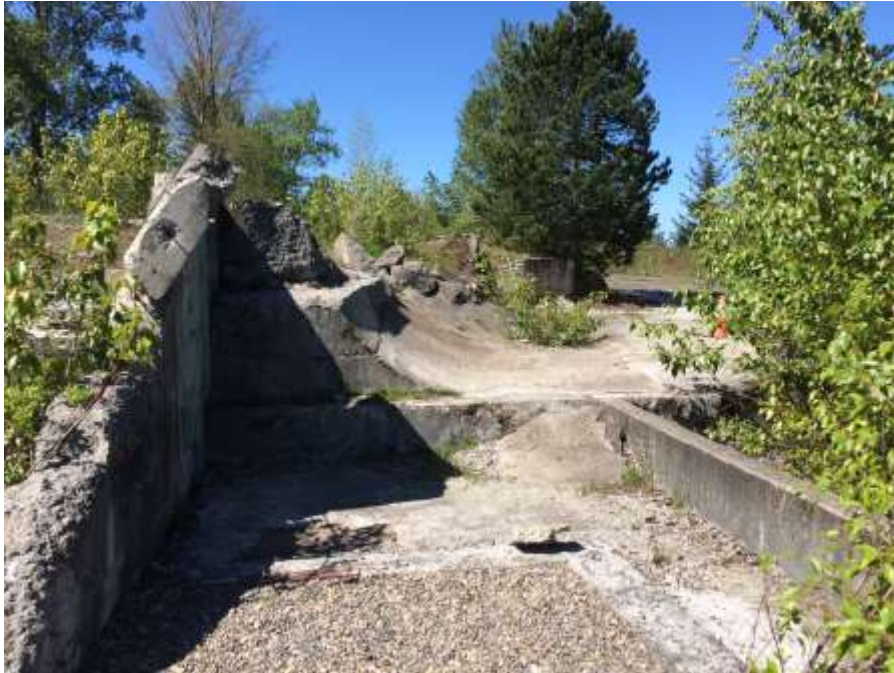
North End of Site, Old Building Foundation

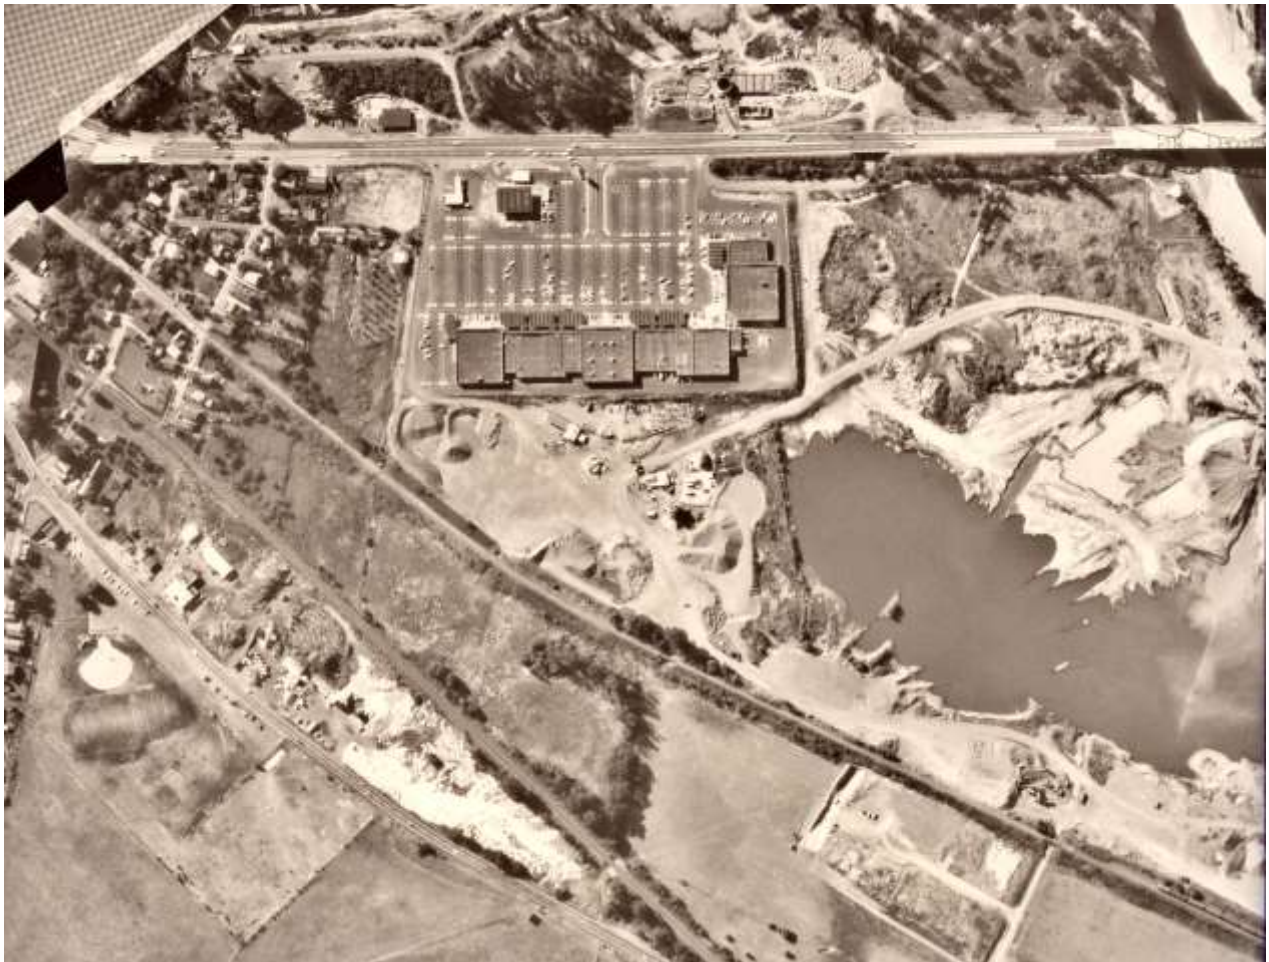
1963, North at Right

The southern and eastern portion of the site contains areas which appeared to be remnant crushed aggregate stockpiles. The crushed aggregate was observed to generally consist of $\frac{3}{4}$ "-0 to $1\frac{1}{2}$ "-0 sand and gravel mixtures. In many locations, such as the southern portion of the site, the gravels were observed to be dense to very dense, and caused refusal of excavation. Based upon review of historical aerial photos it appears that some of the stockpiles were placed prior to the operation of the concrete plant, however, extensive earth movement from the concrete batch plant included placement of fill in the area (see historical aerial photograph from 1963).
