Reference: Oregon City Annex Tennant Improvement  
698 Linn Avenue, Oregon City

Subject: Evaluation and Feasibility Study

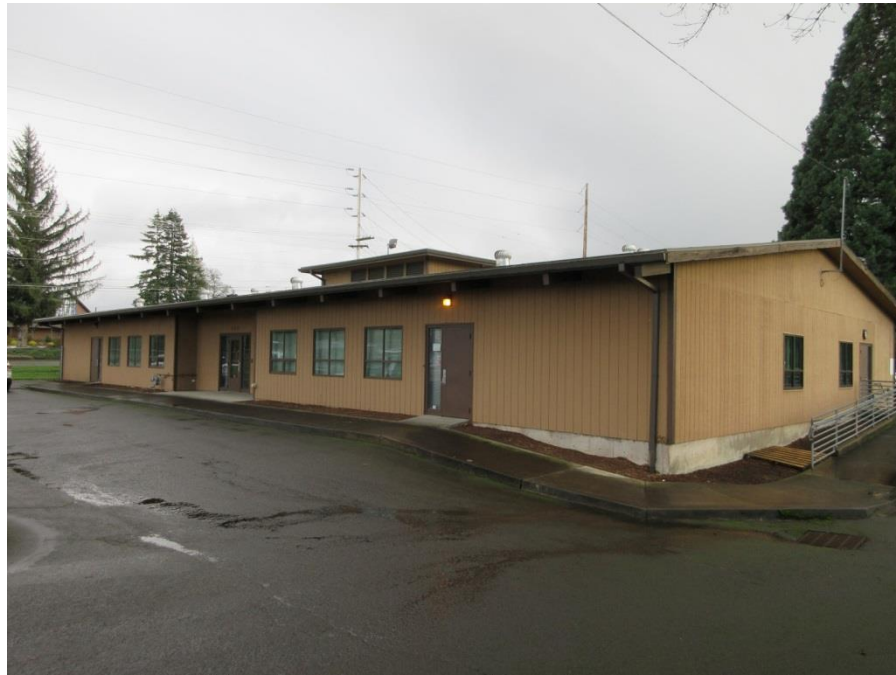
Figure 1:  
Northeast Building Elevation

The building is a single story, type VB non-sprinklered building of approximately 7,080 sf with a mechanical penthouse located at the center of the building (Figure 1). The building is approximately 15-17 feet tall at the ridge line of the sloped roof creating the opportunity for some tall interior spaces. A portion of the building is presently used as a training facility for the City Police Department. The balance of the facility is lightly used as overflow storage for the City. It is our understanding that the building was originally utilized as additional classroom space for Mt. Pleasant Elementary School. The building currently houses two classrooms, the gym area, storage, and restrooms. The main corridor between the building entrances separates the classrooms on the north side of the building from the gym on the south side of the building. Accessory spaces such as restrooms are present along the corridor walls.

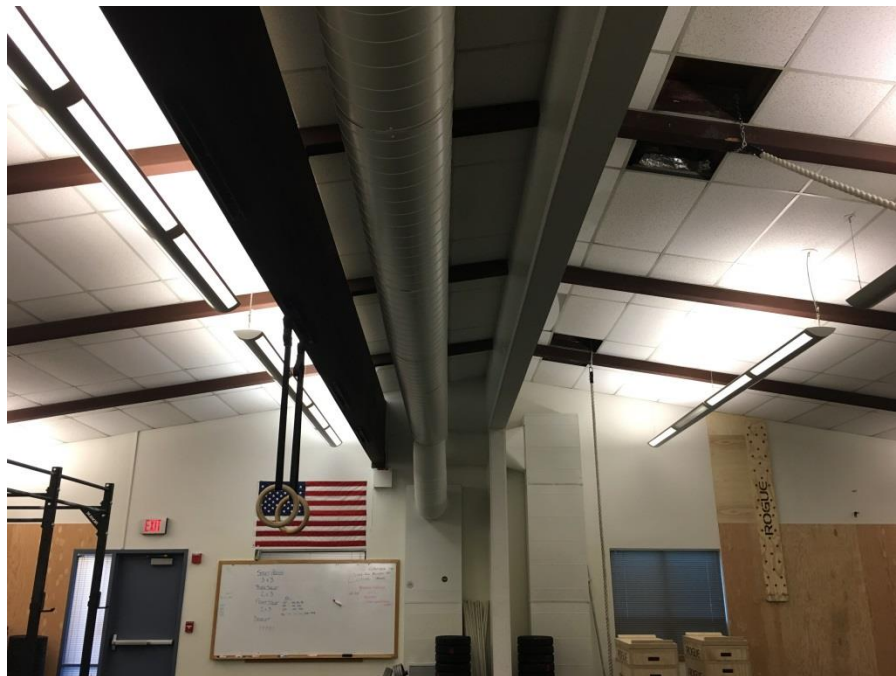
Figure 2:  
Beam at Training Room

Presently, the structure appears to be performing adequately. There was no visible damage to existing structural elements beyond the siding deterioration noted above. The beam located in the police training portion of the structure is curious but appears to be functioning as intended. Without original drawings it is not possible to determine without a doubt the reason the beam was installed in its current location. It appears that there used to be a full height demising wall that split the training room in half similar to the north side of the structure. The wall would have supported the glulam rafters and when it was removed a beam was added adjacent to the wall rather than in its place. The connection between the rafters on either side of the ridge is suspect and should be evaluated further through selective destructive investigation if the project is advanced.

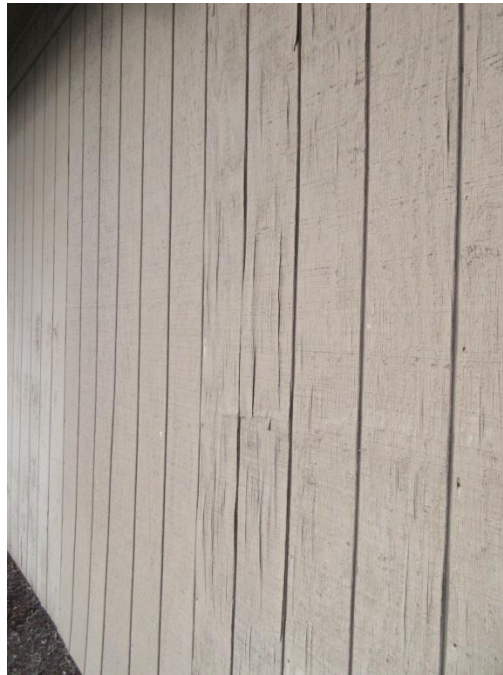
Figure 3:  
Siding Damage

- Exterior walls:
  - Exterior walls consist of 2x studs and T1-11 siding that also functions as wall sheathing. The siding shows significant signs of weathering including delamination in some locations with deterioration along the bottom edge and peeling paint throughout (Figure 3). In several locations, it was observed that there was not adequate separation from the siding material and the soil at grade. This condition has caused the siding to deteriorate more rapidly at these locations because the material has a higher exposure to moisture.

- The existing exterior envelope package is compromised and in need of repair. Adding the proposed windows is an excellent idea and will both improve the exterior elevations and allow more natural light into the work areas. We recommend replacement of the roof with a more durable and aesthetically appealing product such as metal roofing or an architectural composition shingle. By removing the existing T1-11 siding there are substantial opportunities to change the siding package. Fiber cement panel siding and stucco are both legitimate options that we

- feel would improve the appearance of the building. Some existing windows can be rehabilitated while others should be replaced to match the new window packages.

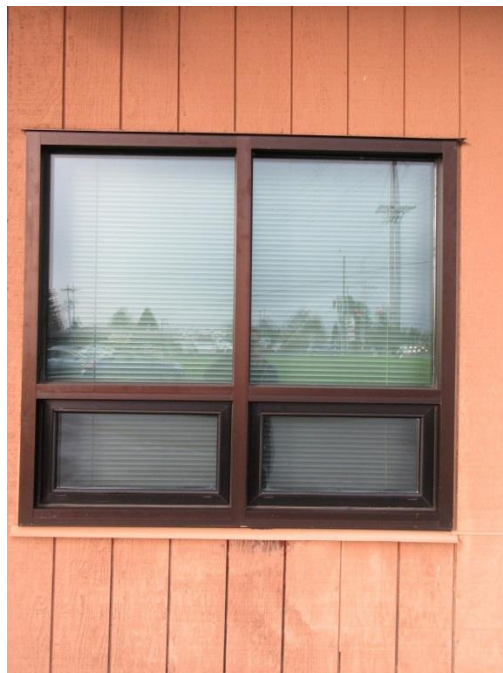
Figure 4:  
Replaced Window

- Exterior windows:
  - There are two types of exterior windows present around the perimeter of the building. Both systems are storefront style with double glazed glass units; however, one appears older than the other. It appears that at some point windows began to fail and a portion of the windows were replaced (Figure 4). The older style windows (approximately half of the total) are significantly weathered, are poorly flashed, and should be replaced. The newer style windows appear to be in reasonable condition and have adequate flashing. There are locations where the gaskets are beginning to fail and will need to be repaired if reused.

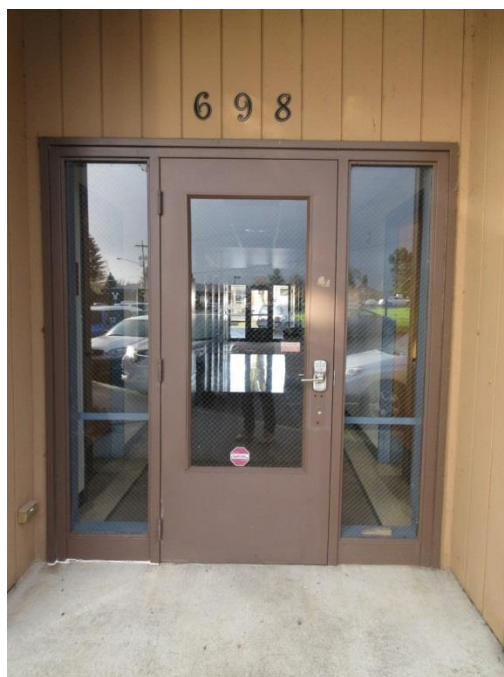
Figure 5:  
Exterior Door

- Exterior doors:
  - The exterior doors are hollow metal with metal frames and appear to be in acceptable condition (Figure 5). The paint is weathered and hinges have been painted in the past, but can be refurbished and repainted.

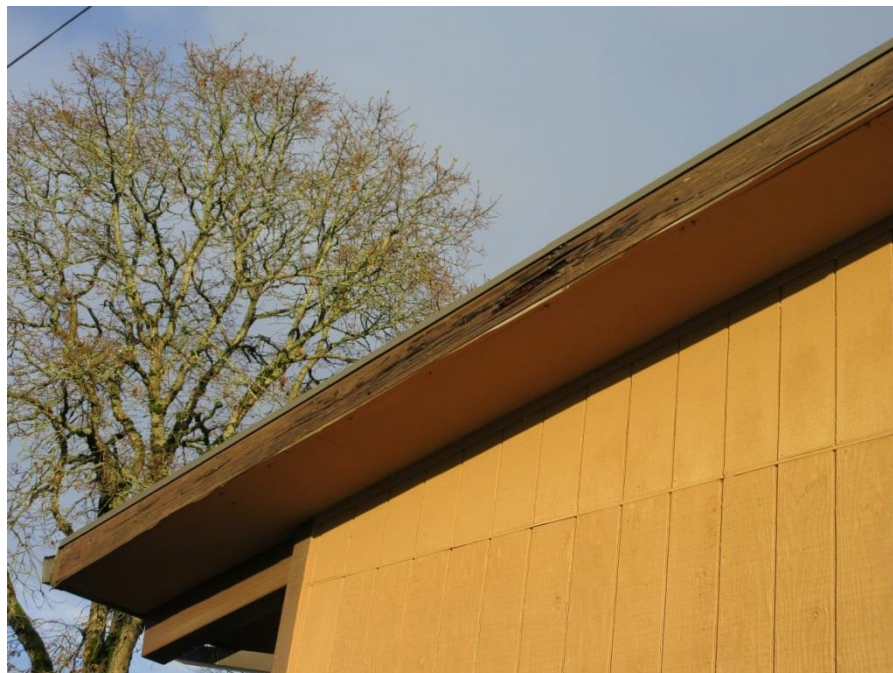
Figure 6:  
Fascia Damage

- Roof covering and components:
  - The existing roof covering is a built-up system that appears to be fairly weathered. Sporadic interior roof tile replacement indicates that there has been a history of water intrusion through the roof. Around the perimeter of the roof the gutters leak in several locations and the fascia shows signs of decay both on the exposed rakes and behind the gutter (Figure 6). The flashing at the roof edge is showing signs of decay and delamination and should be replaced.

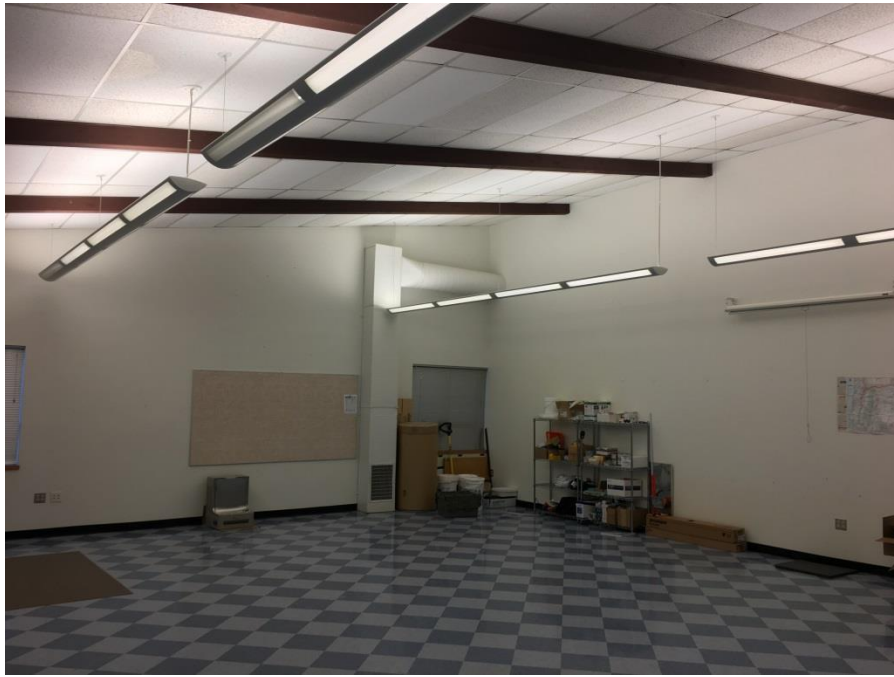
Figure 7:  
Typical Interior

- Floor finishes:
  - The floor finishes in the northern portion of the building appear to be relatively new vinyl composite tile (VCT) that has been maintained and in good condition (Figure 7). The floor base throughout is a rubber base that is also in good condition. The corridor floor finish is not the same material and appears to be original sheet goods. With the removal of some corridor walls, the replacement of flooring material in some areas may be necessary.

The existing ceiling is a suspended acoustic ceiling tile (ACT) between exposed roof beams in most areas and a combination of dropped gypsum board ceilings and ACT ceilings in the corridors and smaller accessory areas (Figure 7). It appears that this ceiling is tightly suspended to the roof sheathing and has batt insulation placed between the ACT and roofing. Our initial observation indicates that this roof/ceiling may not meet the current code requirement of R-38 insulation. In addition, throughout the larger spaces there are mismatched tiles that are visually apparent and indicate some tile replacement was performed in the past. This could imply that there are different levels of acoustic performance of this material in the spaces.
