Technical Memorandum

Project title: I/I Abatement Program

Technical Memorandum 1

Subject: Smoke Testing

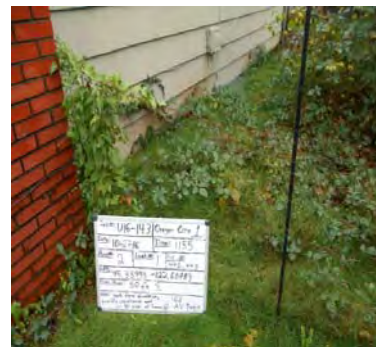
Basin 1 Run 2 Leak 1 A

Comments: Smoke coming from crawlspace vent

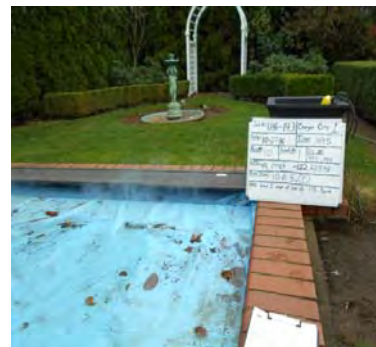
Basin 1 Run 10 Leak 1 A

Comments: Leak type is unknown, smoke coming from edge of pool. Apparently connected to Sanitary

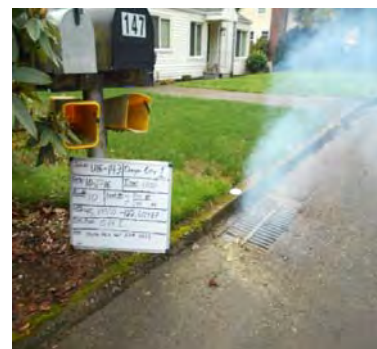
Basin 1 Run 10 Leak 2 A

Observations: Heavy smoke from Stormwater catch basin

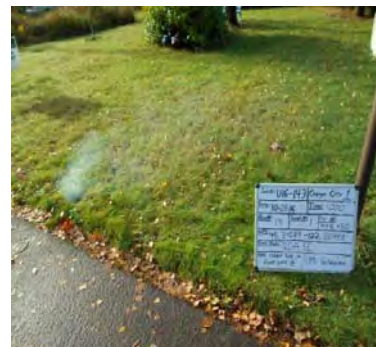
Basin 1 Run 14 Leak 1 A

Comments: Smoke coming from a rodent hole in the front yard.

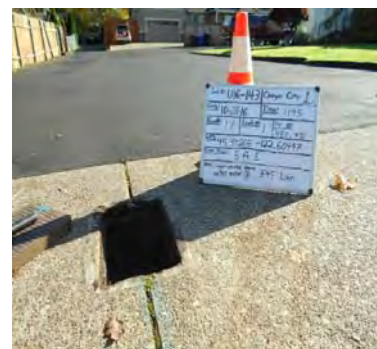
Basin 1 Run 17 Leak 1 A

Comments: Smoke coming from a water meter hatch.

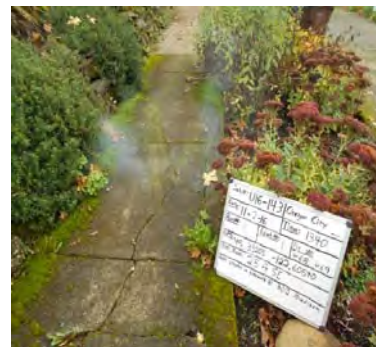
Basin 2 Run 1 Leak 1 A

Comments: Cracks in sidewalk, unknown source

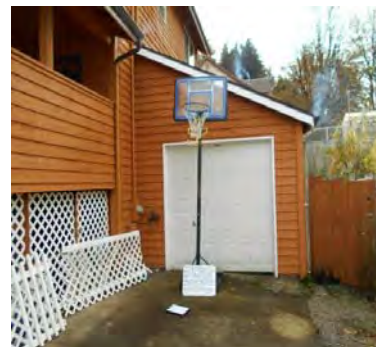
Basin 2 Run 1 Leak 2 B

Comments: Downspouts at N corner of house.

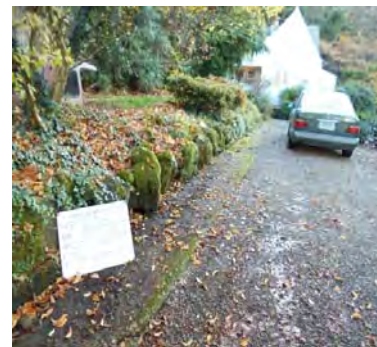
Basin 2 Run 2 Leak 1 B

Comments: Leak at end of driveway/sidewalk. Unknown Source

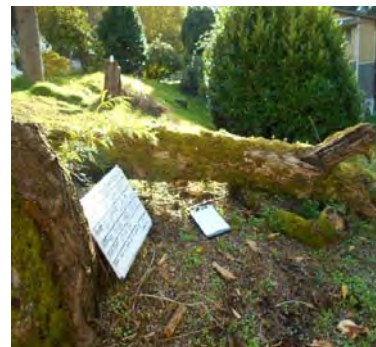
Basin 2 Run 2 Leak 2 B

Comments: Hole in tree at E corner of property. Unknown Source

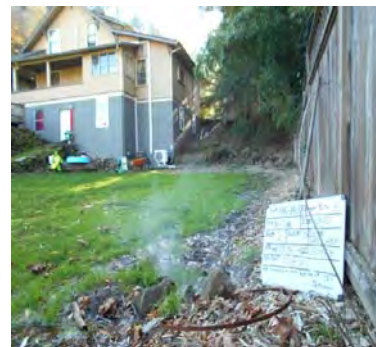
Basin 2 Run 2 Leak 3 B

Comments: Black drainage pipe along back side of property.

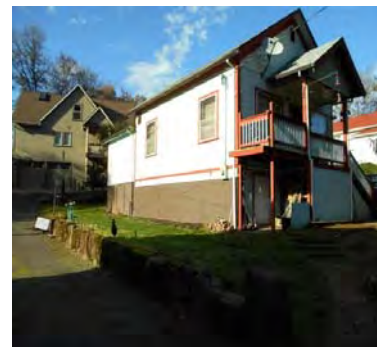
Basin 2 Run 2 Leak 4 B

Comments: Leak from stone wall at SW side of property.

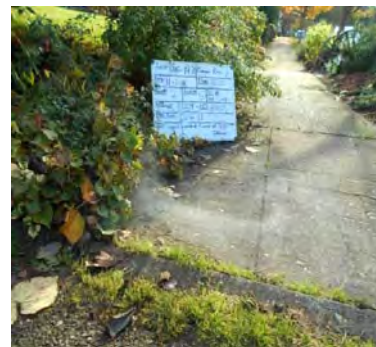
Basin 2 Run 2 Leak 5 A

Comments: Smoke from edge of sidewalk at N corner. Unknown Source

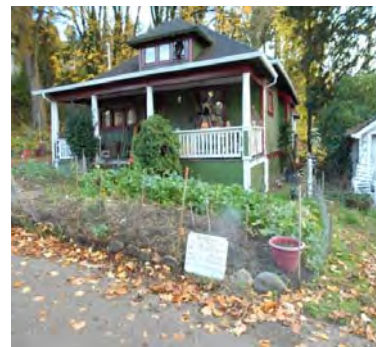
Basin 2 Run 3 Leak 1 B

Comments: Smoke coming from garden at N corner of property. Unknown Source

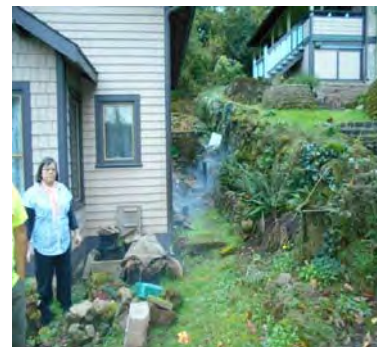
Basin 2 Run 4 Leak 1 B

Comments: Smoke coming from rock wall. Unknown Source

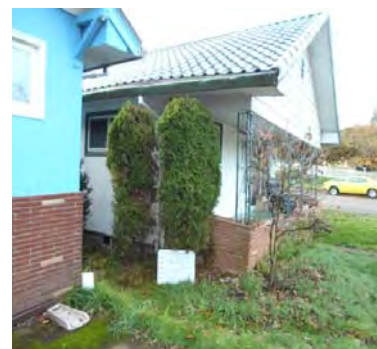
Basin 2 Run 5 Leak 1 B

Comments: Leak at N corner of 100 High St.

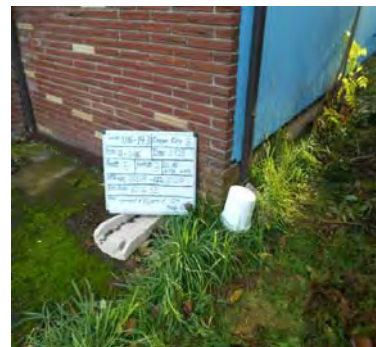
Basin 2 Run 5 Leak 3 A

Comments: Downspout at W corner of house.

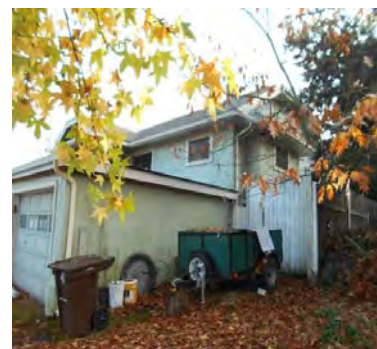
Basin 2 Run 6 Leak 2 B

Comments: Downspout at W corner of house.

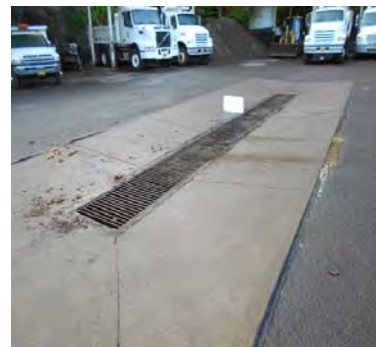
Basin 2 Run 6 Leak 3 B

Comments: Wash pit appears to be connected to Sani

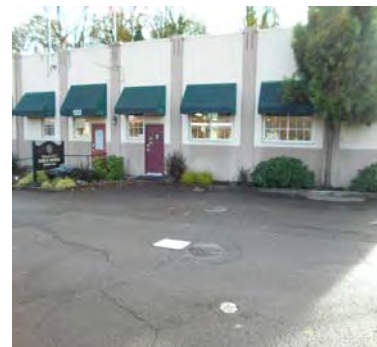
Basin 2 Run 6 Leak 4 B

Comments: Storm MH near MH #11599 smoking. Need to verify that this is Storm line. Possible manhole lid mis-label.

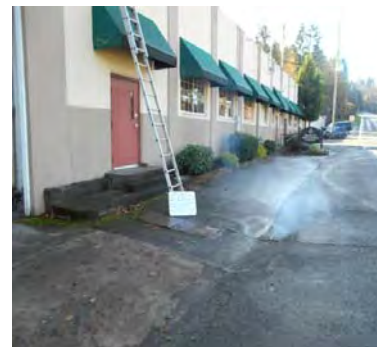
Basin 2 Run 7 Leak 1 B

Comments: Storm drian in parking lot appears to be connected to Sani

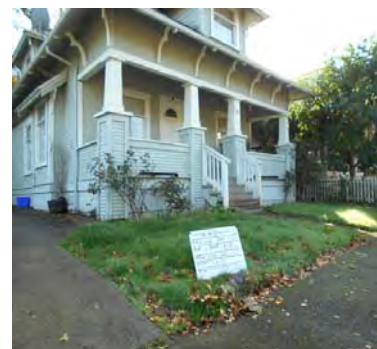
Basin 2 Run 7 Leak 2 B

Comments: Smoke coming from edge of sidewalk, Unknown Source.

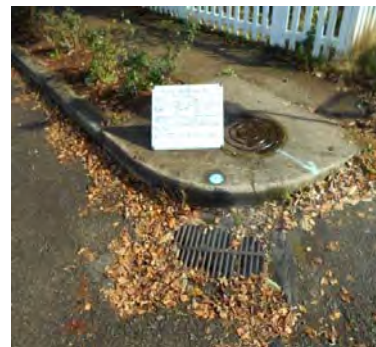
Basin 2 Run 7 Leak 3 A

Comments: All storm drains at 1st + Center have smoke coming out, 4 storm drains

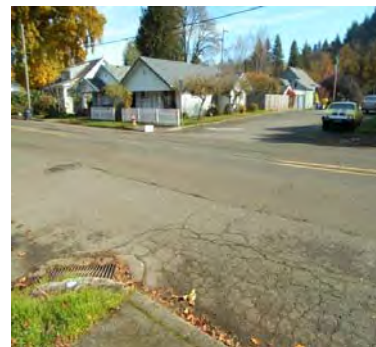
Basin 2 Run 7 Leak 4 B

Comments: All storm drains at 1st + Center have smoke coming out, 4 storm drains

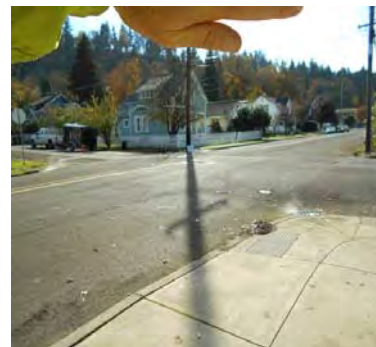
Basin 2 Run 7 Leak 5 B

Comments: All storm drains at 2nd + Center have smoke coming out, 4 storm drains

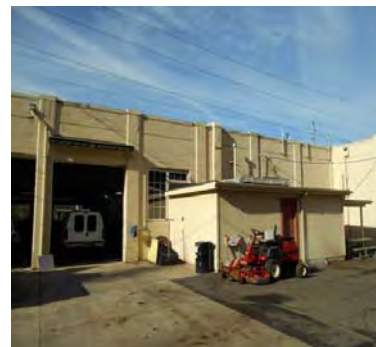
Basin 2 Run 8 Leak 1 B

Comments: Leaks from gutters and downspouts at city shop

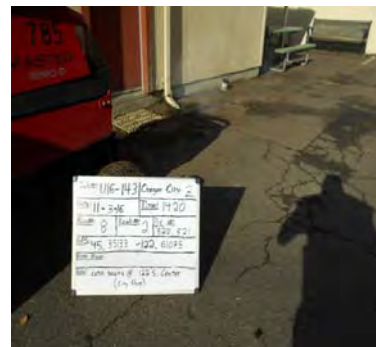
Basin 2 Run 8 Leak 2 A

Comments: 3 catch basins in city shop parking

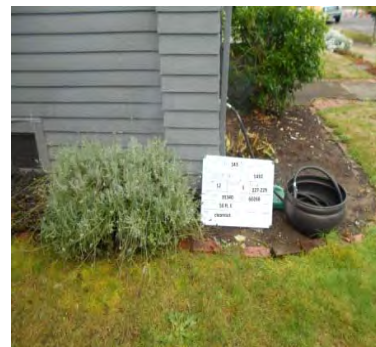
Basin 3 Run 12 Leak 1 A (edited)

Comments: Broken CB at corner of house

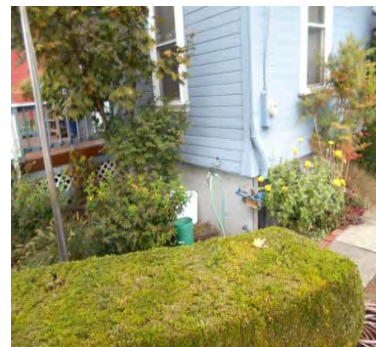
Basin 3 Run 12 Leak 2 B

Comments: Leaking cleanout

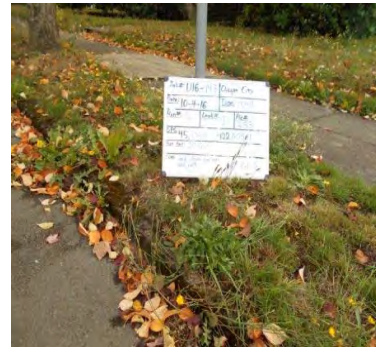
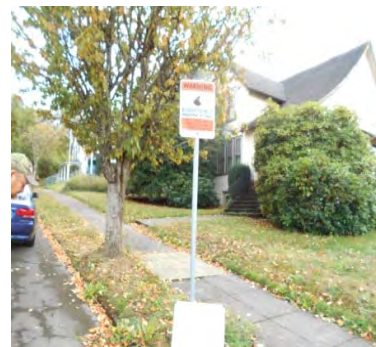
Comments: Leak from below sign post and curb

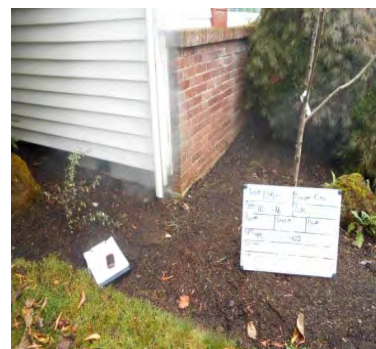
Basin 3 Run 22 Leak R1 A

Comments: Leak-downspout at front corner of house.

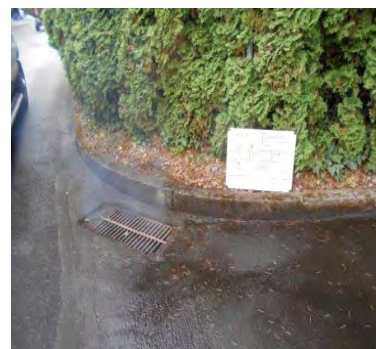
Basin 3 Run 22 Leak 2 B

Comments: Storm drain near MH 11554

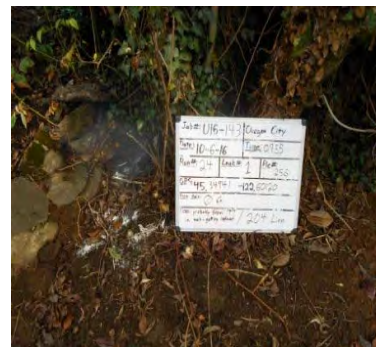
Basin 3 Run 24 Leak 1 A

Comments: Leak #1 was actually found during run #26, but is located within run #24. Leak suspected to be from "T" in the main getting replaced.

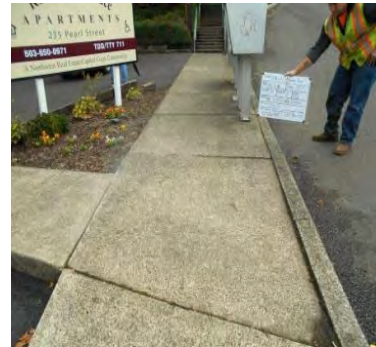
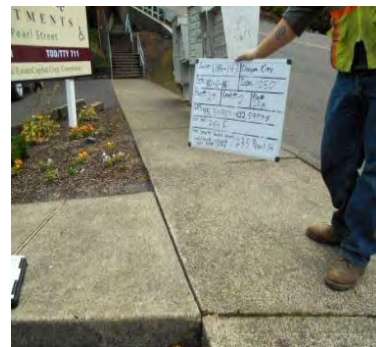
Comments: Several leaks from underneath sidewalk near MH 11476. Unknown Source

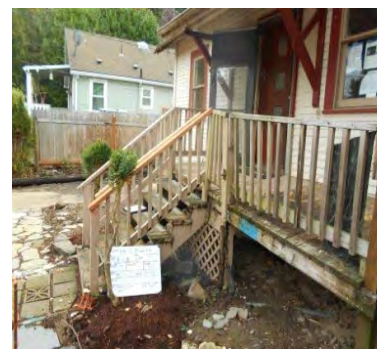
Basin 3 Run 24 Leak 3 B

Comments: Cleanout under front porch smoking

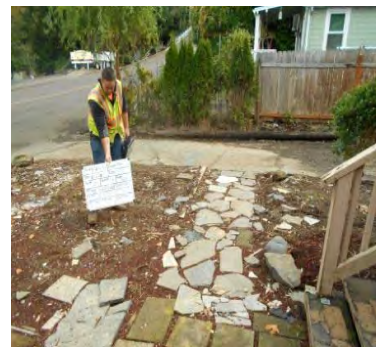
Basin 3 Run 24 Leak 4 B

Comments: Smoke from hole in front yard. Unknown Source

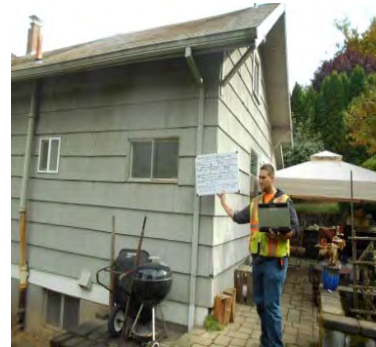
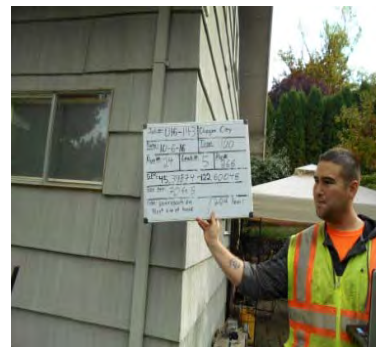
Comments: Downspouts on west side of house.

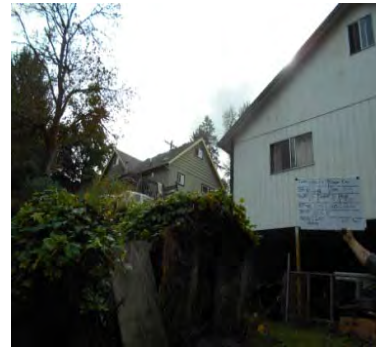
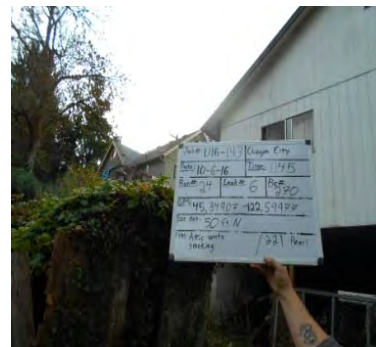
Comments: Attic vents smoking.

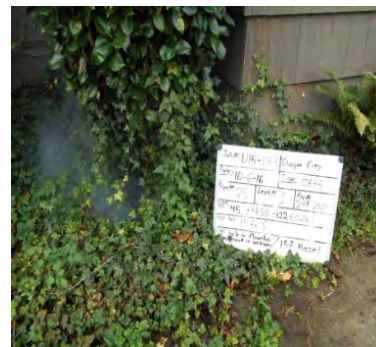
Basin 3 Run 25 Leak 1 A

Comments: Smoke from hole in flower bed + crack in walkway. Unknown Source

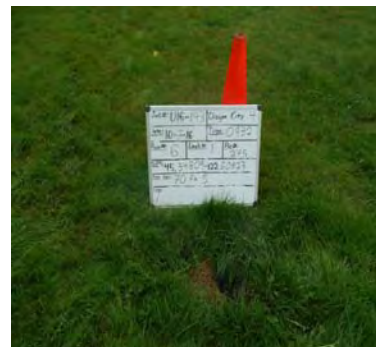
Basin 4 Run 6 Leak 1 A

Comments: Smoke coming from hole in yard.

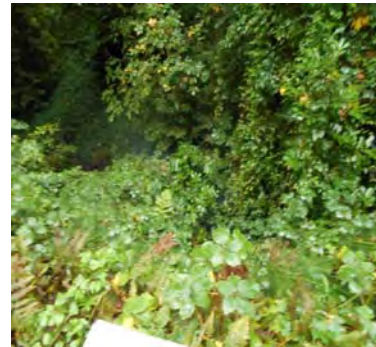
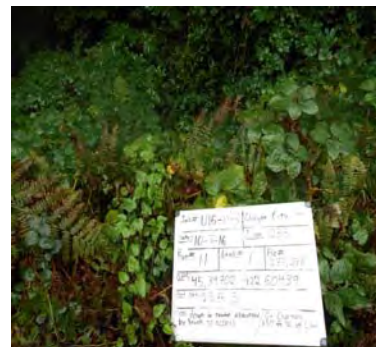
Comments: Medium to heavy smoke from unkown source down in ravine- no access.

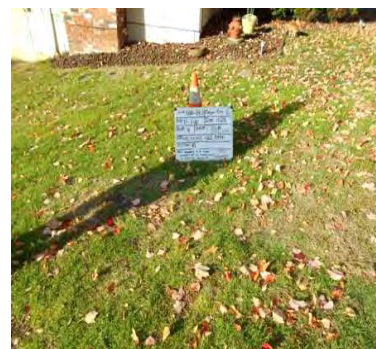
Basin 6 Run 4 Leak 1 A

Comments: Old broken capped pipe.

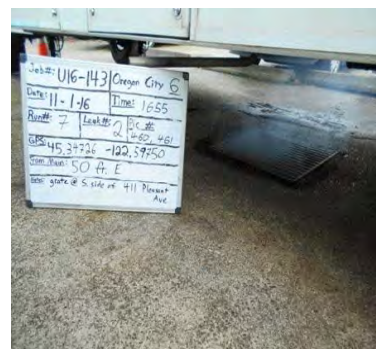
Basin 6 Run 7 Leak 2 A

Comments: Smoke from Wash drain

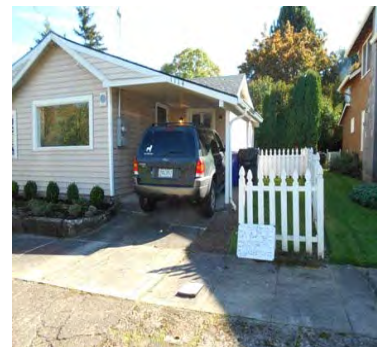
Basin 7 Run 9 Leak 3 B

Comments: Leak from sidewalk at fencepost + driveway, possibly a lateral.

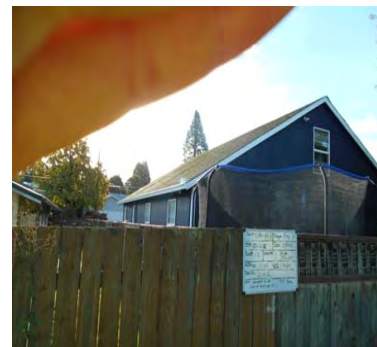
Basin 7 Run 17 Leak 1 D

Comments: Downspout at NE corner of house.

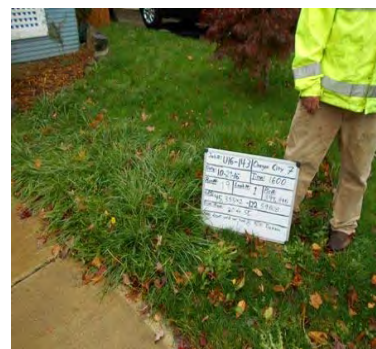
Basin 7 Run 19 Leak 1 A

Comments: Smoke from ground in line with service lateral.

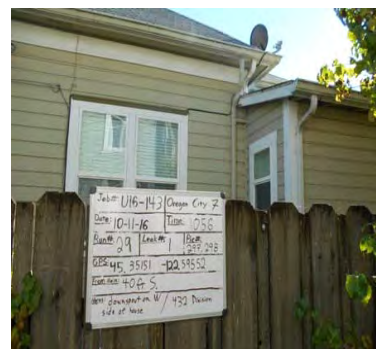
Basin 7 Run 29 Leak 1 A

Comments: Downspouts appear to be cross connected

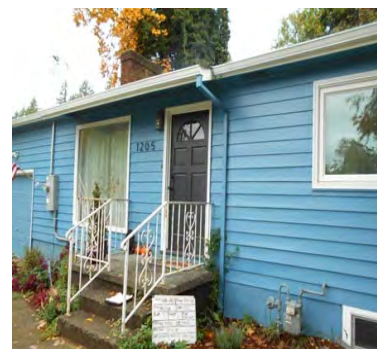
Basin 8a Run 9 Leak 1 B

Comments: Downspout located at front of house (front door)

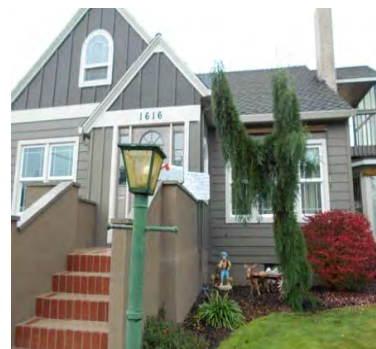
Basin 8a Run 11 Leak 1 B

Comments: No smoke from 13732 to 12913 possible sump pump system.

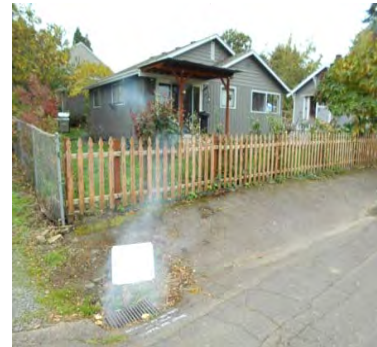
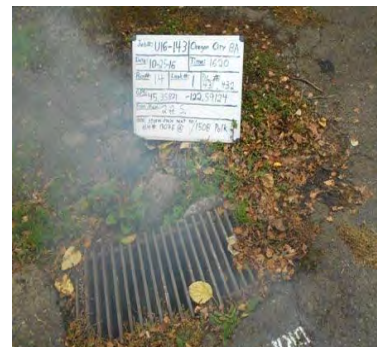
Comments: Smoke from stormwater catch basin

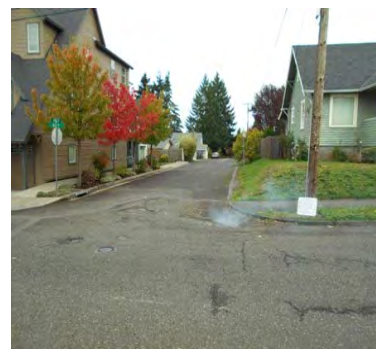
Basin 8a Run 18 Leak 1 B

Comments: Storm drain at E corner of intersection.

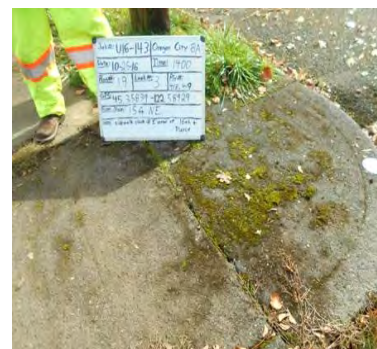
Basin 8a Run 19 Leak 3 A

Comments: Sidewalk crack at E corner of 16th + Pierce. Unknown Source

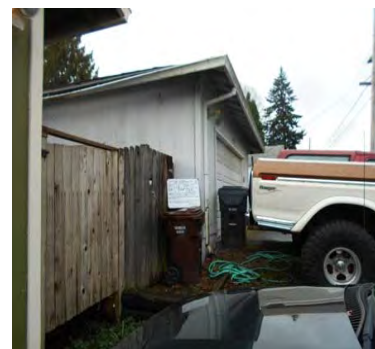
Basin 8B Run 4 Leak 1 B

Comments: Downspout at NE corner of house.

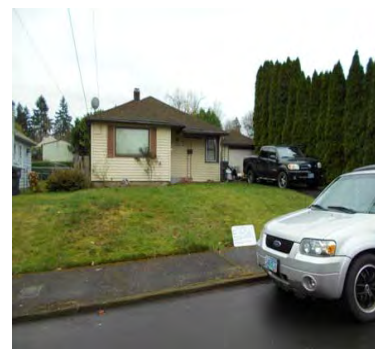
Basin 8B Run 6 Leak 2 B

Comments: Smoke from ground, Unknown Source. Likely service lateral

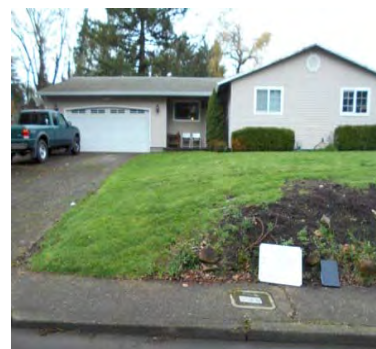
Basin 8B Run 8 Leak 2 B

Comments: Water meter access panel.

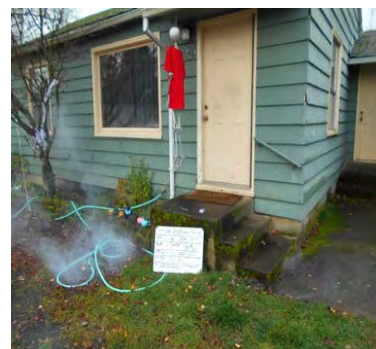
Basin 8B Run 12 Leak 1 B

Comments: Smoke from ground, Unknown Source.

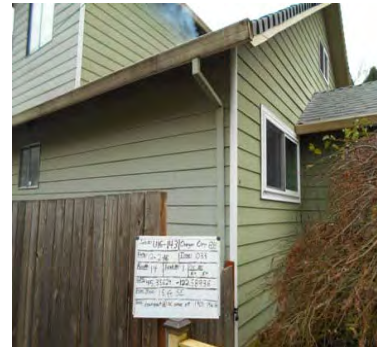
Basin 8B Run 14 Leak 1 A

Comments: Smoke from Downspouts

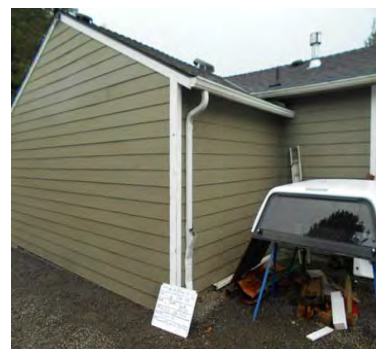
Basin 8B Run 16 Leak 1 B

Comments: Smoke from Downspouts
