Certified Arborist Report

Subject: Tree Health & Safety Evaluation

Address of the Report: Approx. 1208 Linn Ave (Mt. Pleasant Apts.)
Oregon City, OR 97045

Date of the Report: 10/01/2017

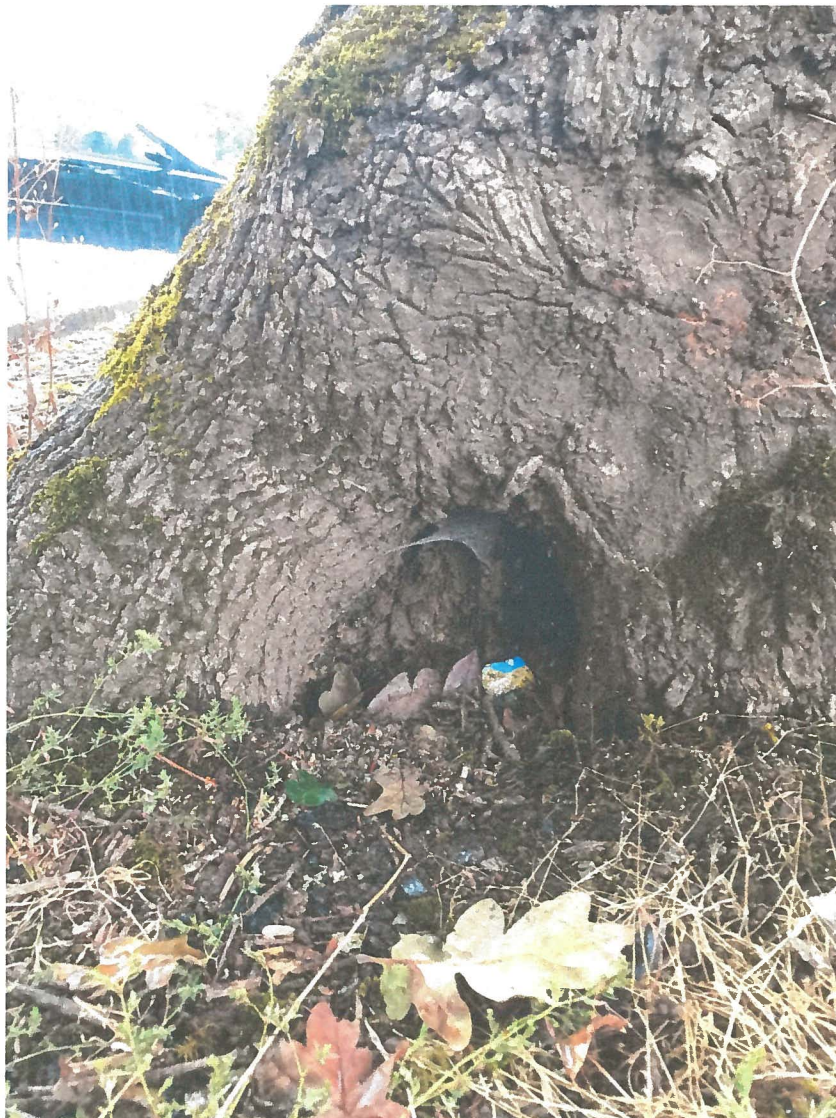
During my initial inspection I didn't see any conks like I did in the middle Oak tree but I did see 2 different areas where the base of the trunk (or buttress) did not meet the root plate. In these areas there was a distinct separation where the trunk didn't make contact to the roots or ground level (see attached photo). This is a sign that injury or decay occurred at these sites. I'm leaning toward decay since there are two separate locations and when knelt down I could see hollow space that led back into the center of the base of the trunk. Looking upward into the crown, I saw basically an exact duplicate of what I saw in the middle Oak tree – areas rotting back into the top of the trunk (see attached photo).

Location 1 of buttress cavity

In conclusion, although this Garry Oak in question didn't show a large conk like the middle Garry Oak, it was still showing similar signs to similar issues on the tree. The crown was dying back and rotting into the top of the trunk and the bottom of the trunk had two different areas where the buttress wasn't connected to root zone where cavities were present. Due to the lack of connectivity here and a visibly hollow trunk base, failure of the entire tree becomes much more likely in stressed or storm-like conditions. Given that the Southern-most Oak fell into the road and the middle Oak appeared basically ready to do the same, I think it is only wise to remove this Oak tree as well, given what we are seeing and how its health seems to be lining up with the other two trees.

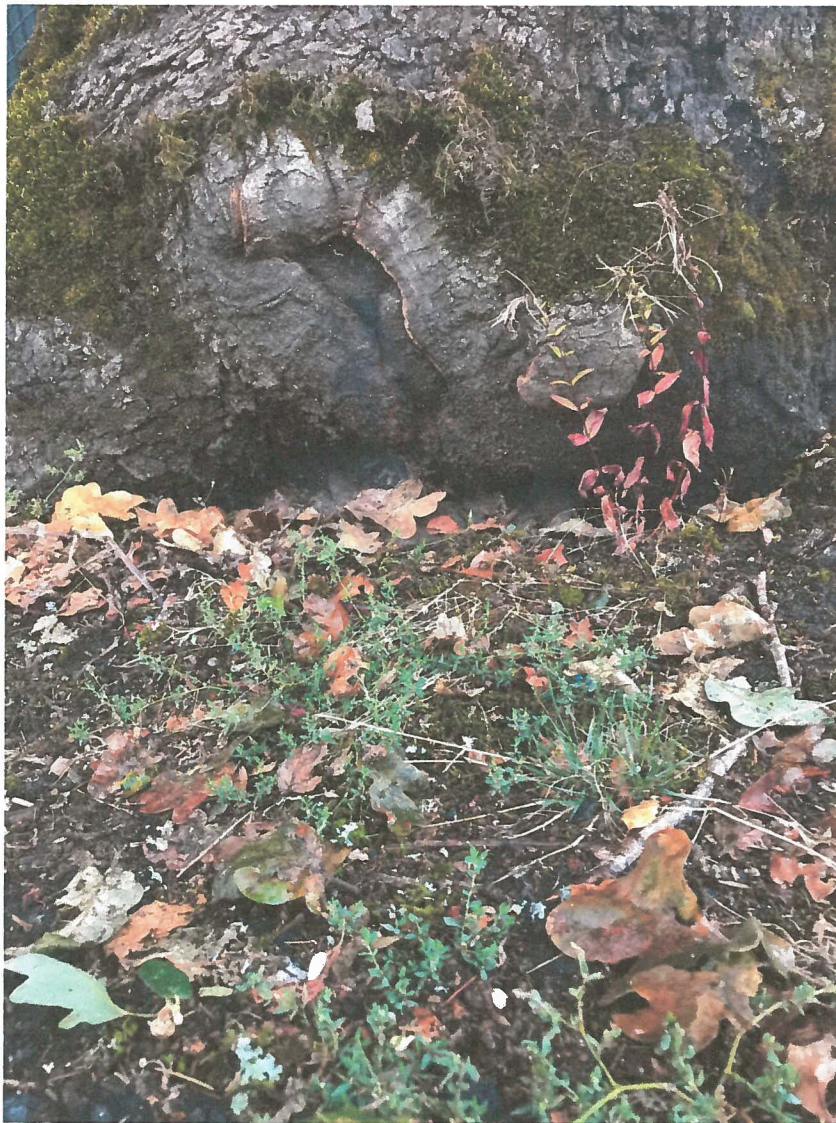
Location 2 of where buttress is disconnected from root plate

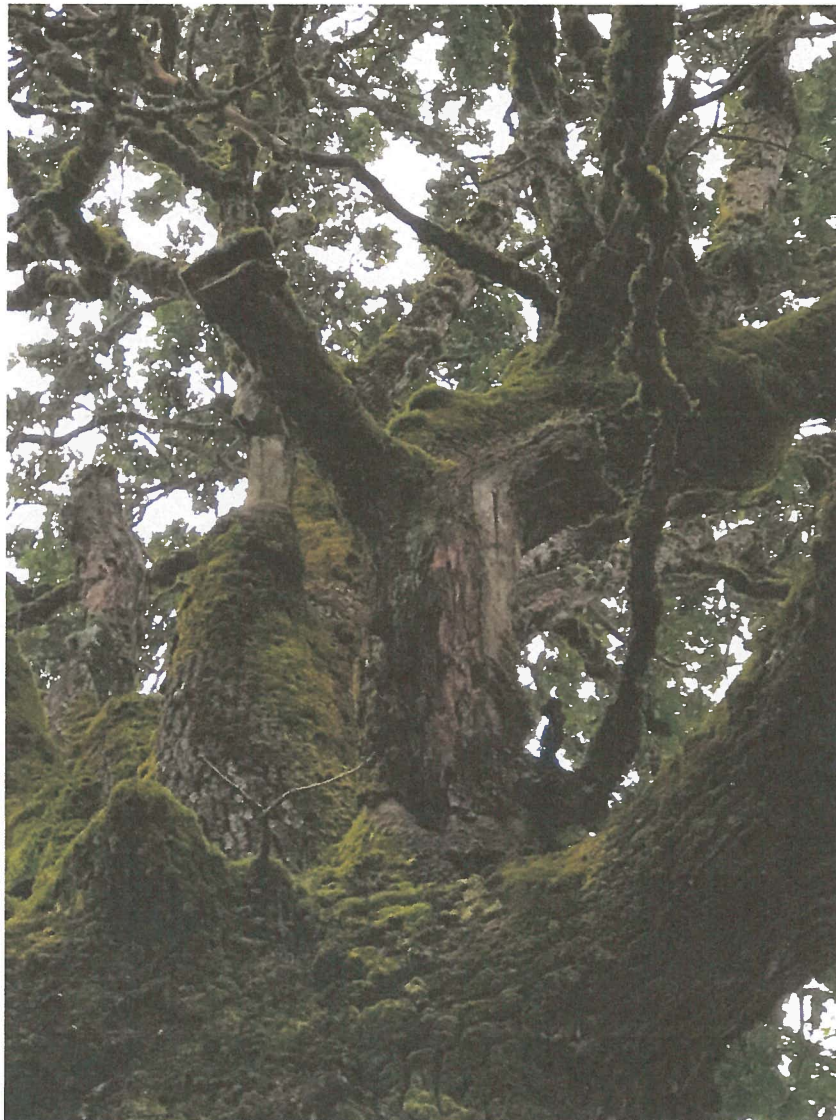
Poor condition of crown showing wood rotting back into top of trunk
