## Certified Arborist Report

Tree Health & Safety Evaluation

Approx. 214 Linn Ave (The Marylhurst School)

10/01/2017

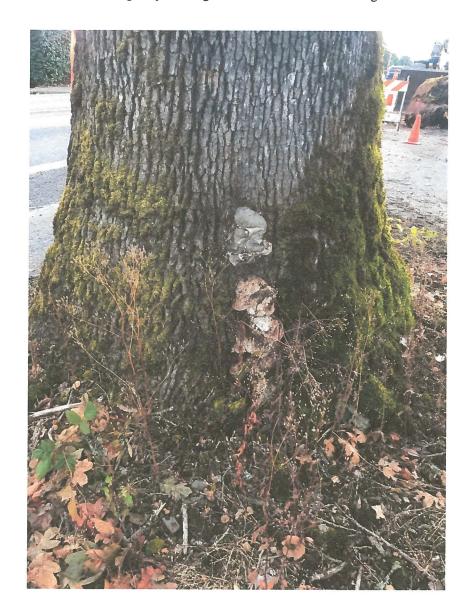
During my initial inspection, it became quickly apparent that there was something wrong this tree. At the base of the trunk (see attached photo) there is a large conk or fungal fruiting body that is significant in size. The size of the conk measures nearly 2 feet in length. The large size and span of this conk is an indicator that there is a substantial and progressed area of wood rot fungus at the base of the trunk (if not also further up the trunk as well). Looking upward, I noticed that the crown had a fair amount of portions that were dying back and rotting inward into the main trunk (see attached photo). This may have helped initiate the entry of the fungus into the main trunk or it could be a secondary issue that was caused by the basal trunk infection. Either way, wood rot is occurring at the top and bottom of the tree.

Ganoderma fruiting body showing evidence of active rot occurring at base of tree

In conclusion, given the substantial and obvious signs of wood rot fungus in the subject Garry Oak as well as the high frequency of foot and vehicle traffic, I am recommending that the tree be removed as soon as possible. This tree is likely the same age as the Oak tree that fell recently into the road and likely is suffering from the same fungal disease.
