Tree # 1

**RE:** Tree Risk Assessment of 36-inch Oregon white oak (*Quercus garryana*), northeast of Mt. Pleasant Elementary School, 1232 Linn Ave., Oregon City, OR.

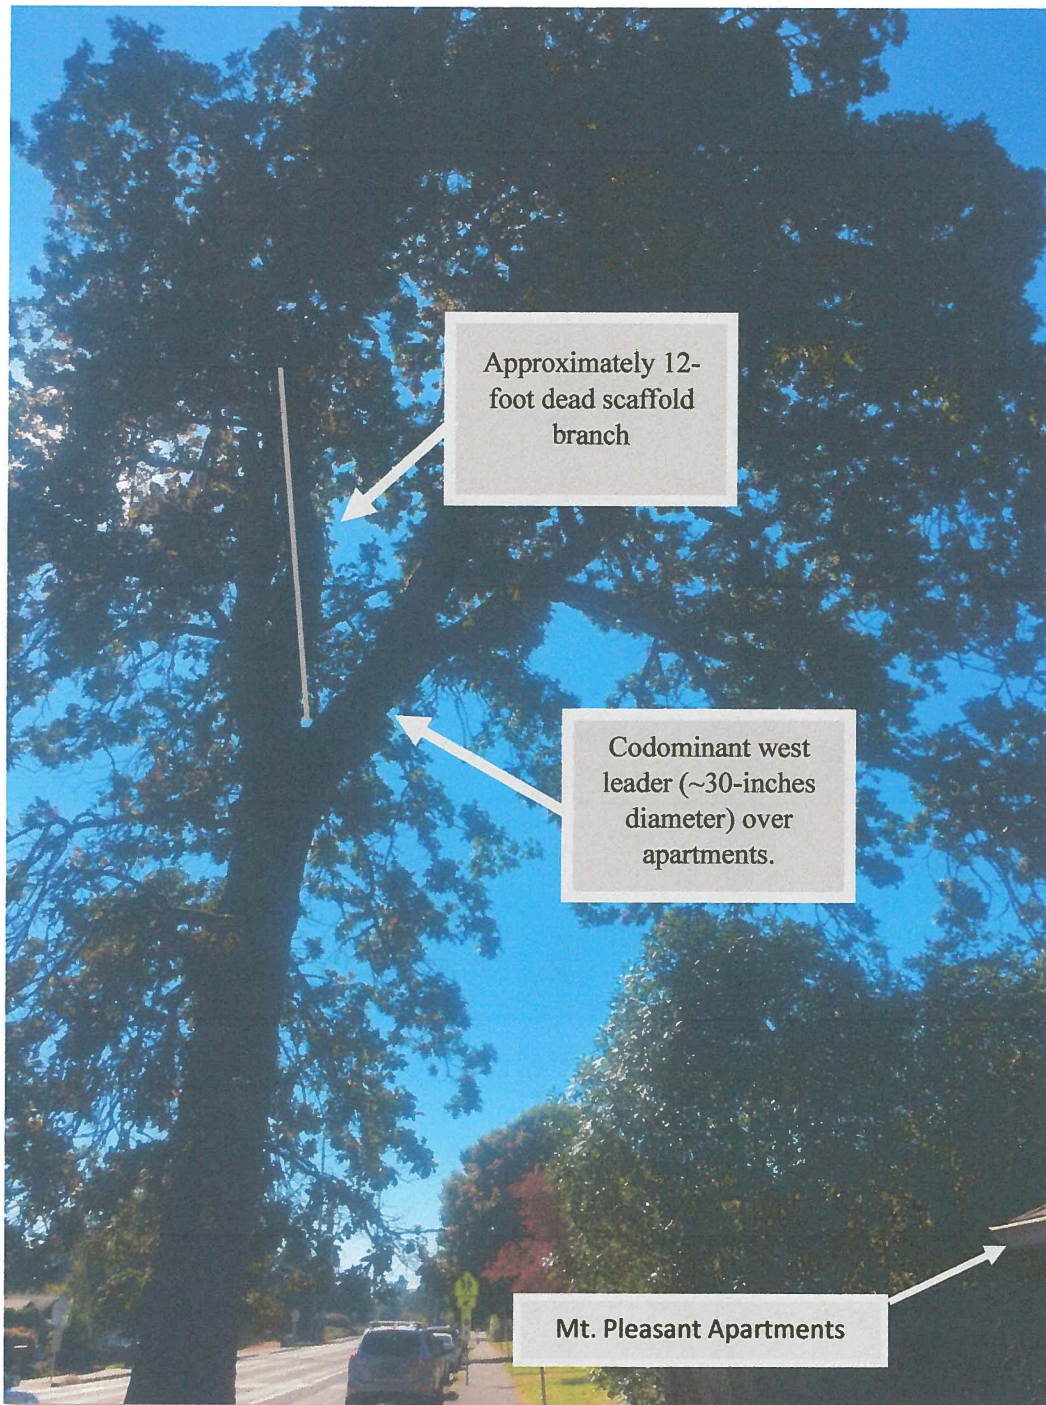
The assessed tree is a 36-inch diameter Oregon white oak (*Quercus garryana*), approximately 55-feet in height (see Figure 1). It is in a parking strip between the sidewalk and bike lane. Asphalt is paved to within 15-inches of the trunk on all sides. A fire hydrant is located on the tree's north side which assumes the supply line for the hydrant runs along the west edge of the right of way, possibly cutting off the roots on the west side of the tree when installed. The oak visually appears to be in fair health and is of fair structural condition. The tree's health is rated fair as the tree's crown is exhibiting signs of stress such as smaller off-colored leaves and short internodal growth, however there is limited die-back. The tree's structure is rated as fair as the crown has two codominant leaders with a wide angle of attachment. The east leader is near vertical; the west leader, approximately 30-inches in diameter, has a 22-degree lean to the west toward the neighboring apartment building. At the north side of the two-leader union is a decayed scaffold branch stub which may indicate the presence of decay in the union, possibly destabilizing the two codominant leaders. In the northeast crown quadrant is a larger, approximately 12-foot long and 8-inch diameter dead scaffold branch with a nesting hole near the top. When viewed from the east, the top of the crown is heavier to the south, possibly due to the absence of the above-mentioned branches.

Figure 1. View from north

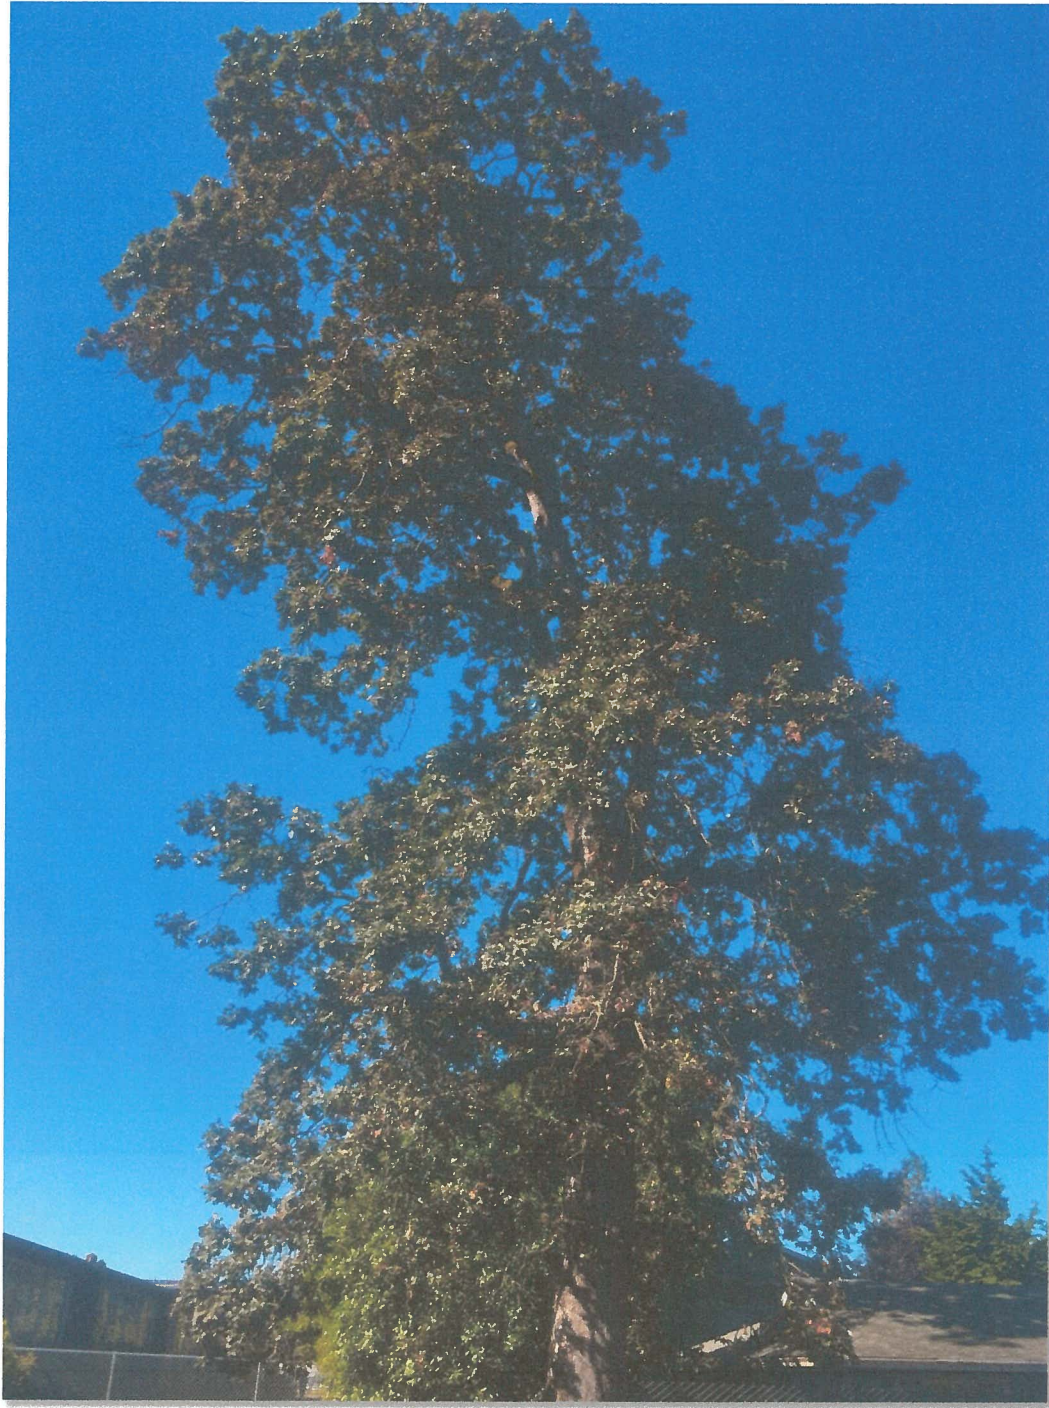
*Figure 2. View from east.*

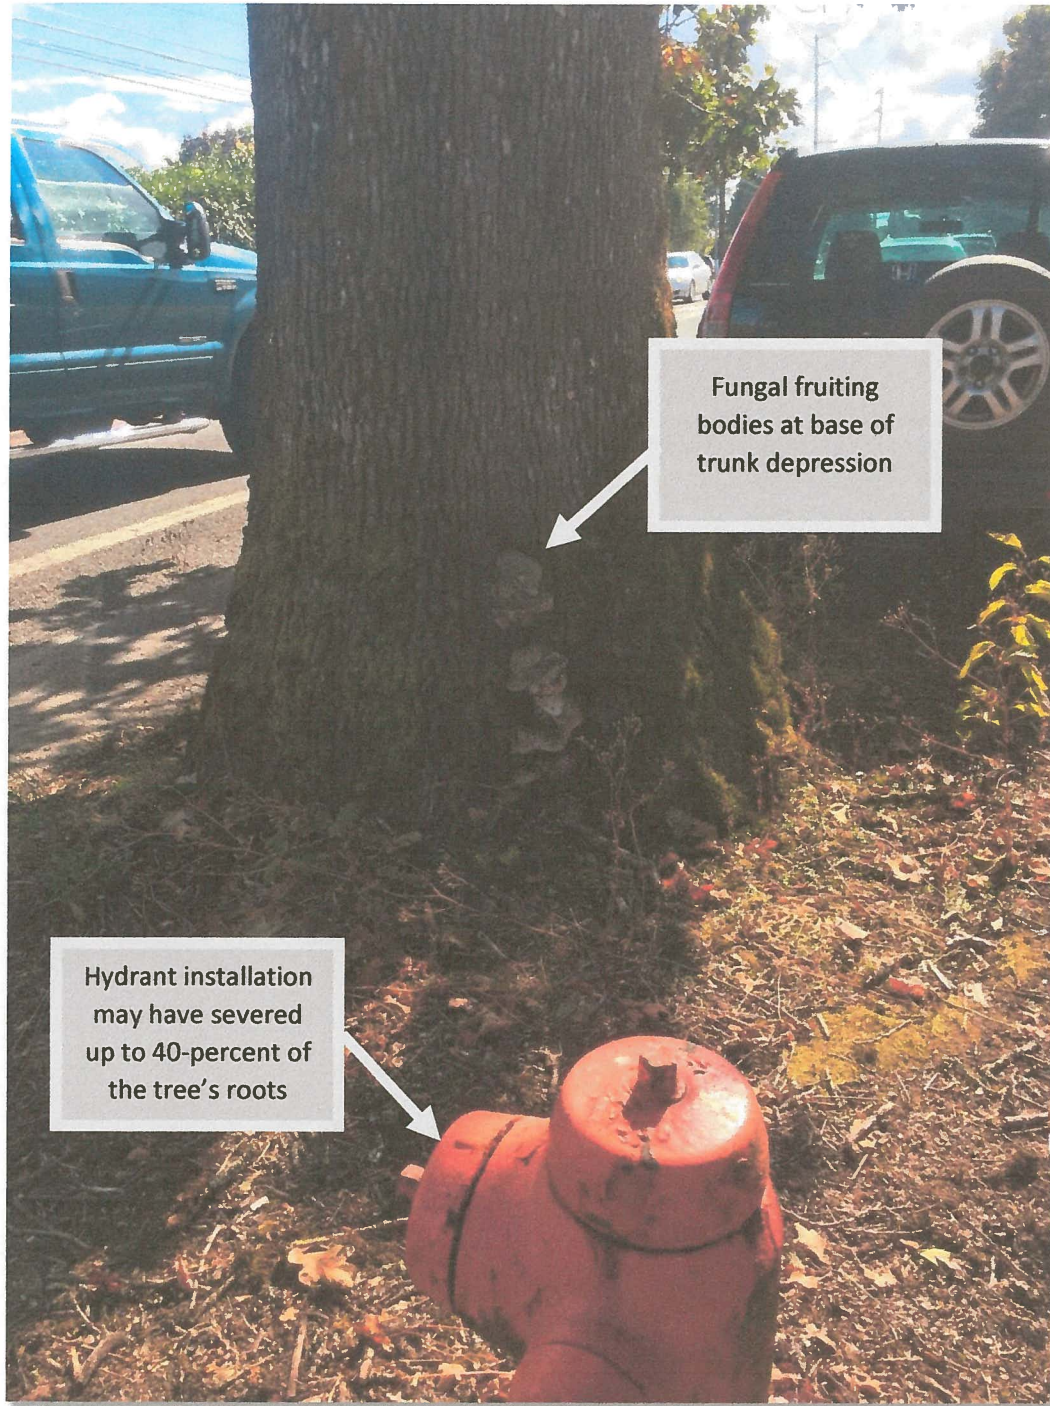
On the tree's northwest side, there are fungal fruiting bodies at the base of a depression in the trunk near soil level. Several layers of white hard fruiting bodies of varied ages span approximately two vertical feet. In the

The laboratory was unable to confirm the identity of the conk found on the tree's north trunk near the base due to the age of the sample (which was the youngest on the tree), and the appearance that the original fungus had been parasitized by a secondary fungus. The presence of several years' worth of conks, the depression on the north trunk above the fungi, and that all conks appear to have been parasitized indicate the original fungus, possibly a species of *Ganoderma*, has colonized the tree for many years. The potential damage associated with the presence of wood-decaying fungi is compounded by the likely root suffocation and therefore death of roots when the parking area was created, and by the installation of the fire hydrant which may have severed up to forty percent of the tree's roots, including structural roots. The likelihood the tree has significant advanced decay in its major roots is supported by the minimal sidewalk and road damage caused by the recent oak's failure that was growing in similar conditions; the root wad of the failed tree shows highly decayed structural roots.

The presence of a *Ganoderma sp.* conk in the lawn west of the 36-inch Oregon white oak indicates the presence of this aggressive pathogen, and has possibly infected the assessed tree. The presence of several conks on the lower northwest trunk indicates a pathogenetic infection that could cause the same or similar weakness in this tree as was present in the tree that failed.

*Figure 3. Fungal fruiting bodies; hydrant proximity.*

**Recommendation:** Given the **high** risk of whole tree failure, this tree should be removed.

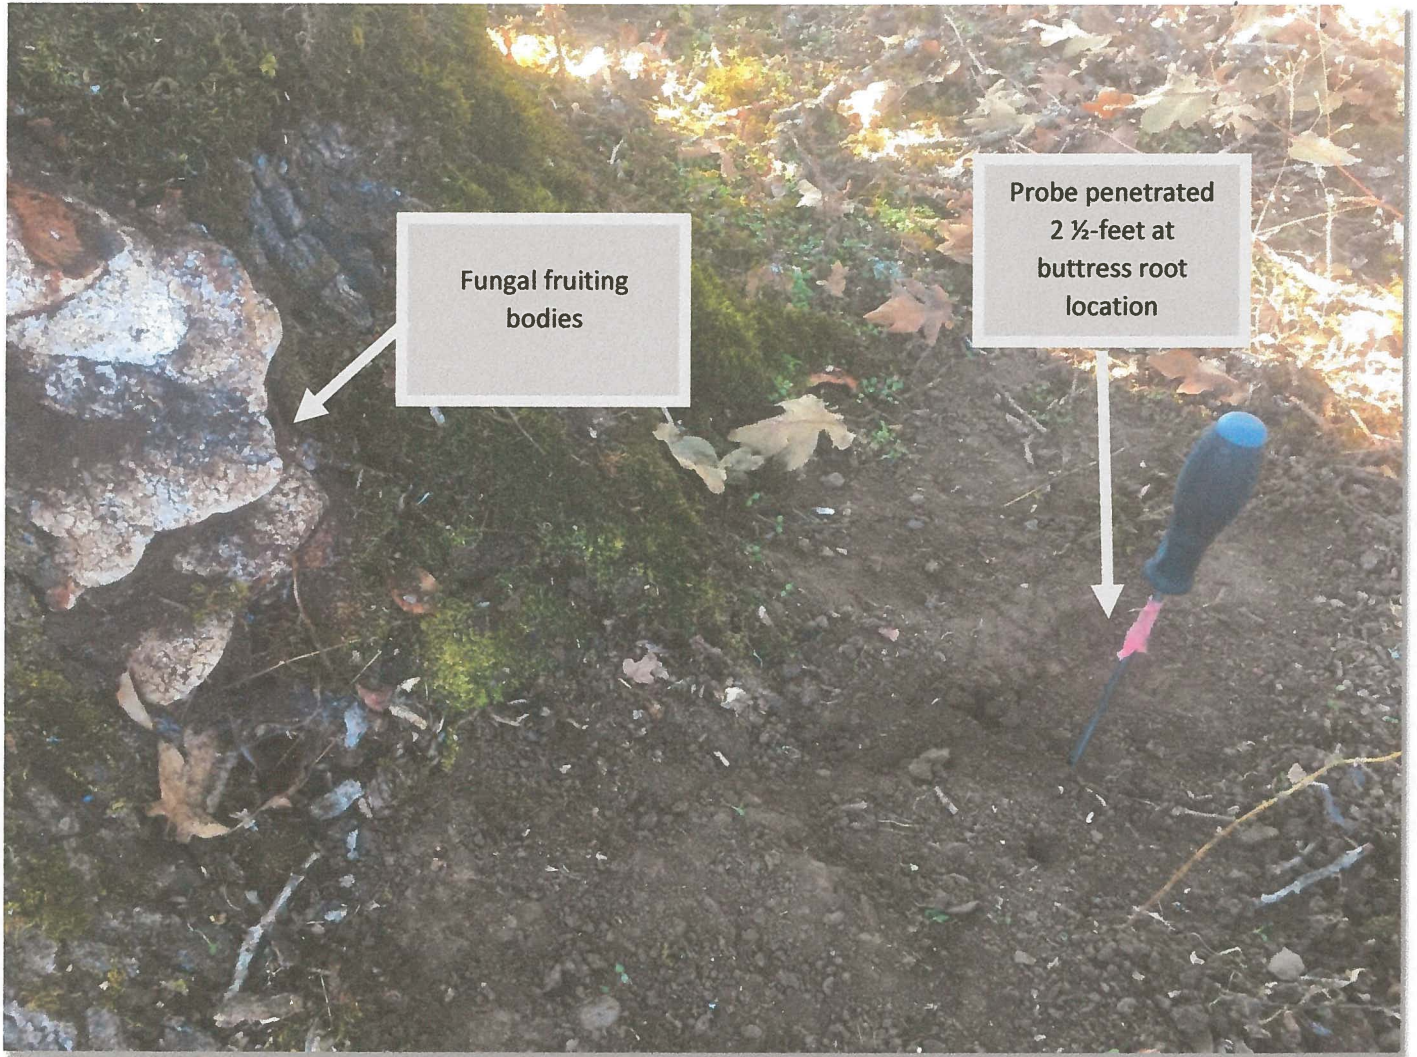
Every 20-inches around the tree adjacent to tree's buttress roots, at 4 to 8-inches from the trunk, I probed the soil with a 3-foot long metal probe. This is a low-invasive technique to determine the integrity of structural roots. In most of locations, the probe penetrated about 18-inches, which may indicate structural root decay. The probe location near the fungal fruiting body on the trunk penetrated approximately 30-inches which strongly indicates the possibility of decayed structural roots.

*Figure 4. Probe penetration at structural root location near fungal fruiting bodies.*

If it is desired to retain this tree, further analysis which may include a root crown excavation will be required to rule out advanced root decay before any recommendation would be made to retain this tree. Removing the tree will eliminate all its associated risks.

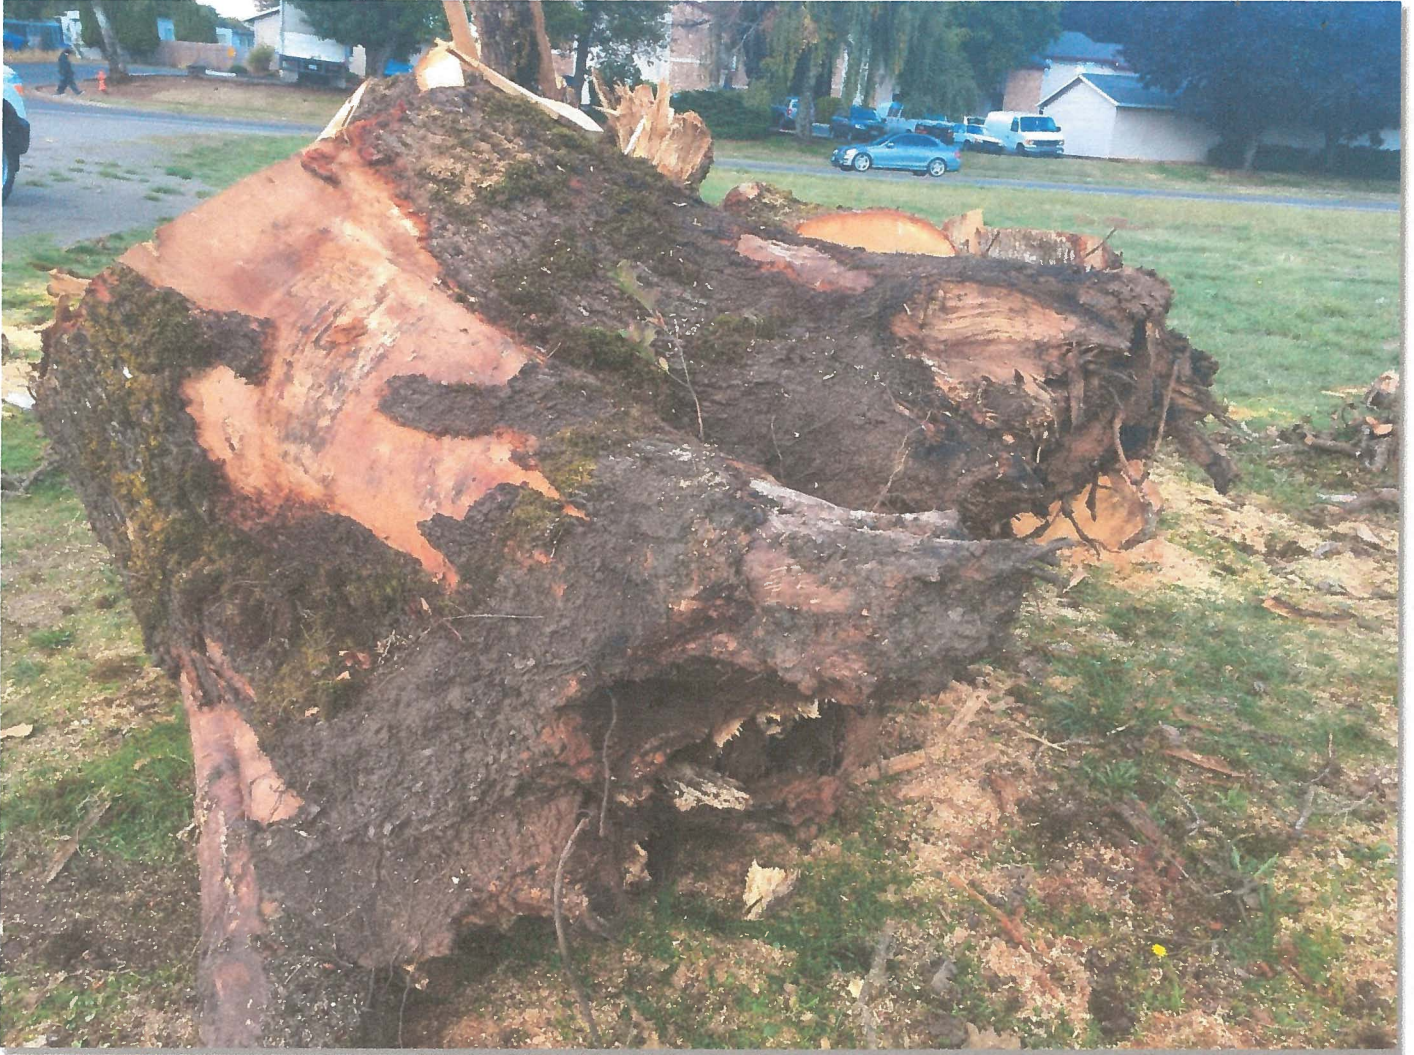
The largest of the three oaks failed near 1:30am on September 19<sup>th</sup>, 2017. The previous day, 0.45-inches of rain fell. Just before the reporting of tree failure, there was a 9mph wind gust that came from the south/southwest, with wind gusts not exceeding 15mph during the hour prior. These low speed wind gusts are not typically associated with whole tree failure which occurs when forces applied to a tree exceed the strength of the tree.

*Figure 5. Failed root wad; extensive decay of structural roots.*
