Certified Arborist Report

Subject: Tree Failure Evaluation

Address of the Report: Linn Ave (near Central Point intersection)
Oregon City, OR 97045

Date of the Report: 09/22/2017

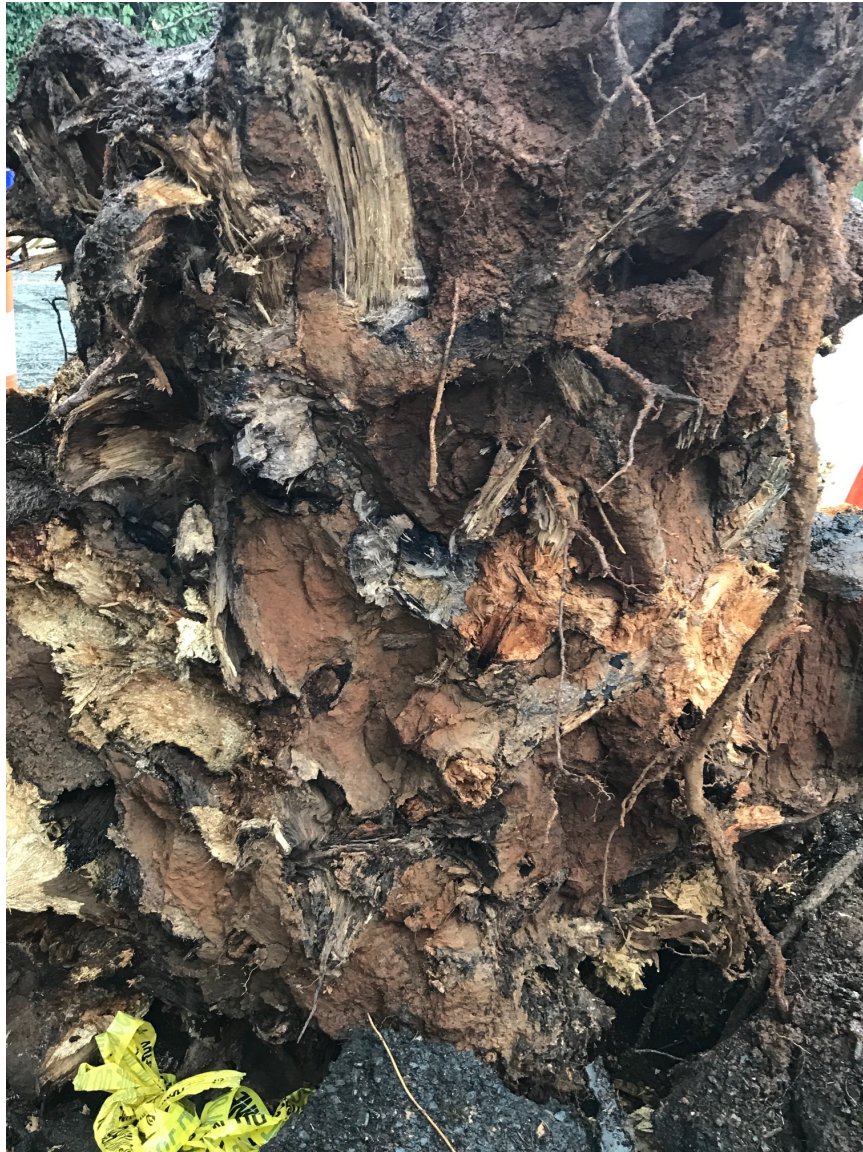
During my initial inspection of the fallen White Oak I was able to identify quickly that the tree failed at the buttress roots (see attached picture). The vast majority of the buttress roots and main root plate are all invaded by fungus which has changed the structural integrity of the wood making it weak and mushy. I was able to identify the fungus as Ganoderma root rot fungus. External signs on the outside of the trunk were surprisingly minimal with a small section on either side showing a dark discoloration and some bark de-laminating from the cambium.

In conclusion, the subject White Oak failed at the roots due to Ganoderma root rot, which had progressed quite extensively through the main root plate. Only by close examination prior to the tree's failure would one be able to identify that something was going on, but even then, it would have not led the examiner to believe such extensive rot was occurring.

Extensive Ganoderma root rot evident throughout root plate

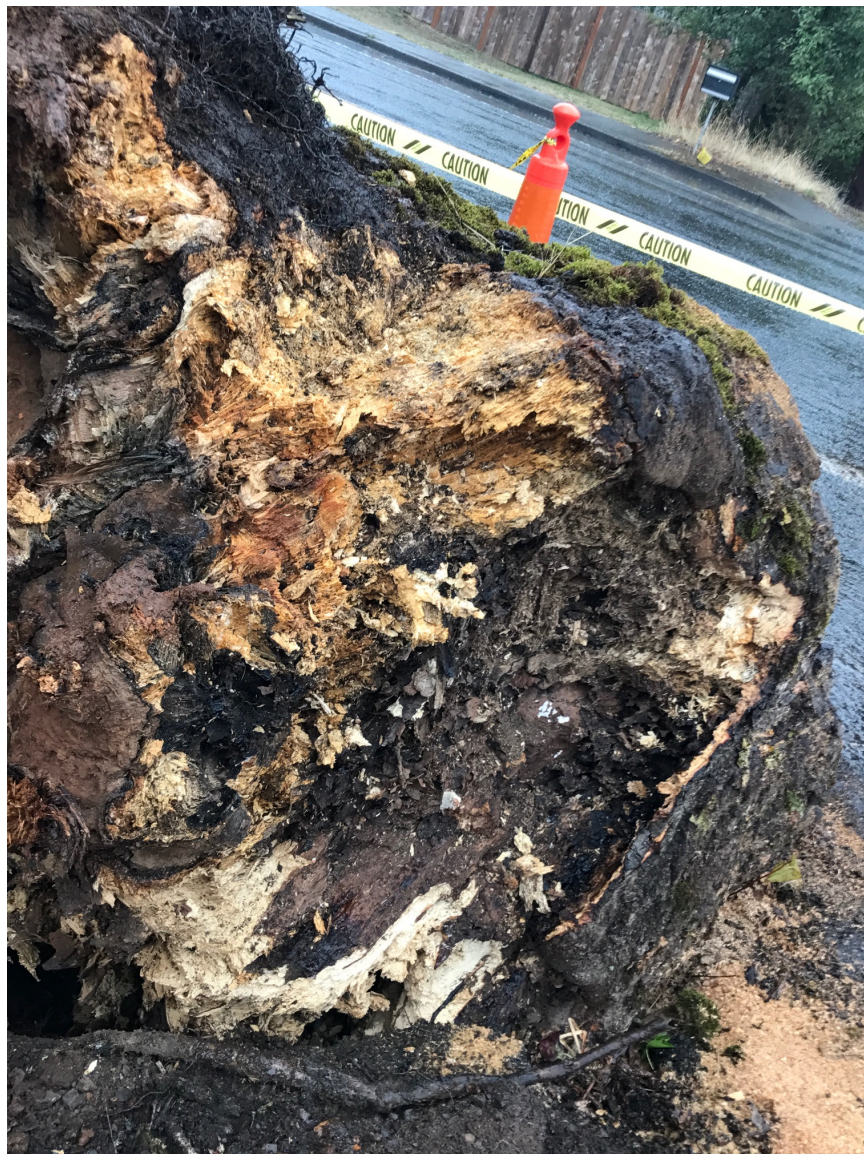
Showing slight discoloration where trunk met the dirt line
