## MEMORANDUM

SUBJECT: Molalla Avenue & Pearl Street Intersection Review

We visited the site on April 25, 2019 @ 9am to review and observe the intersection. Additionally, we drove through the intersection and observed the visibility of pedestrians within the intersection.

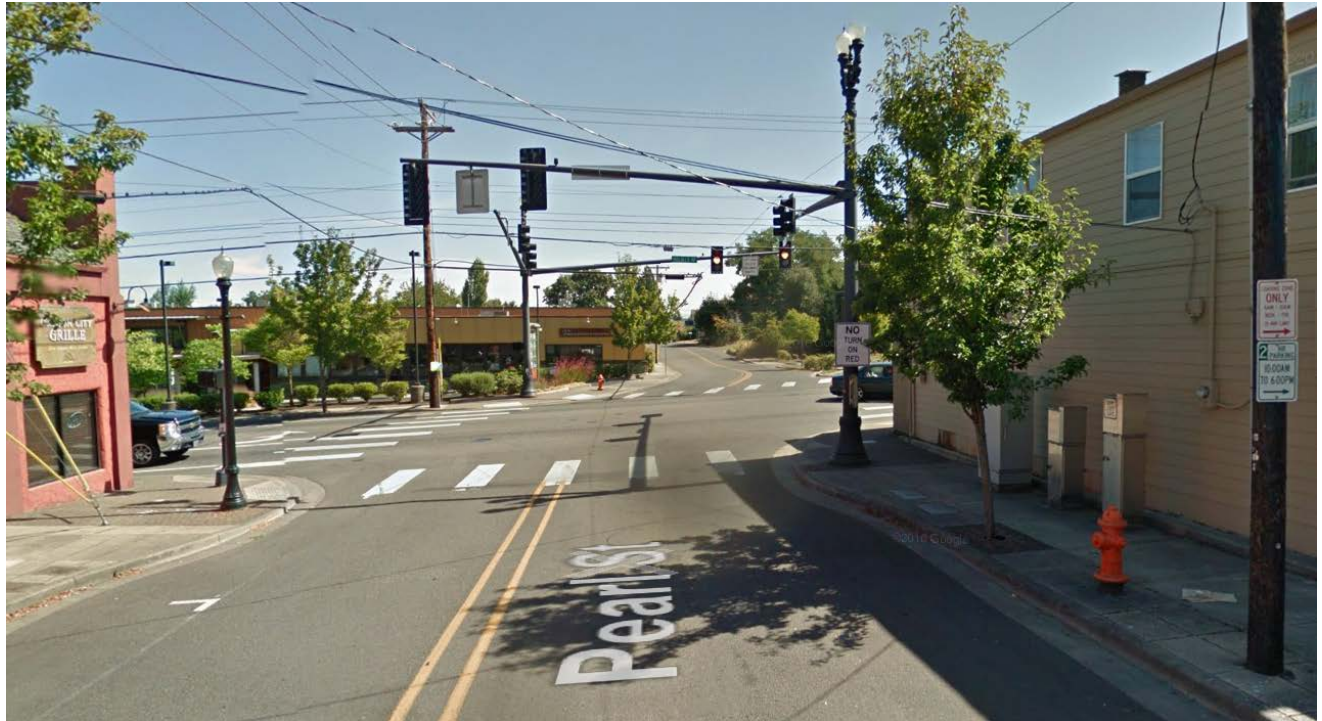
## Pearl Street Travelling West

- Generally, no visual obstructions from trees or excess poles exist from this approach.
- The placement of the buildings directly adjacent to the right of way is problematic at this approach for sight distance of vehicles turning from Pearl Street right onto Molalla Avenue southbound.

- An existing Left Turn Yield to Oncoming Traffic sign is located on the mast arm. This exact sign is no longer included in the MUTCD but is similar to the Left Turn Yield on Green (R10-12).

- An existing No Turn on Red (R10-11a) sign exists near the crosswalk and has clear visibility from the approaching lane.
  - This sign addresses the lack of sight distance around the building for vehicles turning right onto Molalla southbound.

- When a pedestrian activates the button to cross Pearl Street, if Molalla Avenue has a green light, the walk symbol is immediate activated. This creates an area for concern.

- With the northbound permissive left turn movement, a vehicle could make the left at any time. Additionally, if a pedestrian activates the push button, they would get a walk signal. In the event a pedestrian is crossing from south to north, the ramp location at the south end is not visible to the northbound vehicle making a left until they have entered the intersection.

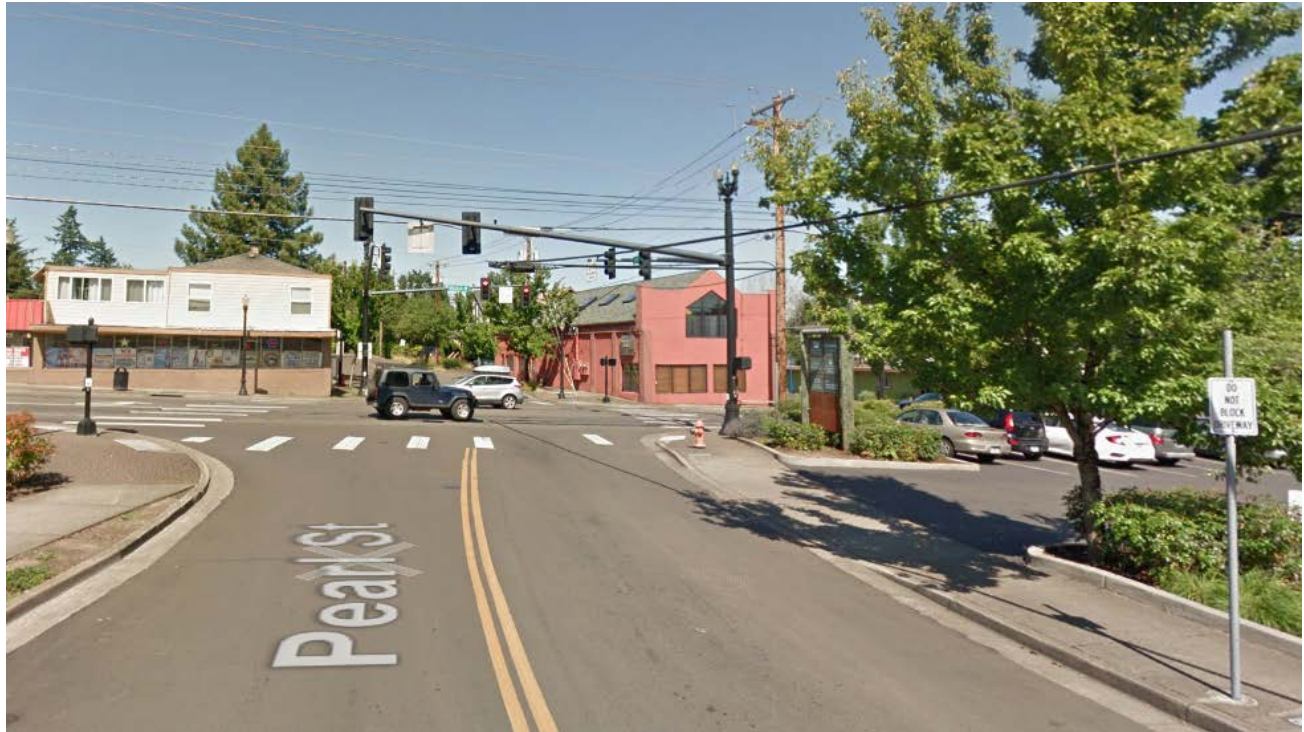
## Pearl Street Travelling East

- Generally, no visual obstructions from trees or excess poles exist from this approach.
- An existing Left Turn Yield to Oncoming Traffic sign is located on the mast arm. This exact sign is no longer included in the MUTCD but is similar to the Left Turn Yield on Green (R10-12).
- As a vehicle waiting to turn left from Pearl Street WB to Molalla Avenue SB the skew of the intersection generally presents the driver with a blind spot from the A-pillar. The pillar that connects the roof to the body, and is located at the front windshield.

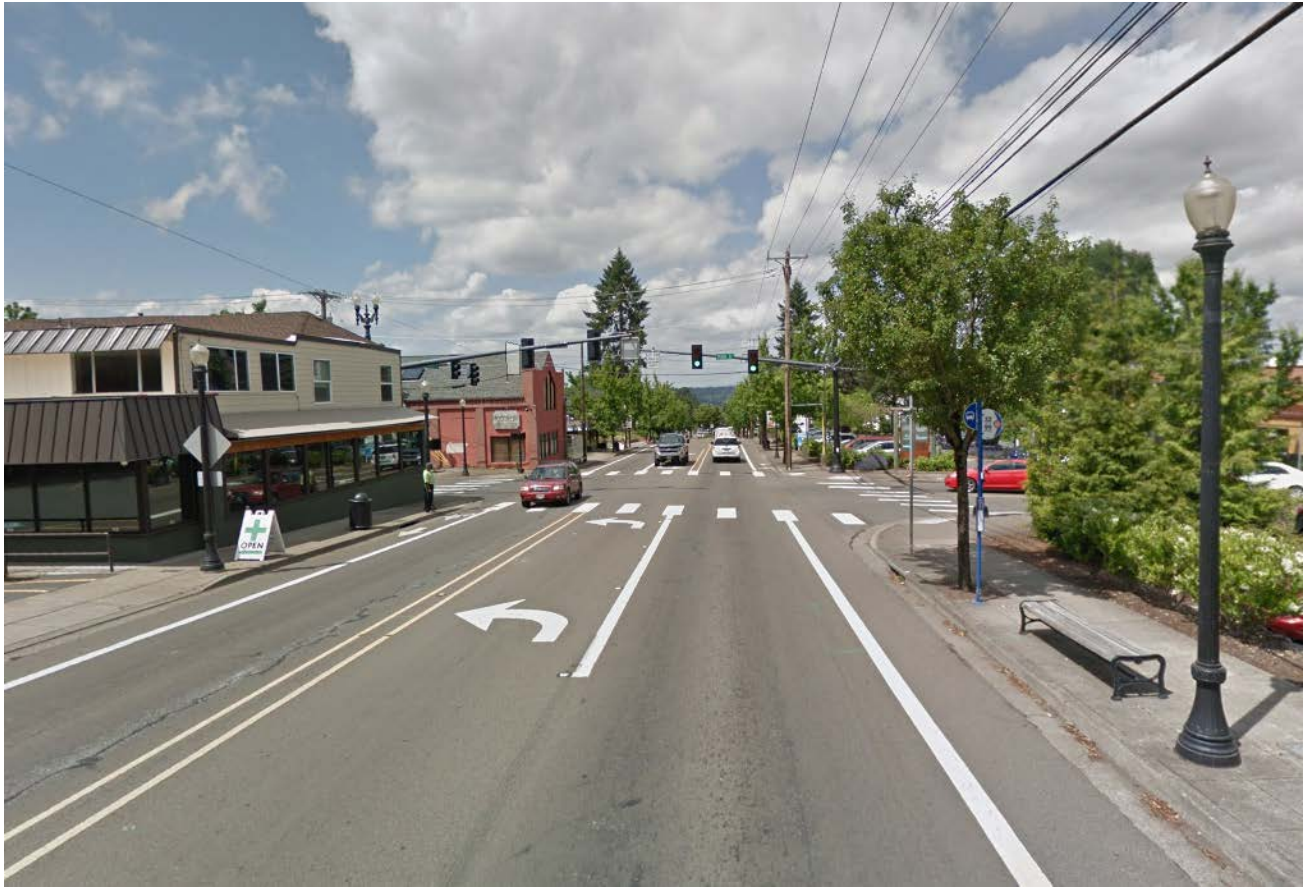
## Molalla Avenue Travelling North

- Generally, no visual obstructions from trees or excess poles exist from this approach.
- A vehicle travelling NB on Molalla Avenue using the left turn lane does not have a protected left, as the signal
- An existing Left Turn Yield to Oncoming Traffic sign is located on the mast arm. This exact sign is no longer included in the MUTCD but is similar to the Left Turn Yield on Green (R10-12).
- Northbound left turns are a permissive movement, not protected and occur from a dedicated left turn lane.

- Convert the Left Turn Lanes on Molalla Avenue from permissive to protected/permissive. This would require the addition of a new left turn signal head and changes to the signal phasing.

- This would resolve the visibility issue with northbound left turns & the conflict with visibility of pedestrians on the west side of Molalla Avenue crossing in a south to north direction, if the left turn is not allowed when the crossing has a pedestrian call.

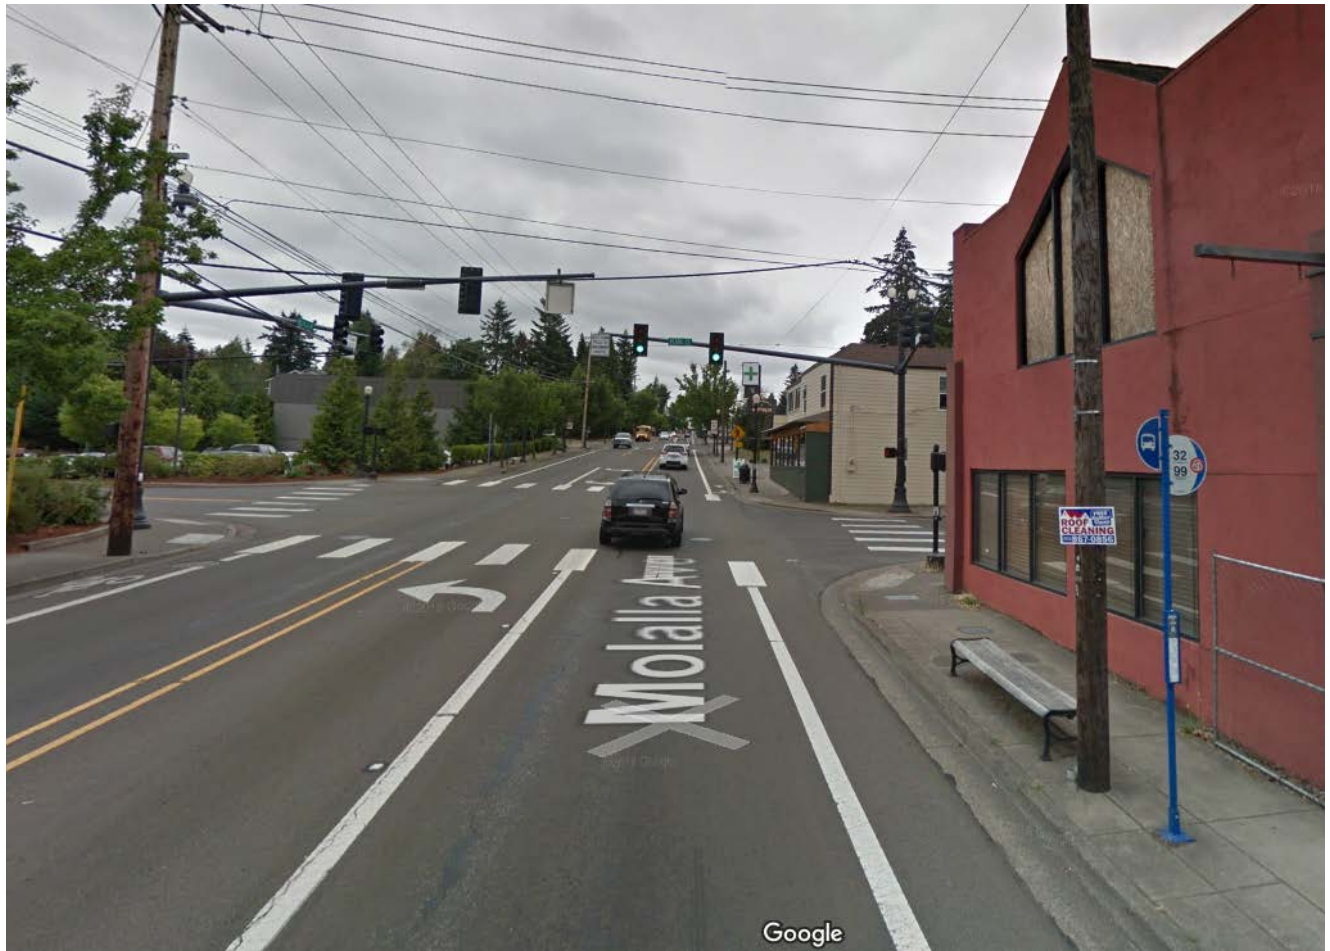
## Molalla Avenue Travelling South

- Generally, no visual obstructions from trees or excess poles exist from this approach.
- The placement of the buildings directly adjacent to the right of way is problematic at this approach for visibility of pedestrians crossing Pearl Street by vehicles turning right onto Pearl Street westbound.
- An existing Left Turn Yield to Oncoming Traffic sign is located on the mast arm. This exact sign is no longer included in the MUTCD but is similar to the Left Turn Yield on Green (R10-12).
- Southbound left turns are a permissive movement, not protected and occur from a dedicated left turn lane.
