# Arborist Report

October 17, 2018

City of Oregon City  
Oregon City Swimming Pool  
1211 Jackson St.

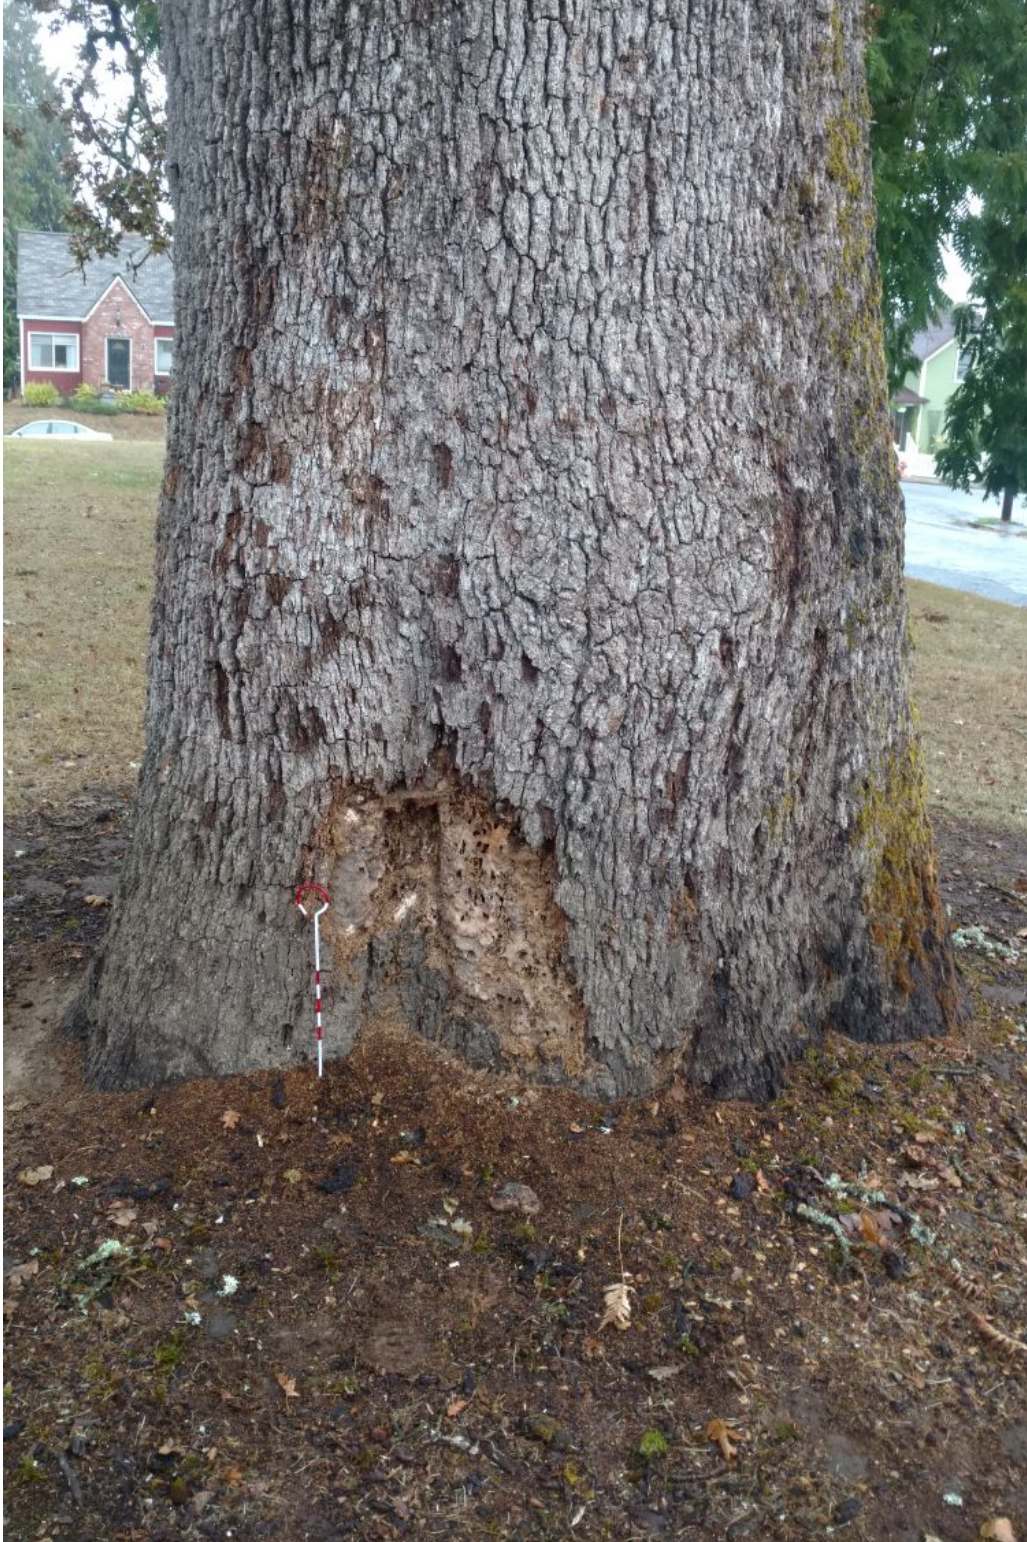
The tree has one major limb with dead foliage and the trunk shows evidence of a column of decay. There is an area of decay at the union of the limb. Minor epicormic shoots have sprouted near decayed areas and old pruning wounds. The foliage is sparse throughout the canopy, and appears more sparse than what is to be expected from a healthy tree with normal seasonal leaf drop. At breast height, it is estimated the dead and decayed trunk area spans approximately 46" of the 157" circumference, representing 29% of the circumference.

Trunk: A large column of decay up to 46" wide and likely 30' tall is shown in Appendix photos.

*Photo 1. Decay in Trunk*

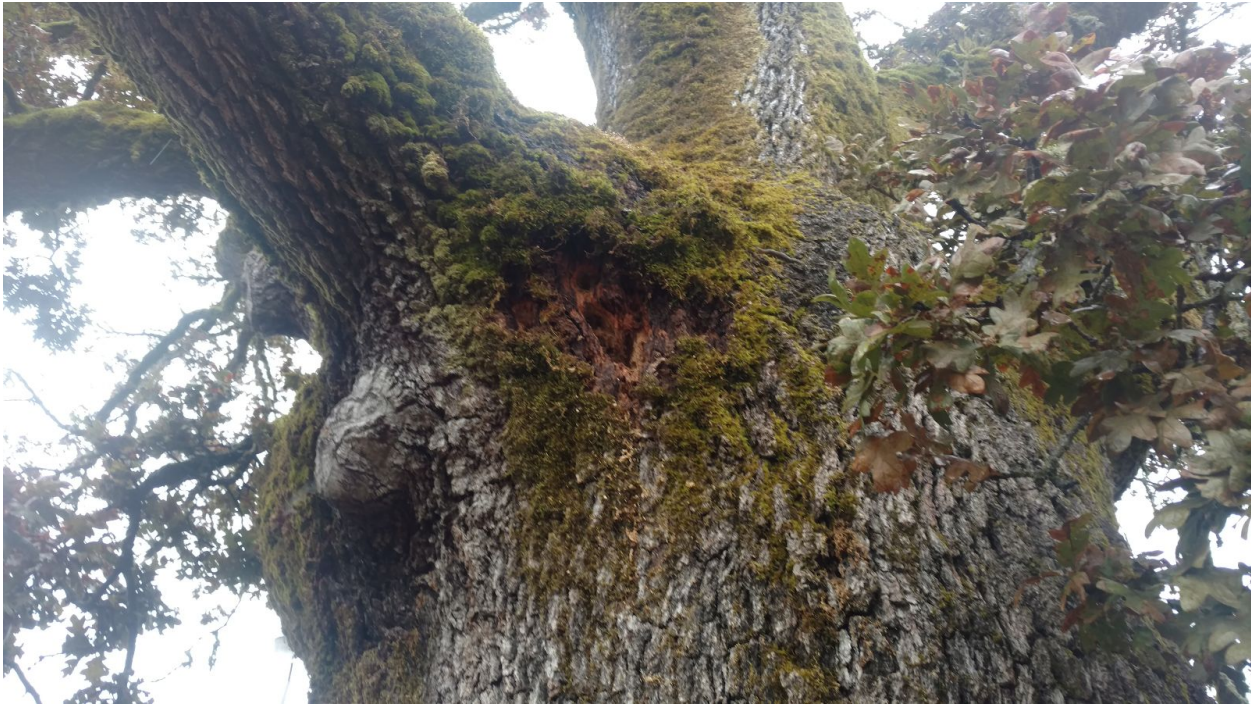
Crown and Branches: The canopy foliage is sparse. Dead leaves persist on one limb that is likely dead or nearly dead due to decay at the branch union.

***Photo 2. Decay at branch union***

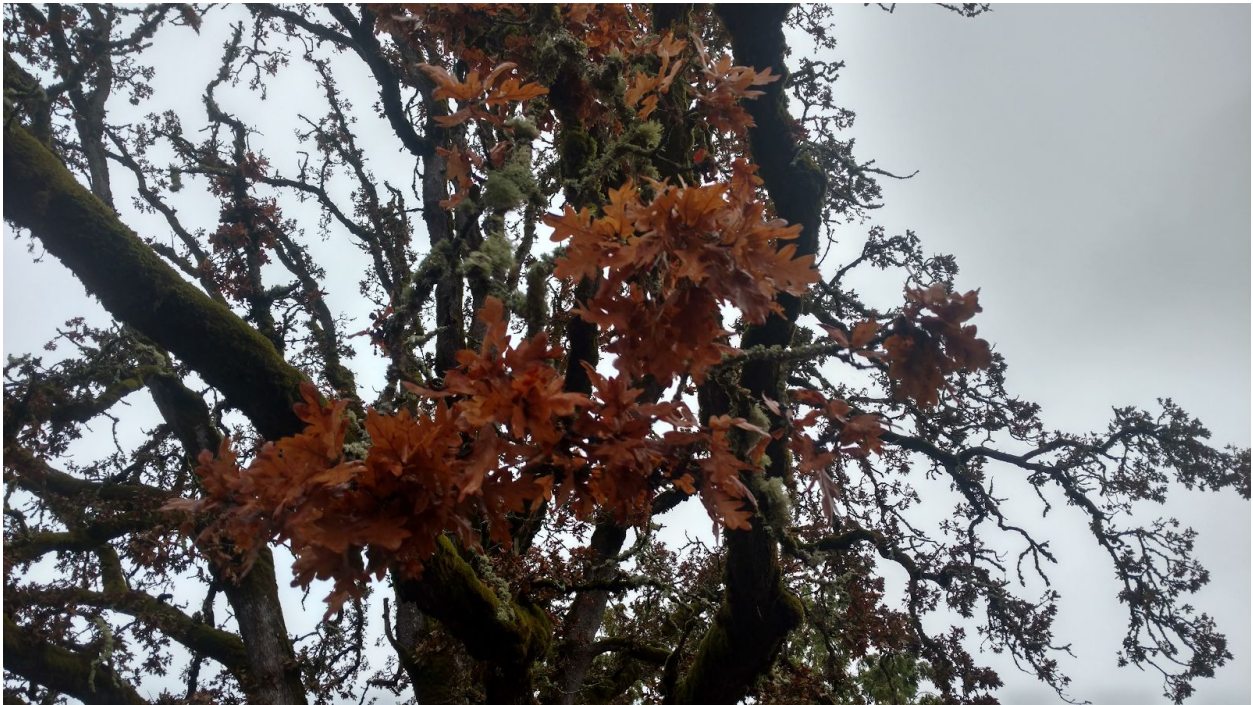
***Photo 3. Dead leaves persist on dying branch***

**Risk Management Pruning (RMP):** 1. The dead limb can be removed. 2. Major retrenchment pruning could be conducted, the area below fenced, and interpretive signage could be posted describing the benefits of wildlife trees in urban areas.

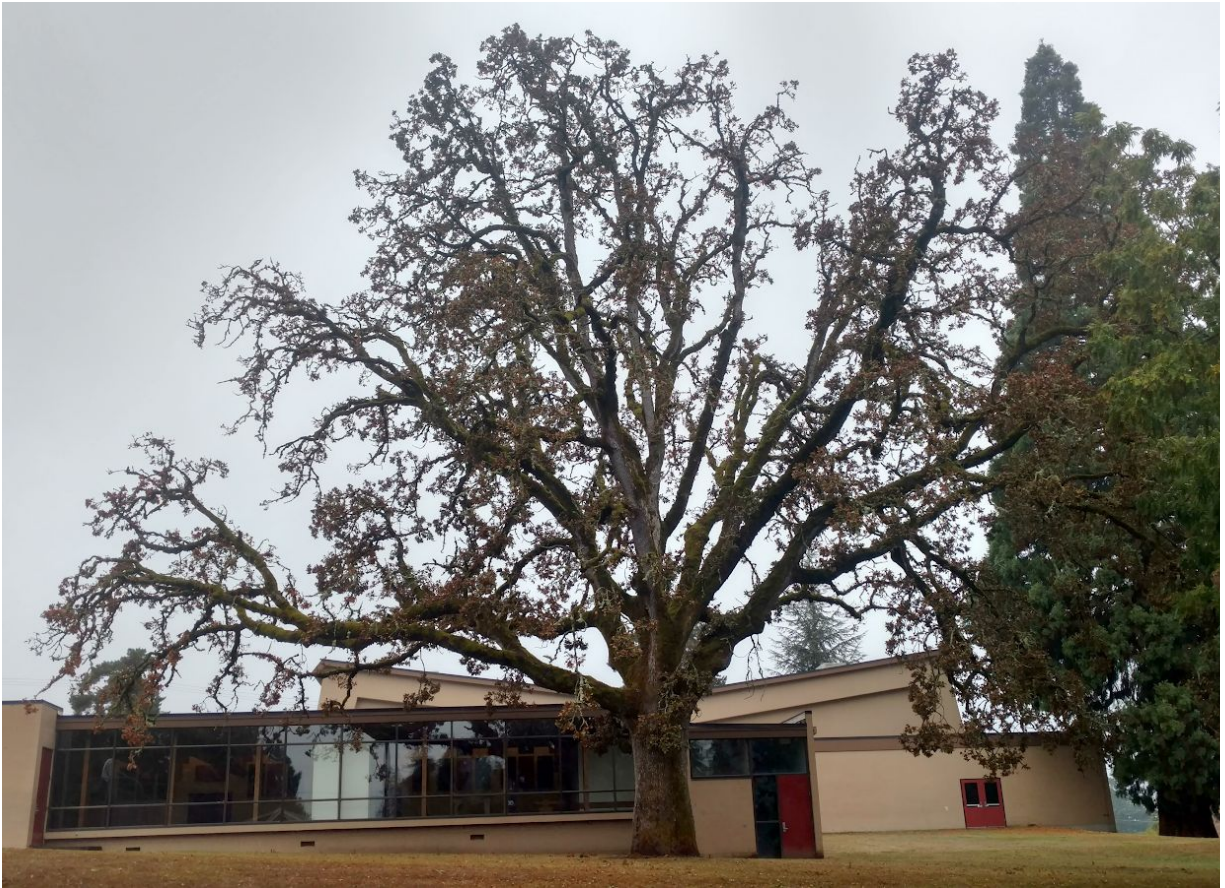
*Photo 4. Canopy is relatively sparse and trunk has some epicormic sprouts*
