Type I Site Plan and Design Review

Site Address or Clackamas County Map and Tax Lot: 1211 JACKSON ST. / 2-2E-32BB-06100

Project Description: oak & WALNUT TREE REMOVALS - HAZARD

Arborist Report

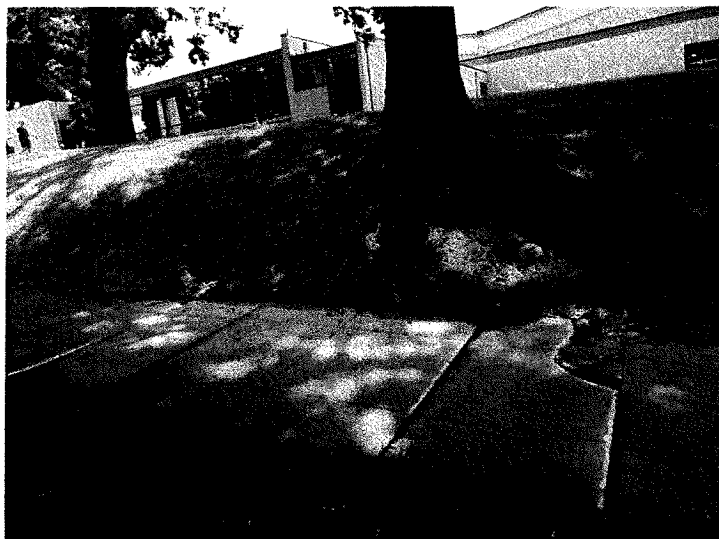
The tree is located the pool facility at 1211 Jackson St., near the intersection of John Quincy Adams St. and 13th St., in Oregon City, Oregon. The tree is on a slope down toward 13th St. The area is not irrigated but has maintained turf. The adjacent public sidewalk, parking lane and road are within the dripline of the tree. The sidewalk has multiple 1" disruptions likely caused by tree roots. The tree trunk is within 4' of the adjacent sidewalk.

Adjacent sidewalk

1. Sidewalk re-routing closer to the road in the vicinity of the tree
2. Ramping the sidewalk slightly to allow reconstruction with minimal root pruning
3. Installation of a 2" construction-grade styrofoam layer between the gravel pad and concrete pour
4. Trip-stop sidewalk hinges that allow sidewalk to bend horizontally but not become displaced vertically or at an angle

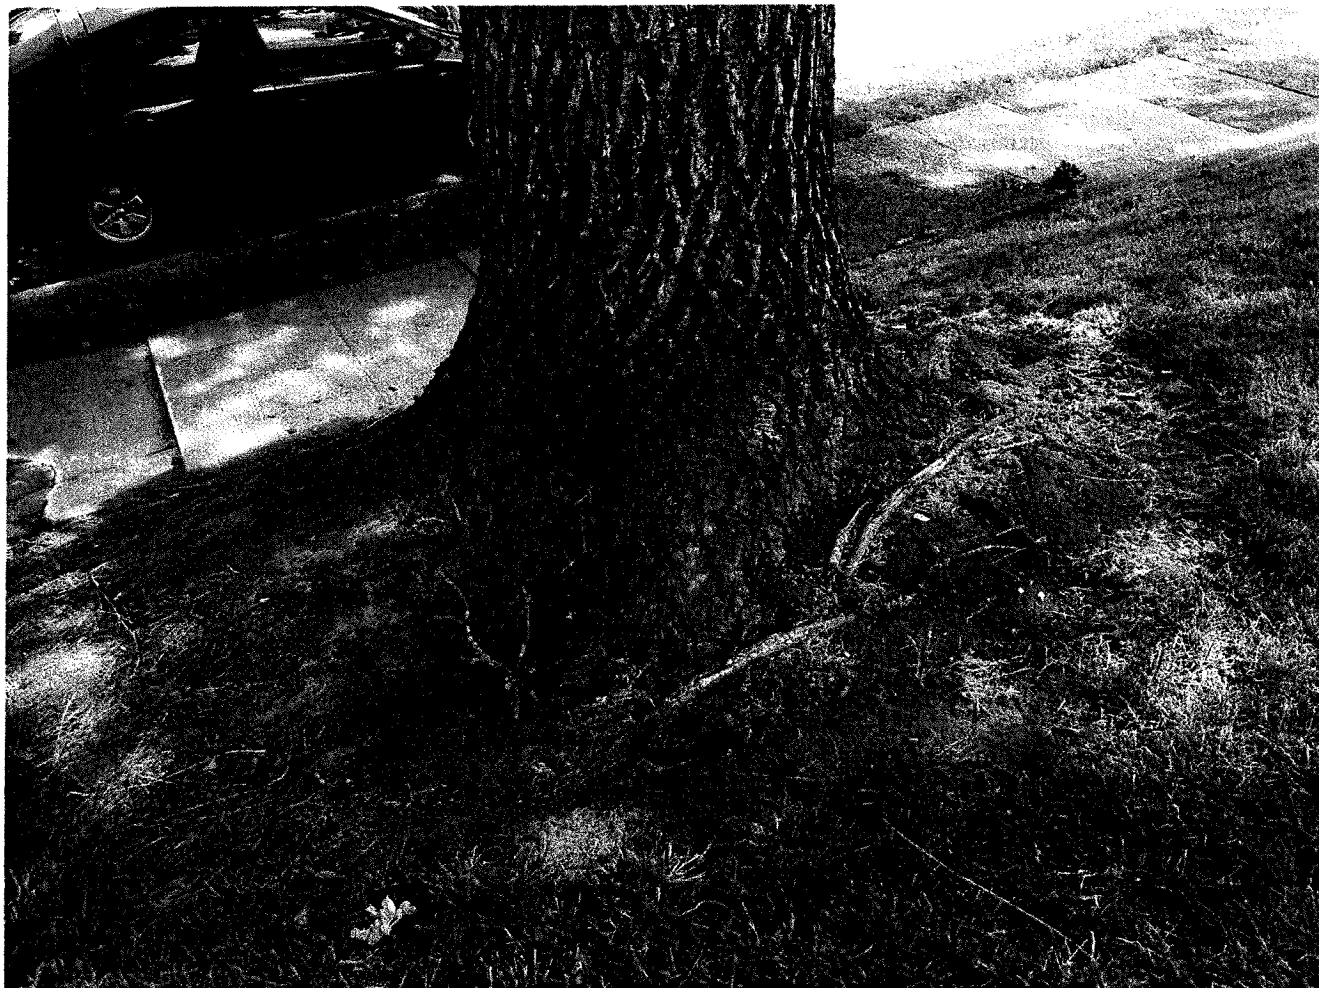
Photo 1. Good root flare, no evidence of decay

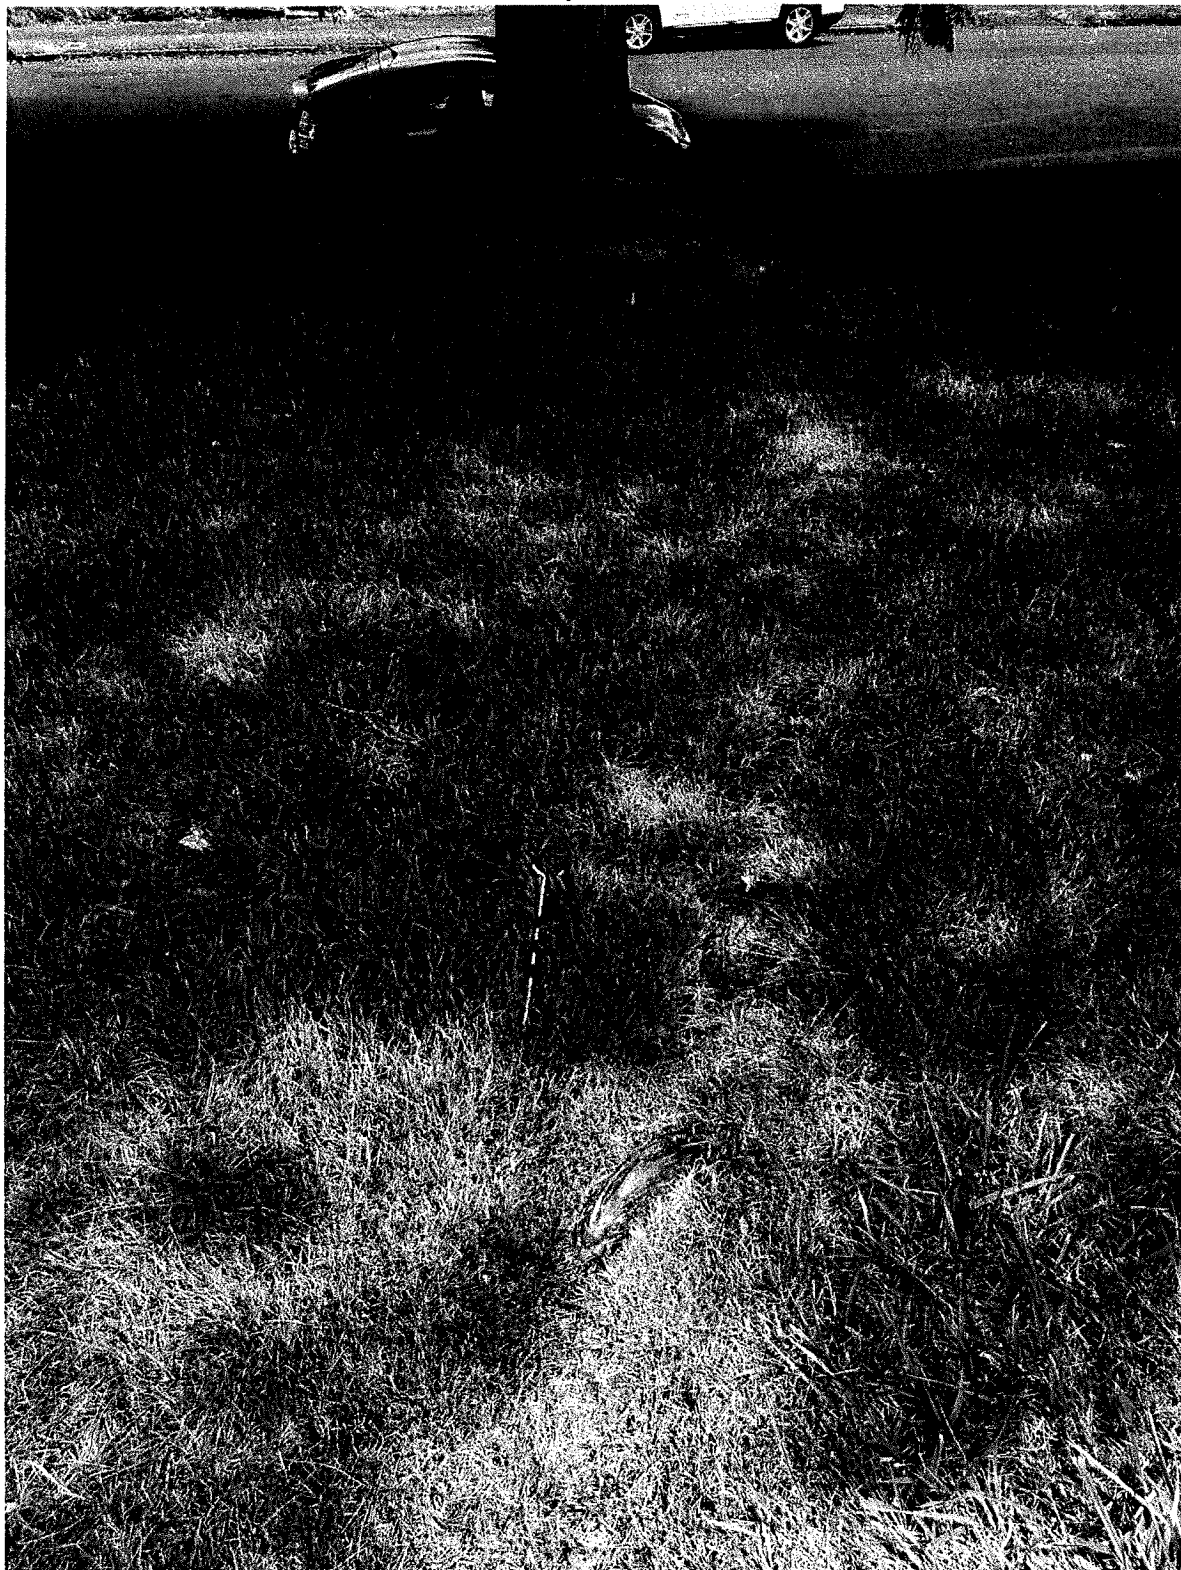
The tree has one trunk wound that is sealing, and one surface root in the lawn that has had mower damage. The health and structure of the roots, trunk, scaffold branches, and foliage is good.

Photo 2. Surface root in lawn

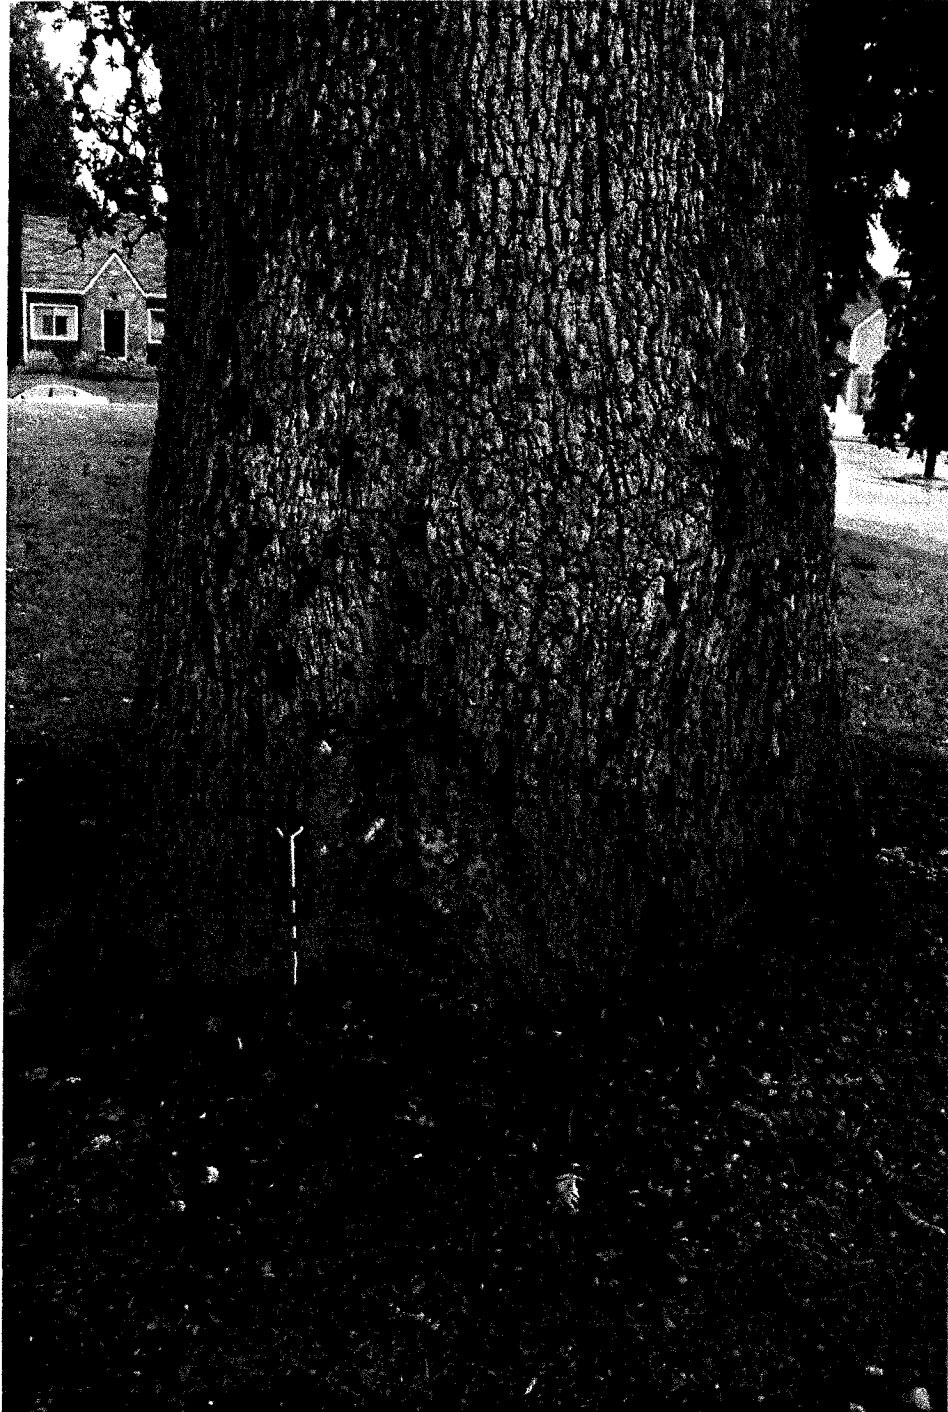
Trunk: A large column of decay up to 46" wide and likely 30' tall is shown in Appendix photos.

The tree has a probable failure risk with a high likelihood of impacting a target (lawn area). This is a somewhat likely event with possible significant consequences. The risk rating for this tree is High.

Photo 1. Decay in Trunk

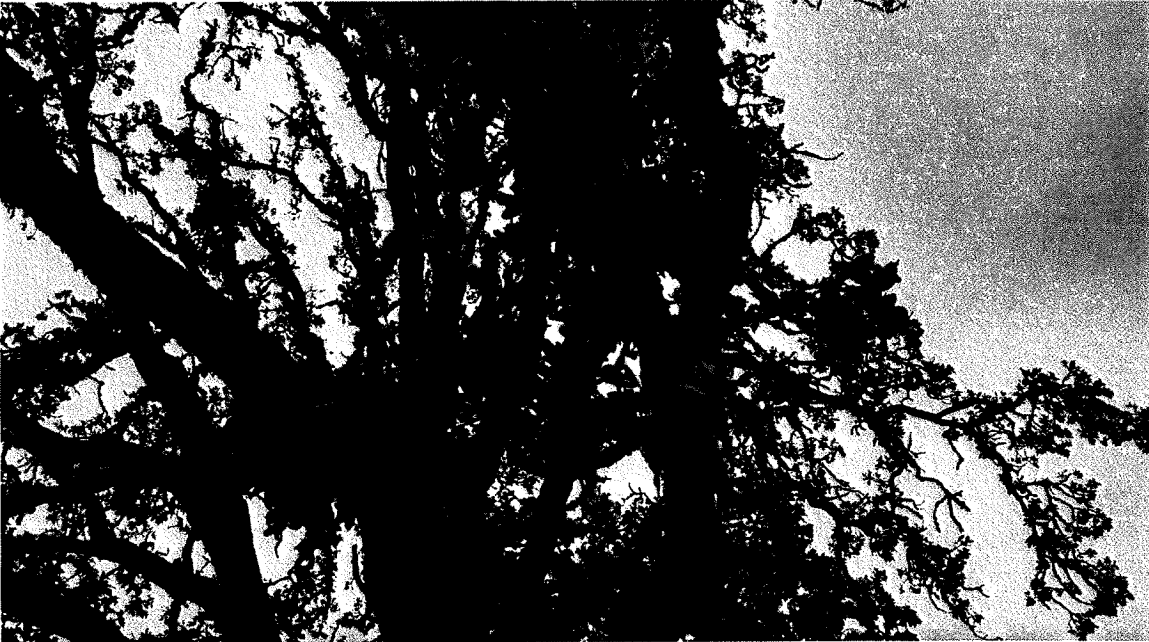
Photo 3. Dead leaves persist on dying branch

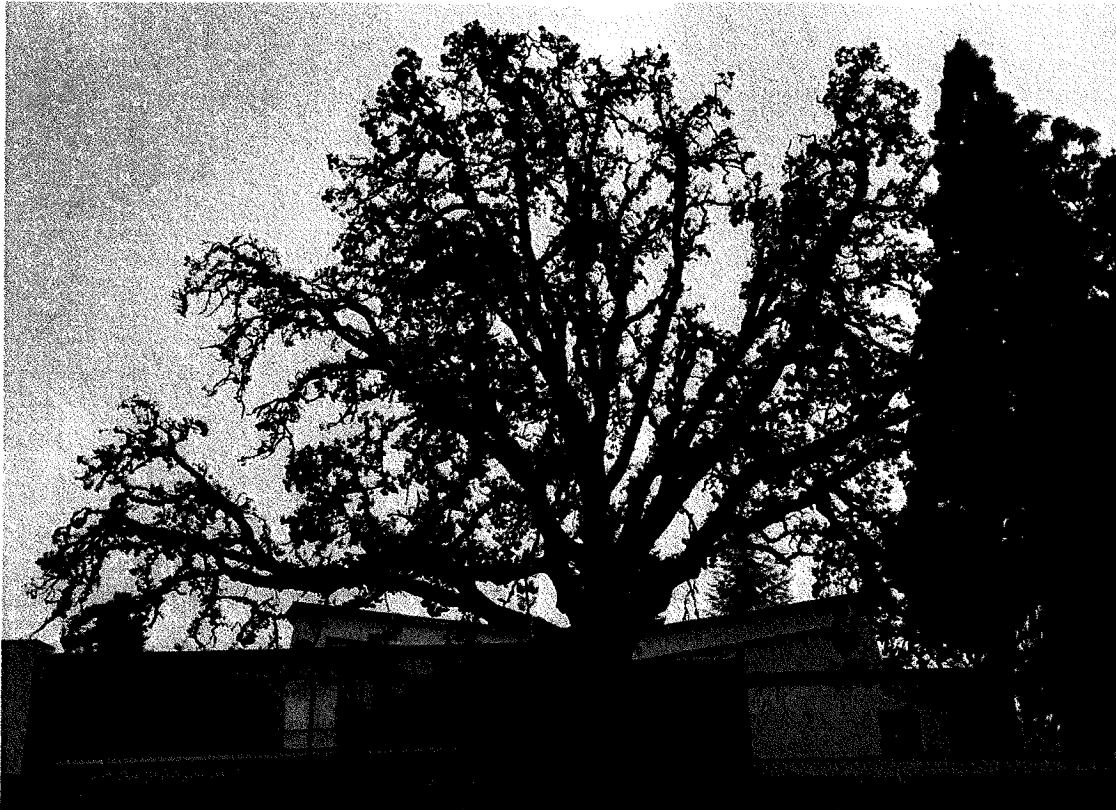
Photo 4. Canopy is relatively sparse and trunk has some epicormic sprouts
