Type I Site Plan and Design Review
Office/Mixed Use/Commercial/Multi-Family/Industrial Uses

File Number: SP 19-00065 Reviewed By: [Signature] Date: 8.30.19

Project Description: OAK & WALNUT TREE REMOVALS - HAZARD
replacing sidewalks - DAMAGED

Arborist Report

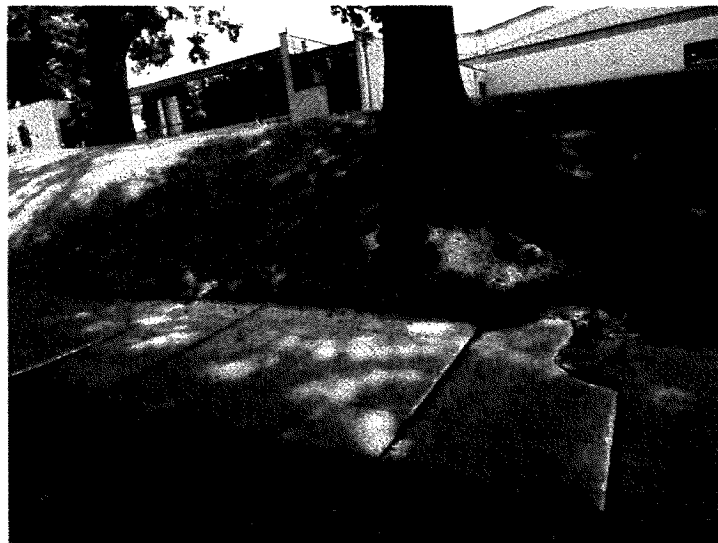
The tree is located the pool facility at 1211 Jackson St., near the intersection of John Quincy Adams St. and 13th St., in Oregon City, Oregon. The tree is on a slope down toward 13th St. The area is not irrigated but has maintained turf. The adjacent public sidewalk, parking lane and road are within the dripline of the tree. The sidewalk has multiple 1" disruptions likely caused by tree roots. The tree trunk is within 4' of the adjacent sidewalk.

Adjacent sidewalk

1. Sidewalk re-routing closer to the road in the vicinity of the tree
2. Ramping the sidewalk slightly to allow reconstruction with minimal root pruning
3. Installation of a 2" construction-grade styrofoam layer between the gravel pad and concrete pour
4. Trip-stop sidewalk hinges that allow sidewalk to bend horizontally but not become displaced vertically or at an angle

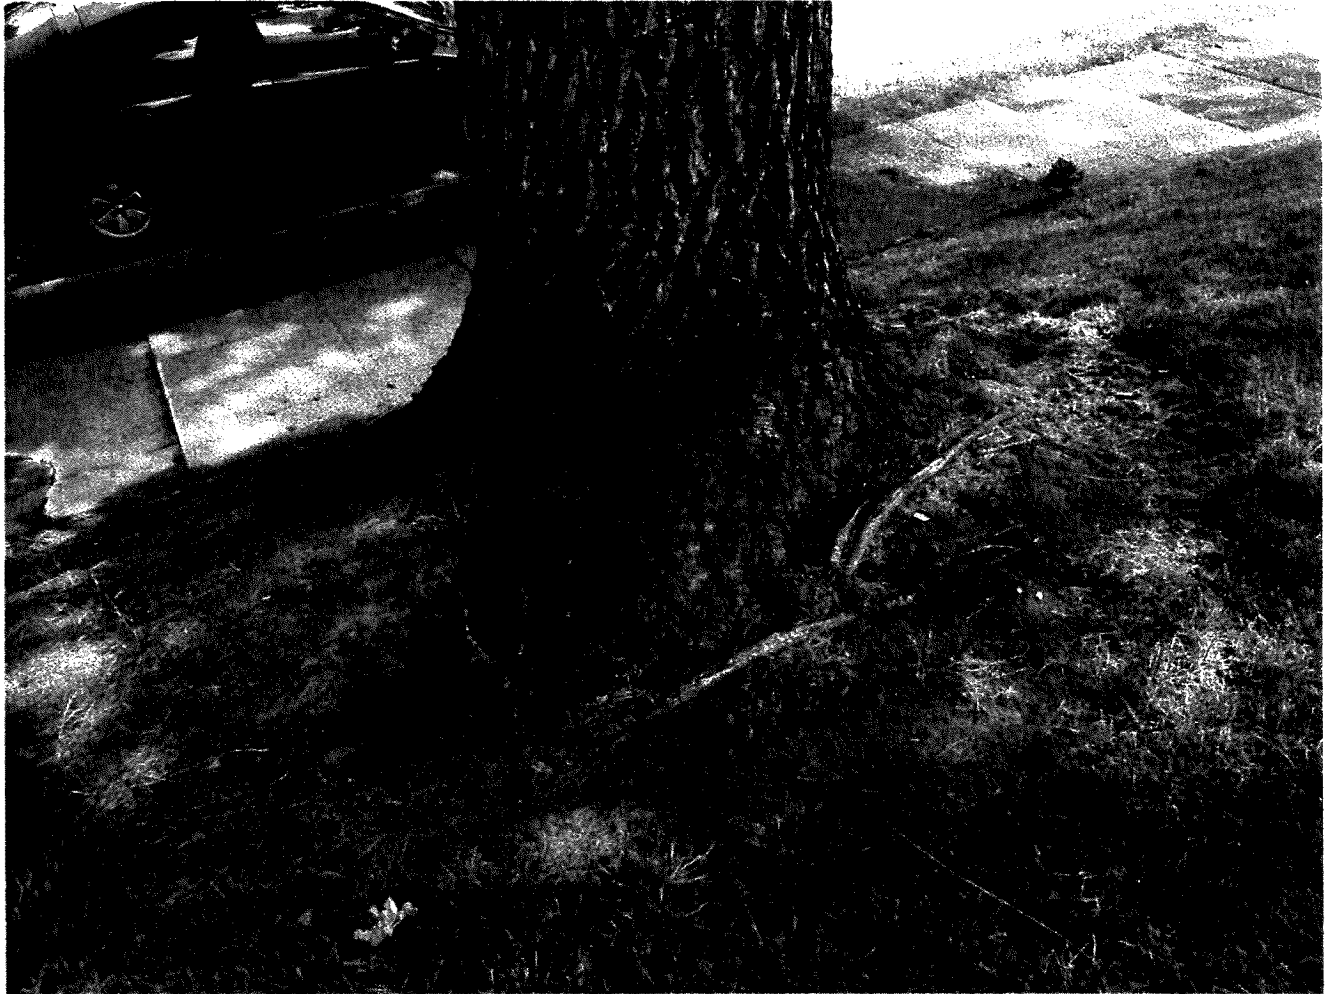
Photo 1. Good root flare, no evidence of decay

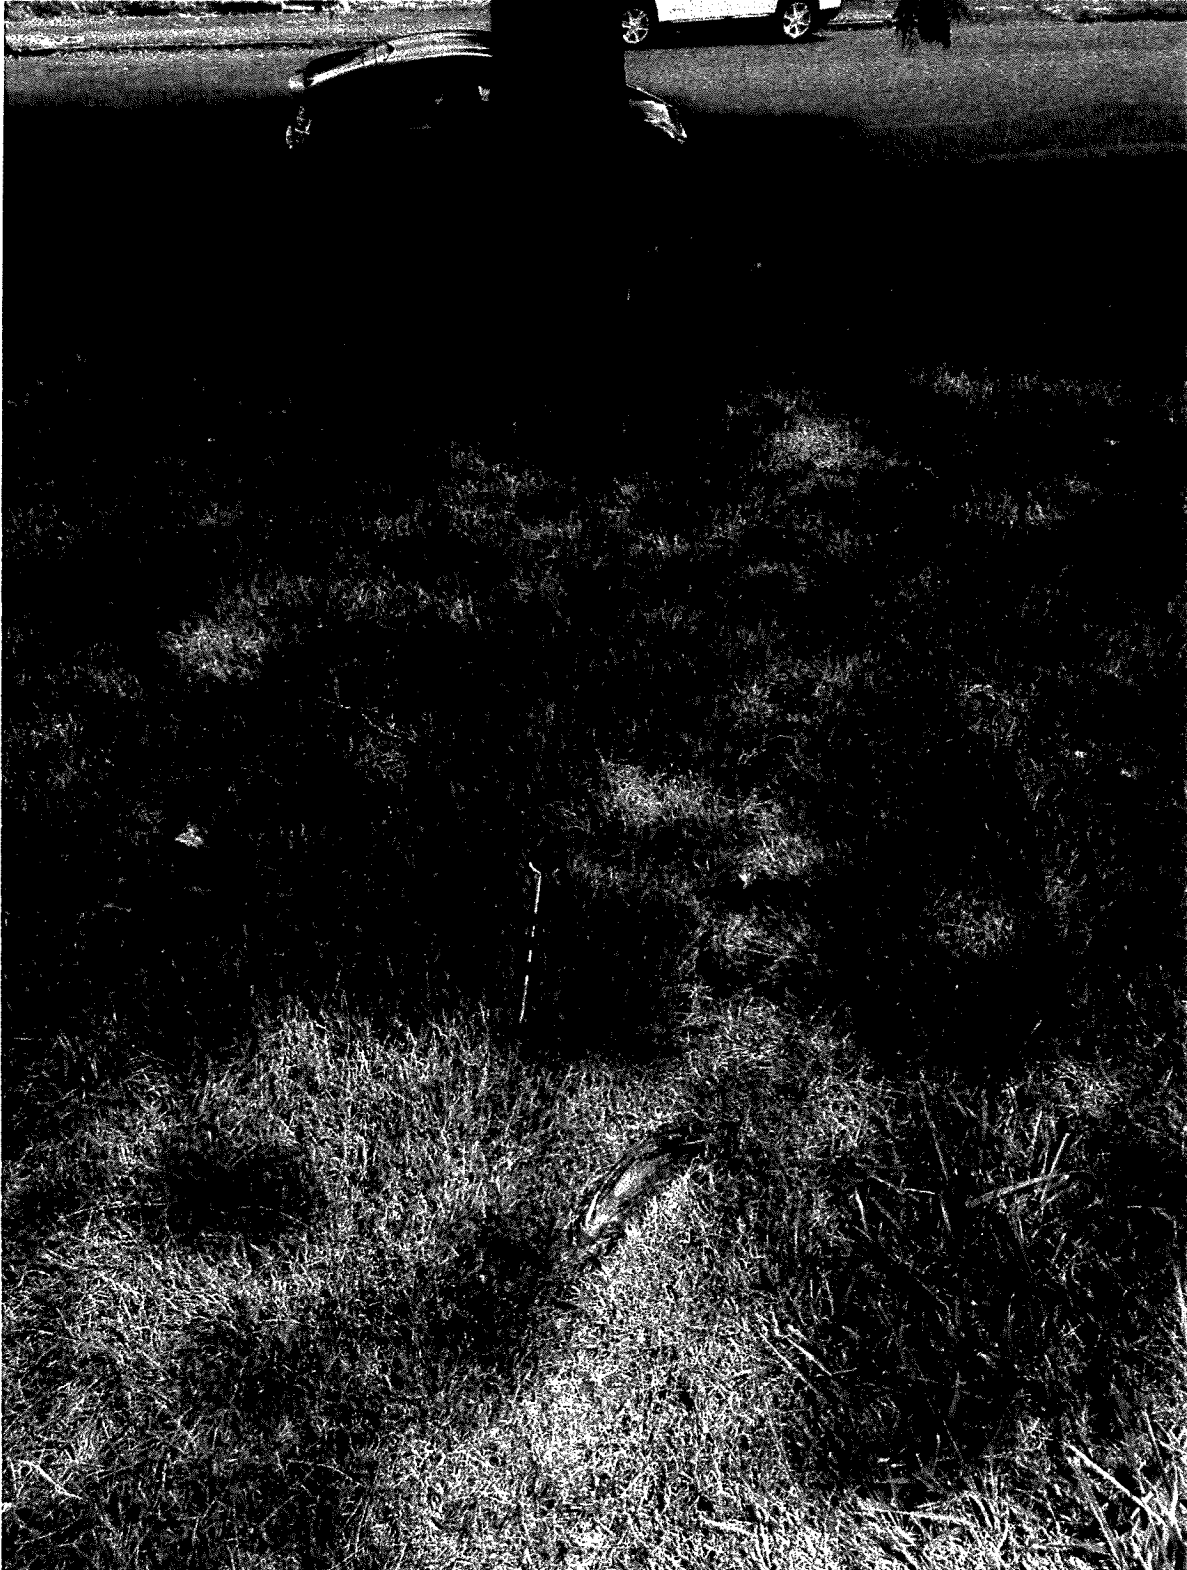
The tree has one trunk wound that is sealing, and one surface root in the lawn that has had mower damage. The health and structure of the roots, trunk, scaffold branches, and foliage is good.

Photo 2. Surface root in lawn

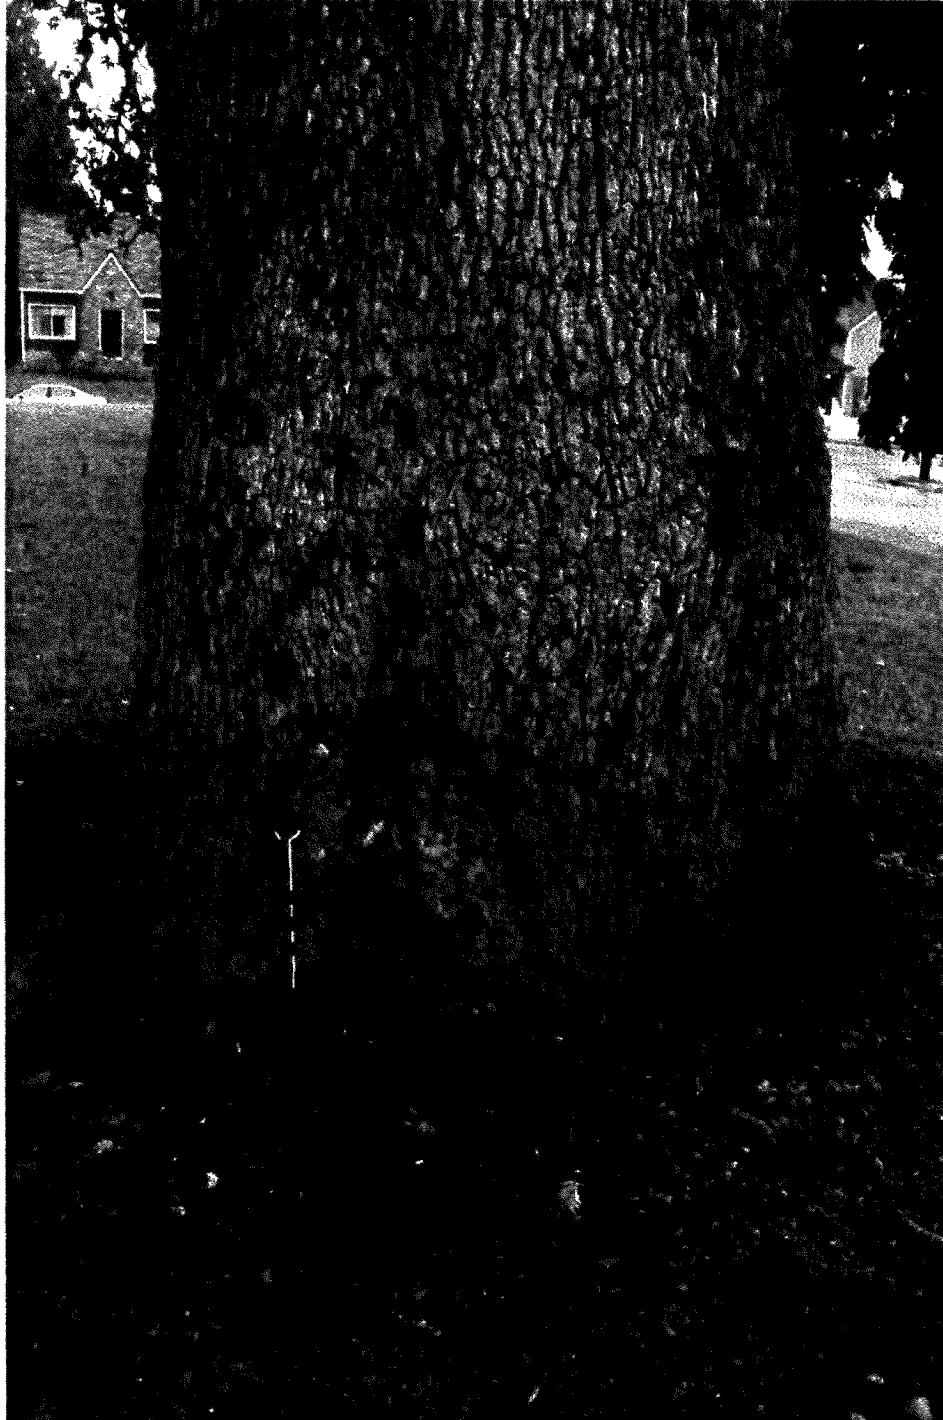
The tree has one major limb with dead foliage and the trunk shows evidence of a column of decay. There is an area of decay at the union of the limb. Minor epicormic shoots have sprouted near decayed areas and old pruning wounds. The foliage is sparse throughout the canopy, and appears more sparse than what is to be expected from a healthy tree with normal seasonal leaf drop. At breast height, it is estimated the dead and decayed trunk area spans approximately 46" of the 157" circumference, representing 29% of the circumference.

Trunk: A large column of decay up to 46" wide and likely 30' tall is shown in Appendix photos.

Photo 1. Decay in Trunk

Risk Management Pruning (RMP): 1. The dead limb can be removed. 2. Major retrenchment pruning could be conducted, the area below fenced, and interpretive signage could be posted describing the benefits of wildlife trees in urban areas.

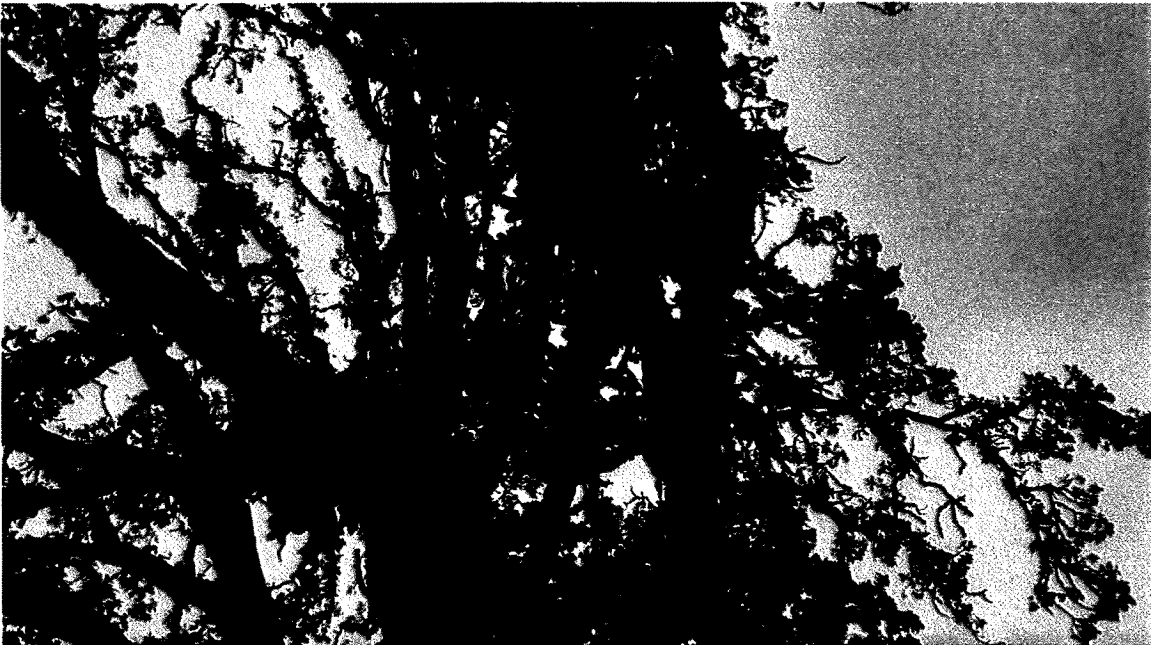
Photo 3. Dead leaves persist on dying branch

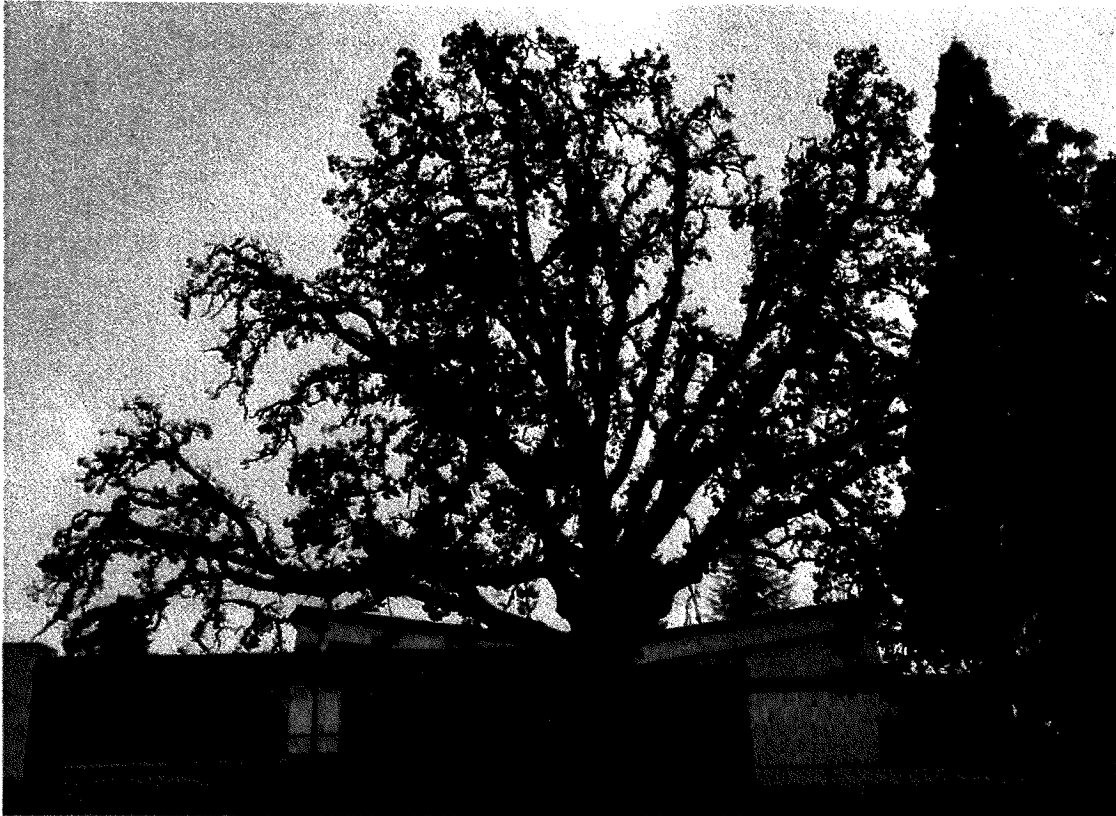
Photo 4. Canopy is relatively sparse and trunk has some epicormic sprouts
