Arborist Report

July 18, 2019

City of Oregon City
Oregon City Swimming Pool
1211 Jackson St.

Ruth Williams
ISA WE-7317-BM
ISA Qualified Tree Risk Assessor

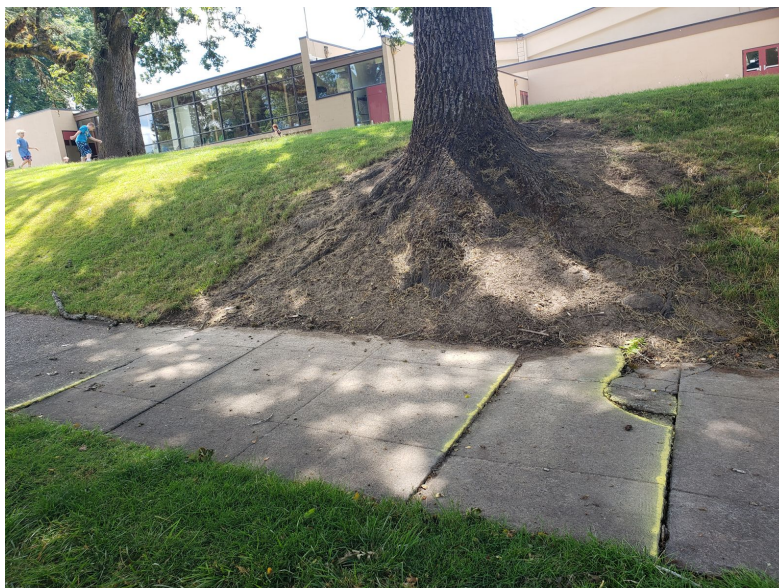
The tree is located the pool facility at 1211 Jackson St., near the intersection of John Quincy Adams St. and 13th St., in Oregon City, Oregon. The tree is on a slope down toward 13th St. The area is not irrigated but has maintained turf. The adjacent public sidewalk, parking lane and road are within the dripline of the tree. The sidewalk has multiple 1" disruptions likely caused by tree roots. The tree trunk is within 4' of the adjacent sidewalk.

Adjacent sidewalk

1. Sidewalk re-routing closer to the road in the vicinity of the tree
2. Ramping the sidewalk slightly to allow reconstruction with minimal root pruning
3. Installation of a 2" construction-grade styrofoam layer between the gravel pad and concrete pour
4. Trip-stop sidewalk hinges that allow sidewalk to bend horizontally but not become displaced vertically or at an angle

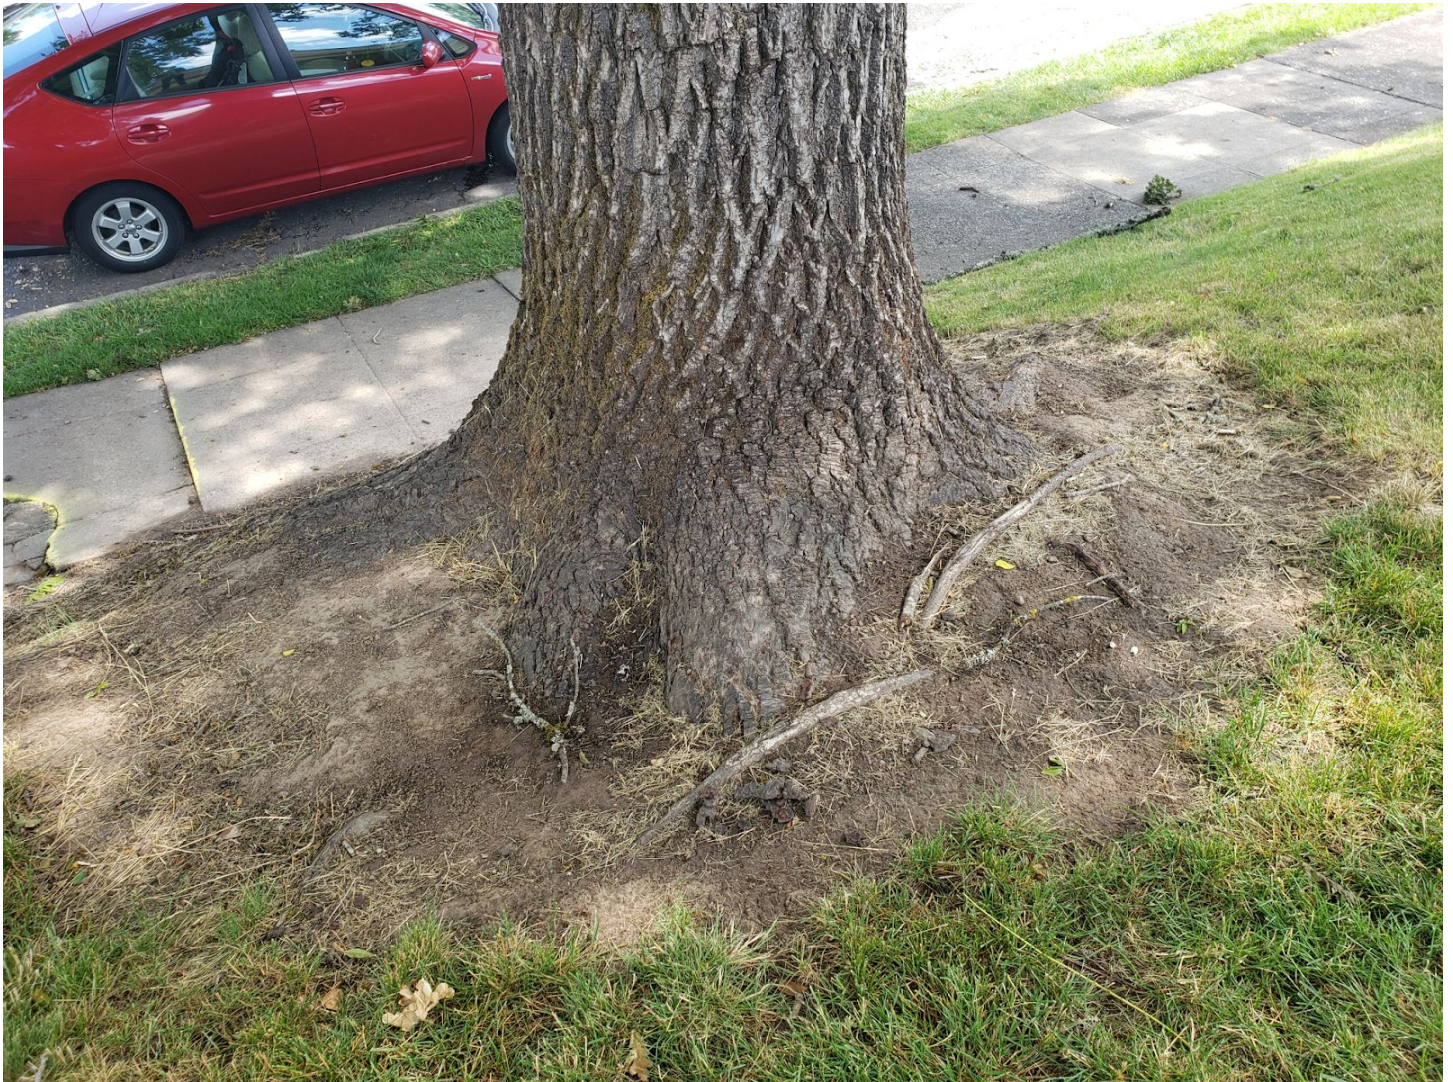
Photo 1. Good root flare, no evidence of decay

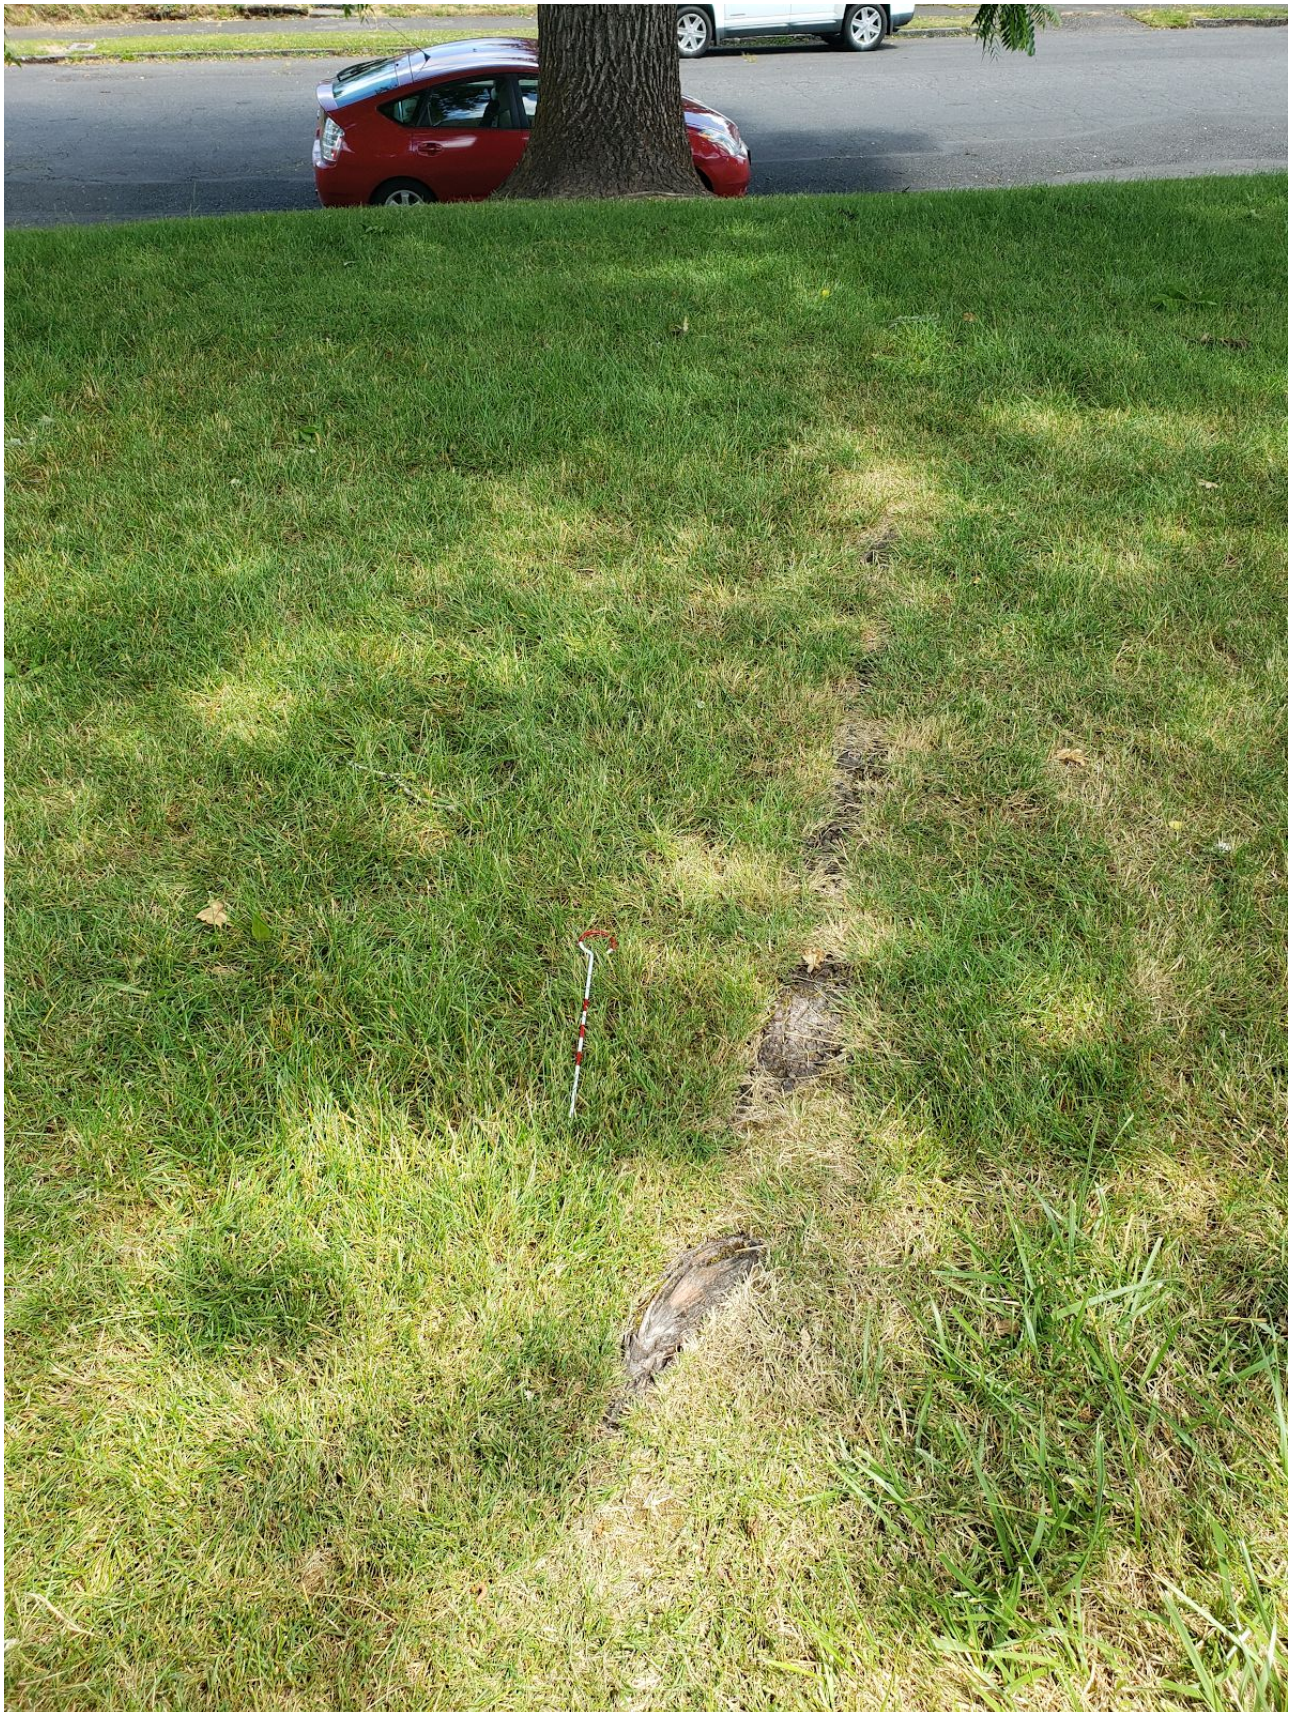
The tree has one trunk wound that is sealing, and one surface root in the lawn that has had mower damage. The health and structure of the roots, trunk, scaffold branches, and foliage is good.

Photo 2. Surface root in lawn

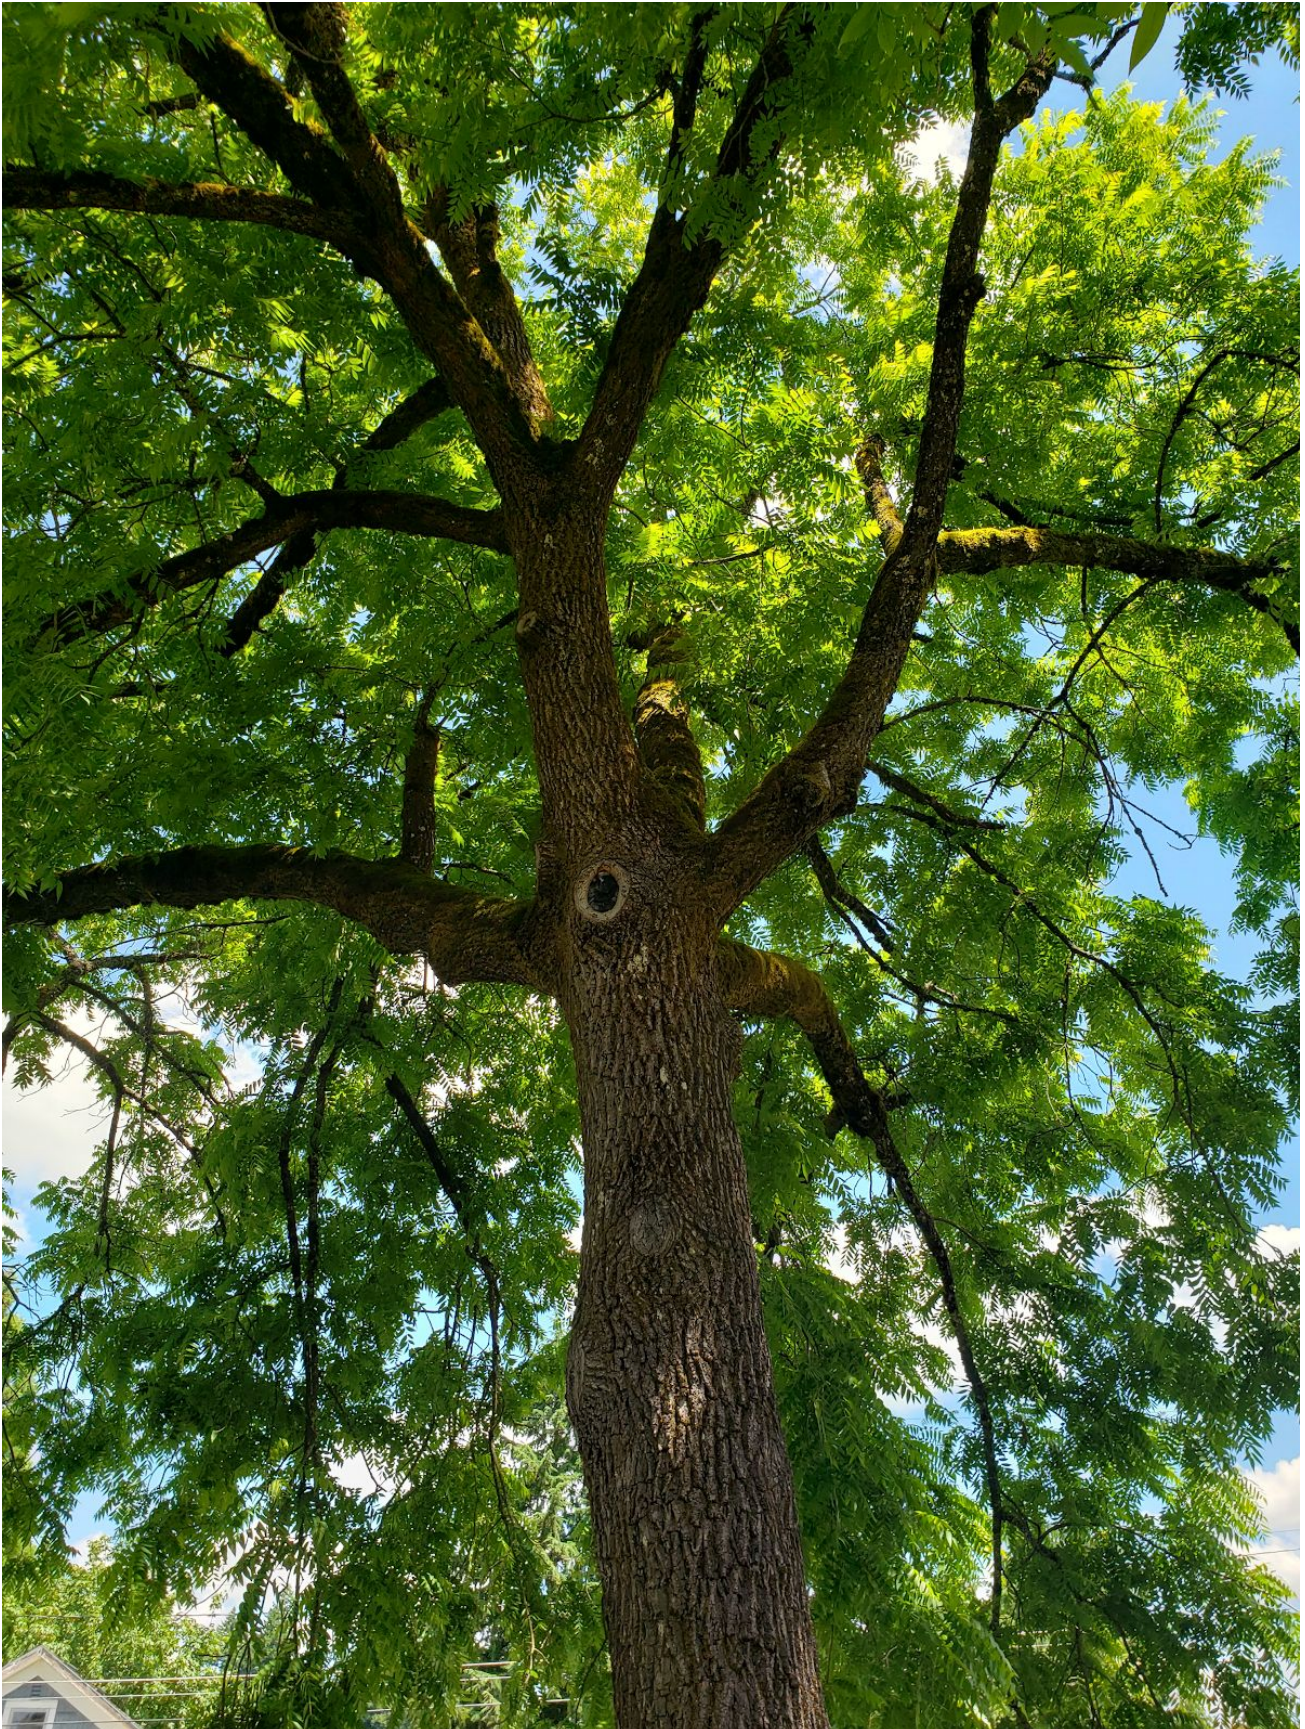
Photo 3. Minor wounds sealing after prior pruning, foliage in very good condition
