March 12, 2019

RJL Holdings, LLC  
14155 Beavercreek Road  
Oregon City, OR 97045

**Supplemental Report of Geotechnical Engineering Services**  
**Geologic Hazards Development Permit**  
Forest Edge Apartments  
Oregon City, Oregon  
GeoDesign Project: RJLHold-1-01

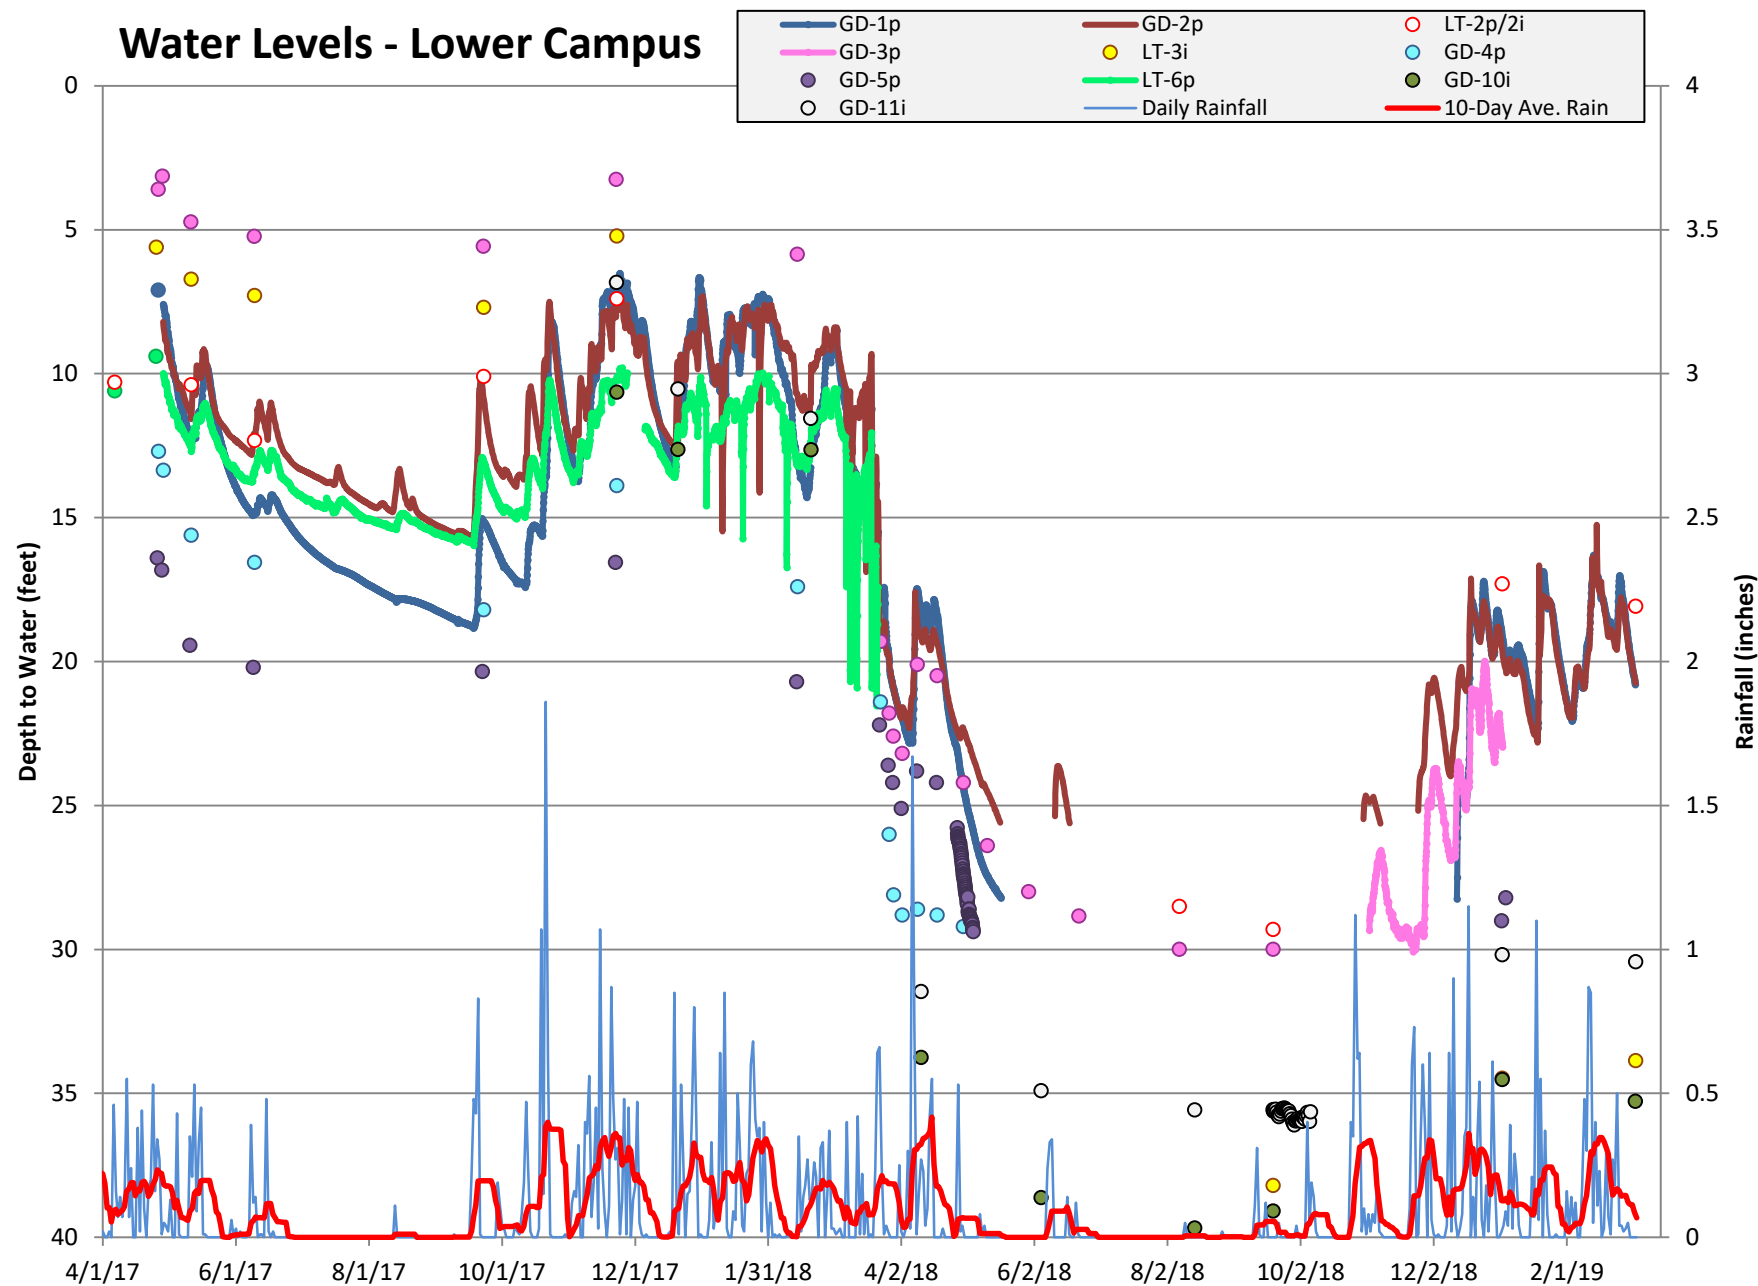
# Water Levels - Lower Campus

Since the spring of 2017 GeoDesign has monitored water levels in a variety of piezometers. The preliminary dewatering system was fully activated in March 2018, and water levels significantly dropped throughout the Lower Campus compared to levels recorded prior to installing the system. We provide updated piezometer data plots in the Attachment of this supplemental report, representing data collected from early April 2017 until our last monitoring event (March 4, 2019). The data show that during the 2018-2019 wet season, water levels have been mostly maintained below the lowest levels observed during the very dry 2017 summer. Water levels are currently 10 to 30 feet lower than observed during the 2017-2018 wet season prior to operation of the dewatering system. Rainfall has been comparable to the last wet season, indicating the dewatering system is the primary cause for lowered groundwater.

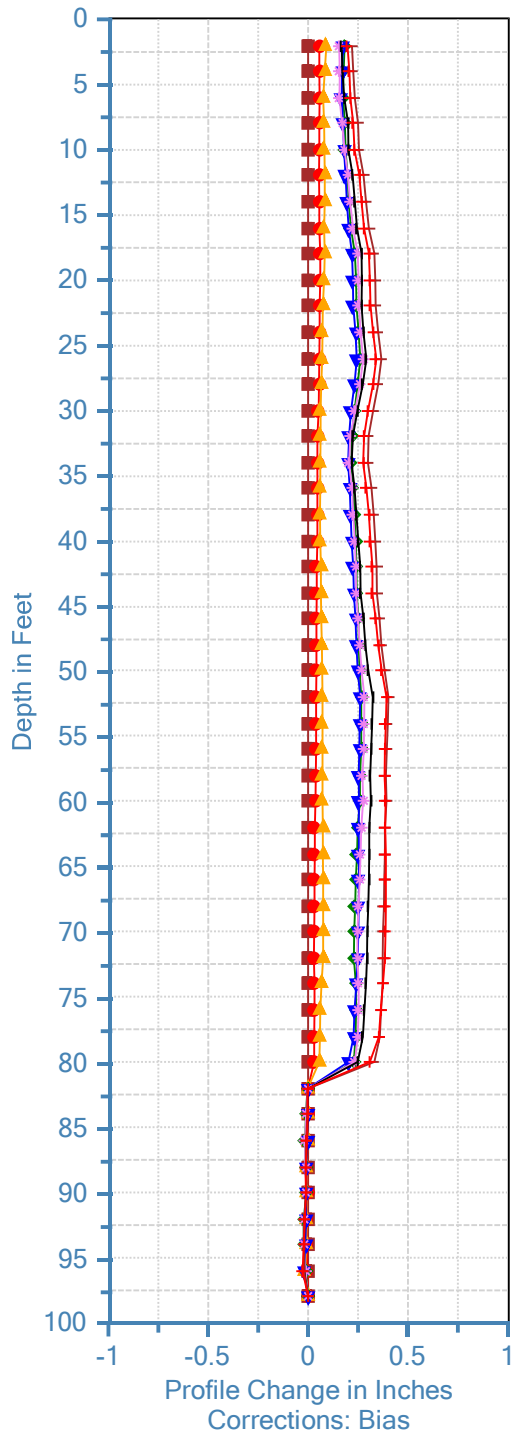
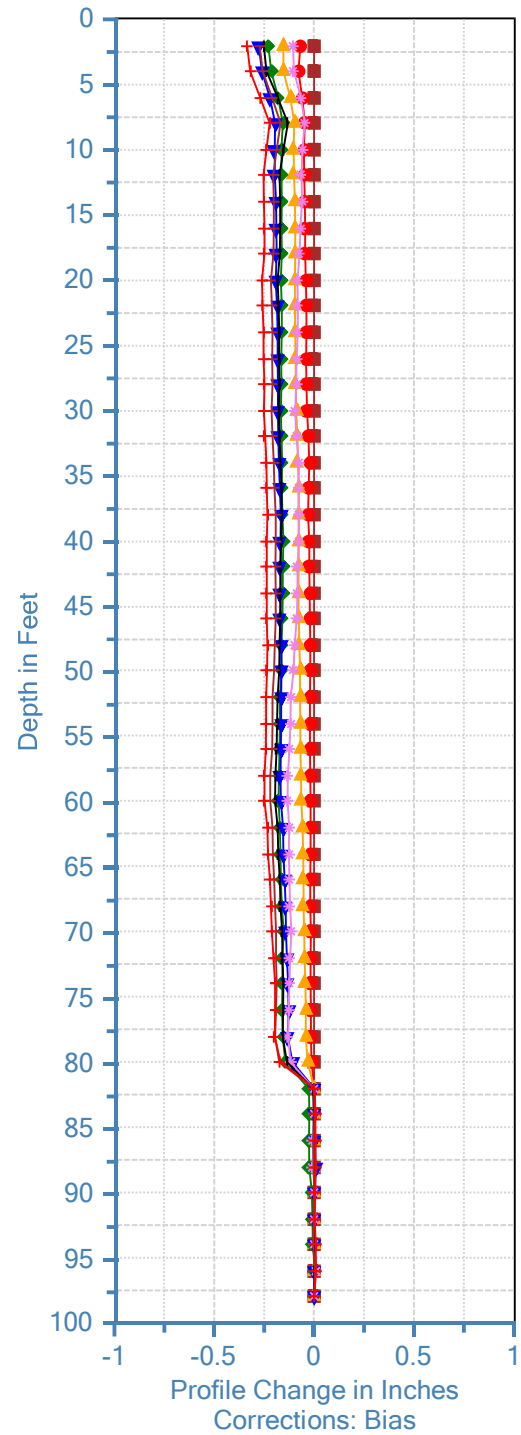
RJLHLD GD-10i A

Inclinometer data collected from inclinometers show the dewatering system is having a positive effect on slope stability. Significant displacement is not observed in the data from GD-11i since April 2018, located on the downhill side of the Lower Campus. A slight displacement (less than 0.1 inch) is observed between September 2018 and January 2019 in GD-10i, the uphill inclinometer on the Lower Campus. The March 2019 reading indicates no further displacement since January 2019. The Lower Campus landslide likely does not move as a single, rigid block. We anticipate that the dewatered landslide could still require time to reach an equilibrium position if it is influenced by uncontrolled surface water infiltration and groundwater pressures from off-site migration into the Lower Campus subsurface.

The displacement between September 2018 and January 2019 in GD-10i, followed by the lack of displacement from January through March 2019, could reflect the discovery of uncontrolled stormwater from the Upper Campus outlet. Previously, the outlet had been temporarily routed to the adjacent drainage off of the Lower Campus. For a time during the 2018-2019 wet season, the outlet apparently had shifted onto the pavement of the Lower Campus, releasing stormwater

into the graben adjacent to the Berryhill slope up until January 2019. The outlet was repositioned soon after discovery. While rainfall through February 2019 was above average, as measured at the National Weather Service station in Portland<sup>3</sup>, displacement was not recorded on any inclinometer. This suggests control of both surface stormwater and subsurface dewatering at the site can stabilize the landslide even during normal wet-season conditions.
