STAFF REPORT AND DECISION

FILE NUMBER: NR 12-04: Natural Resource Overlay District - NROD
(Type I Verification)

LOCATION: 19370 Pease Road, Oregon City, Oregon 97045
Clackamas County Map 3-2E-7B, TL 3300

NATURAL RESOURCE OVERLAY DISTRICT (NROD) – OCMC 17.49.255

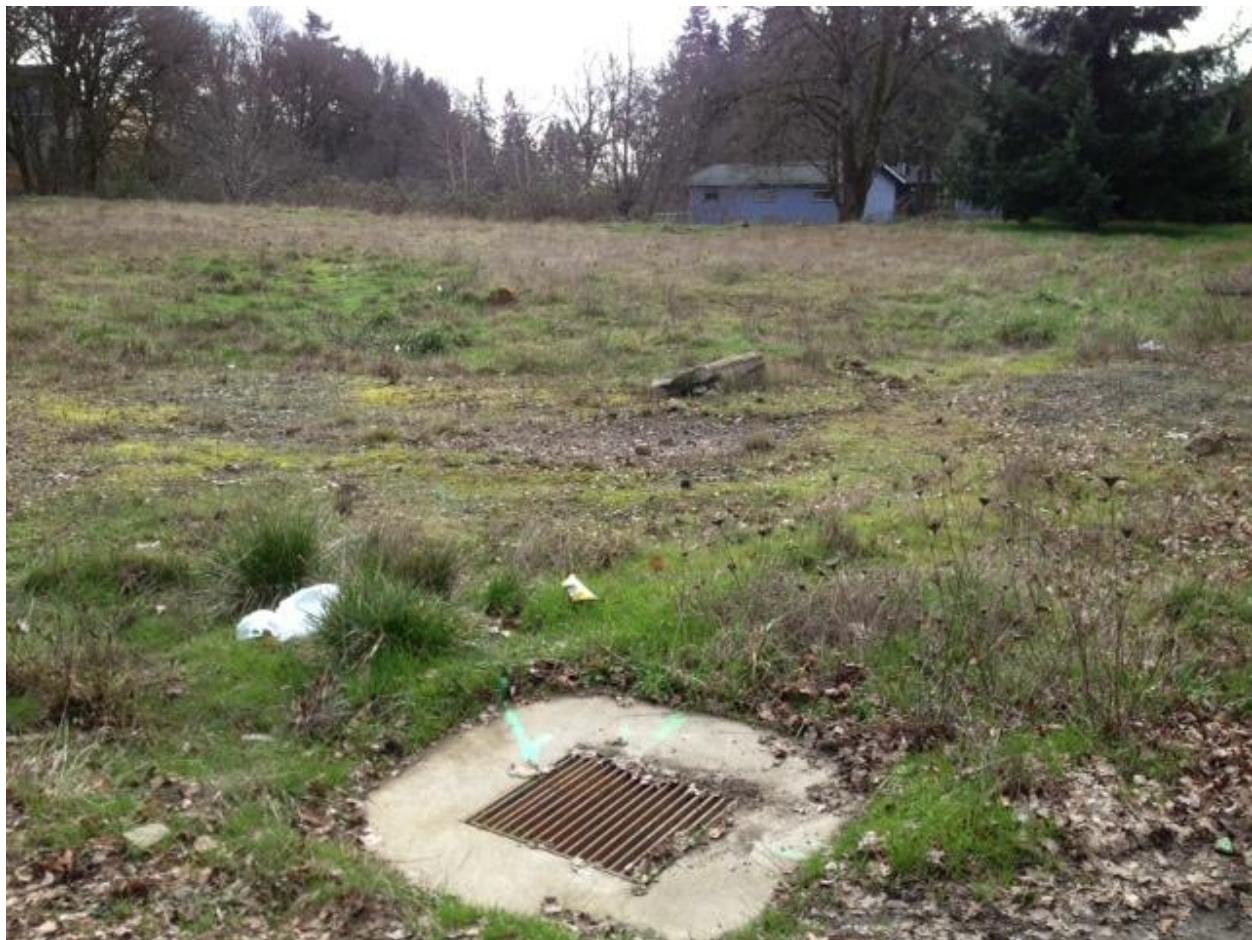
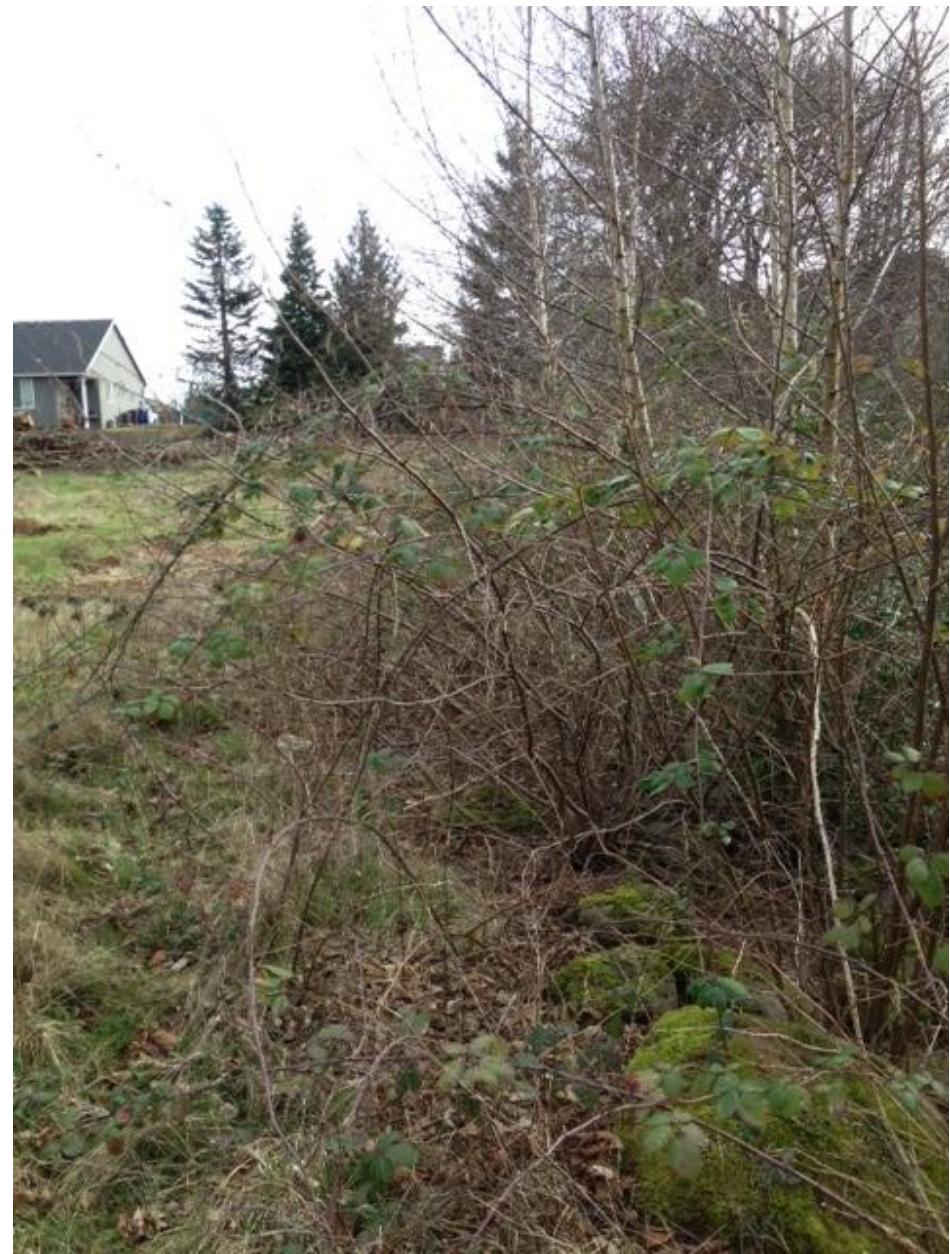
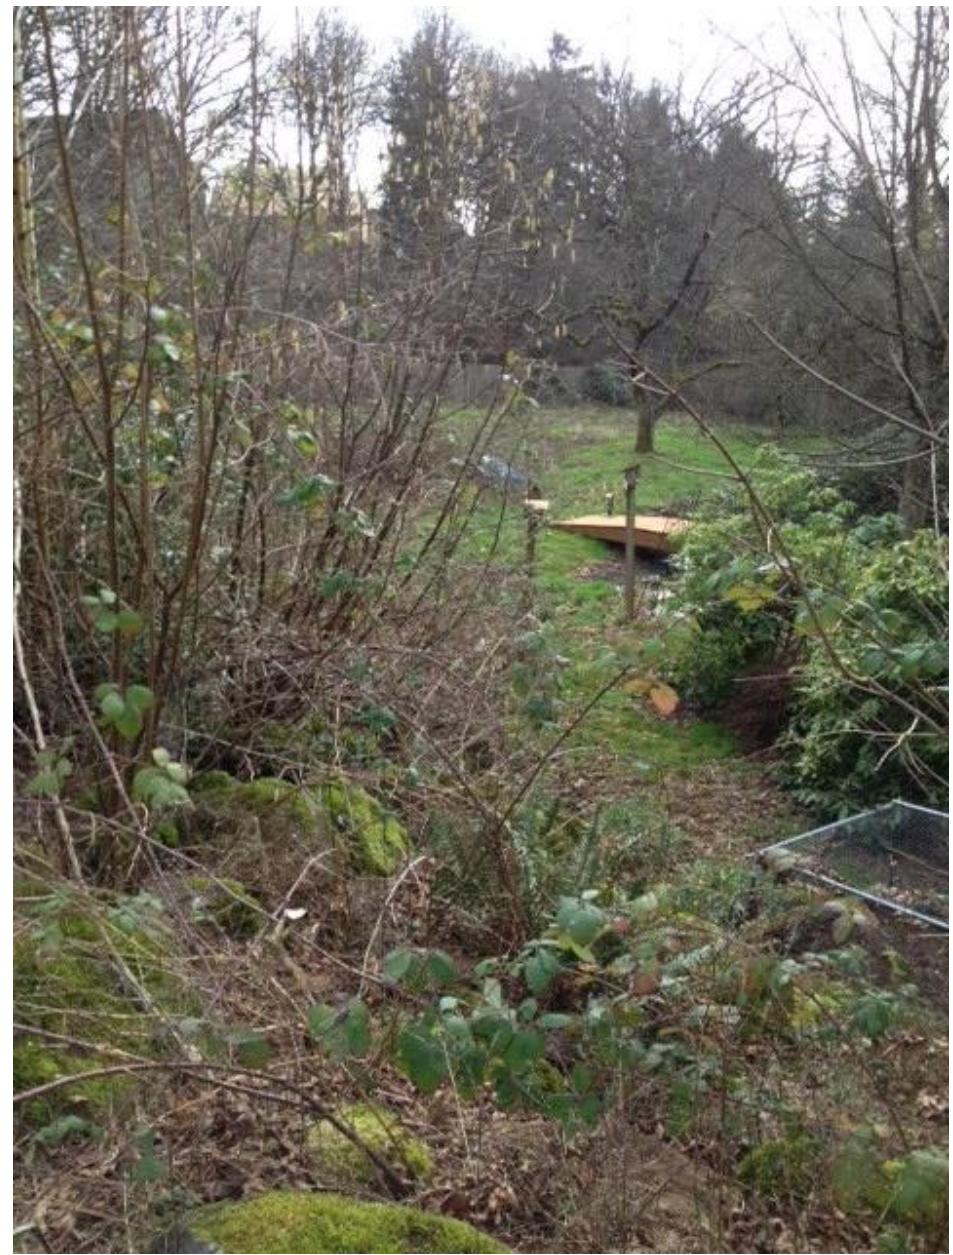
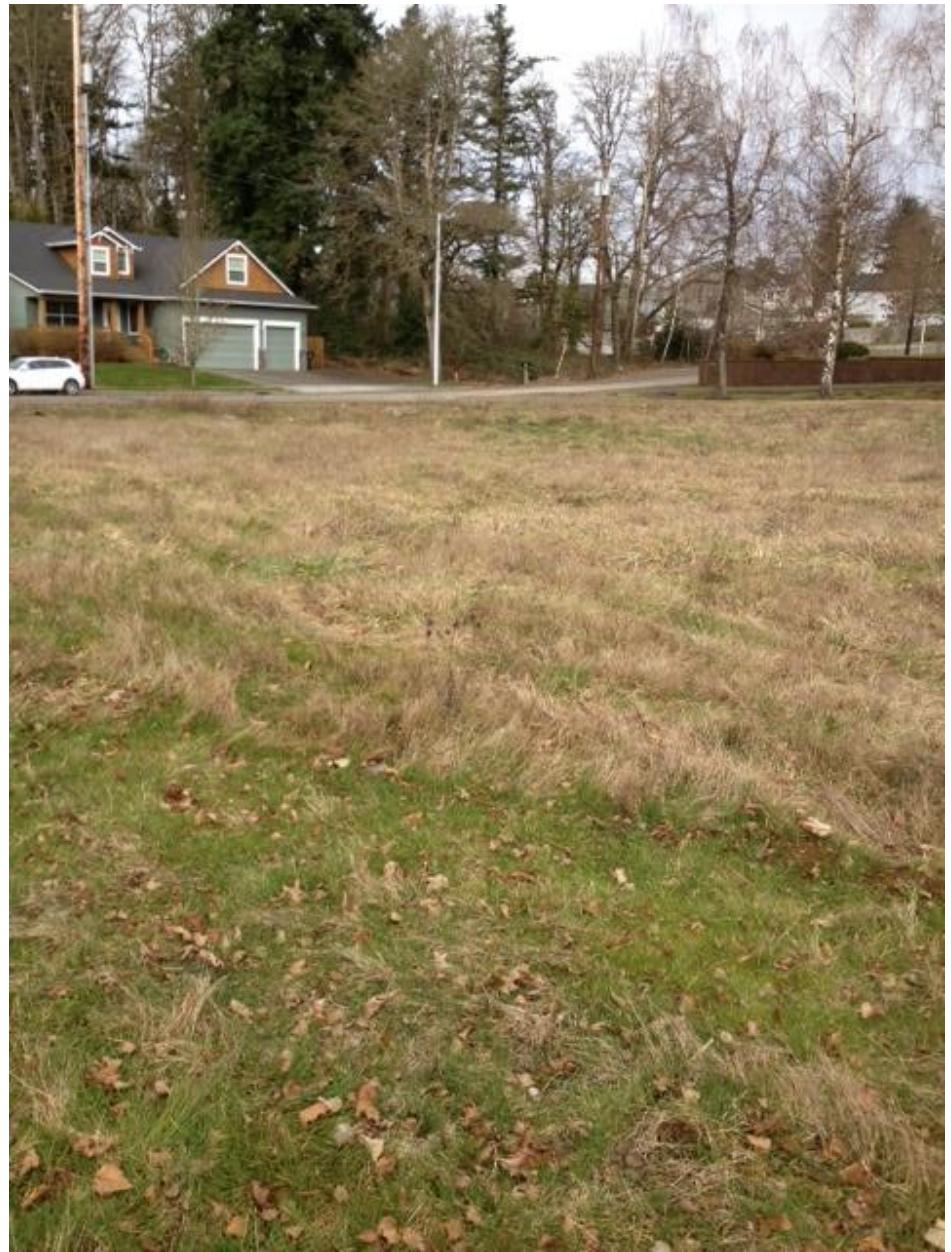
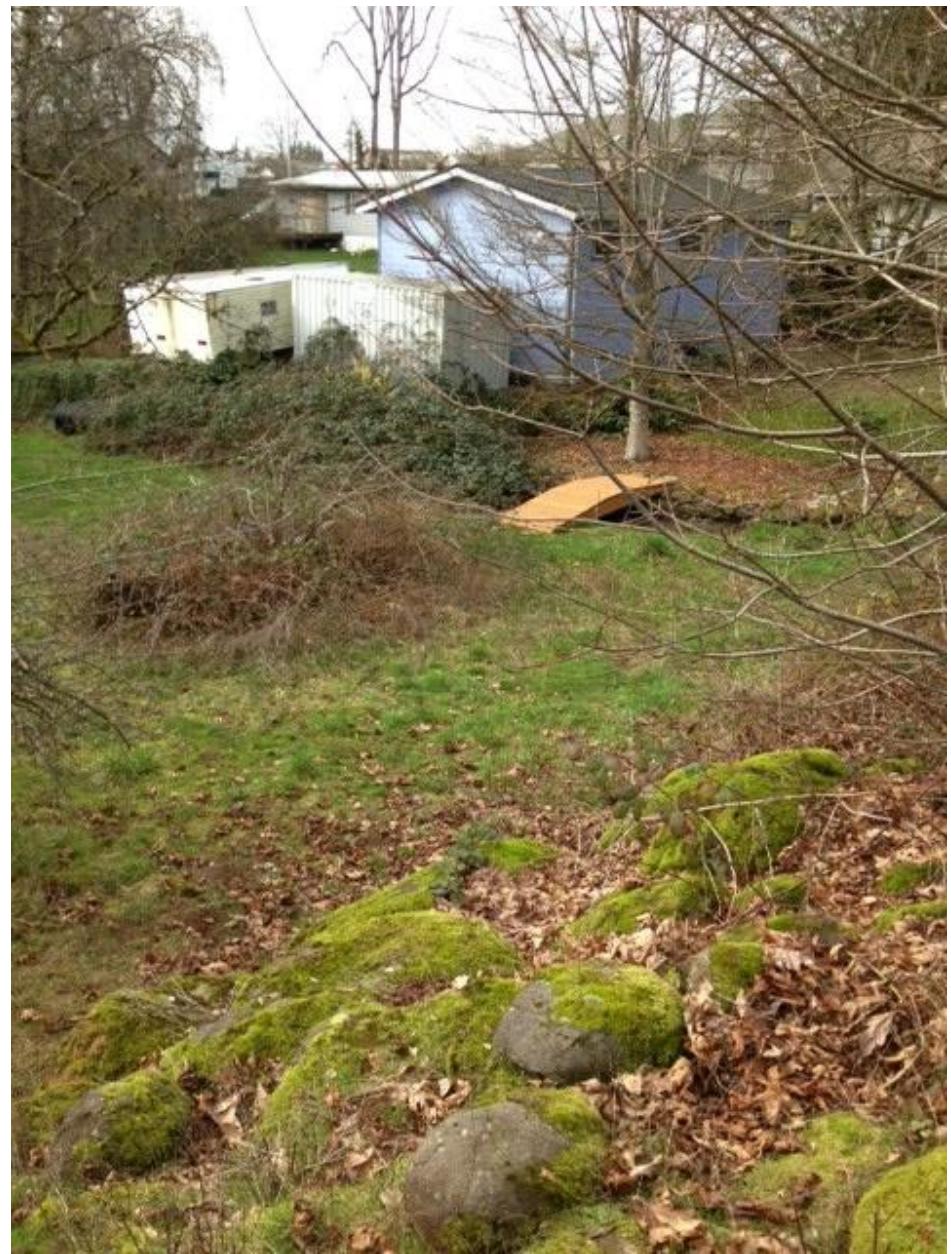
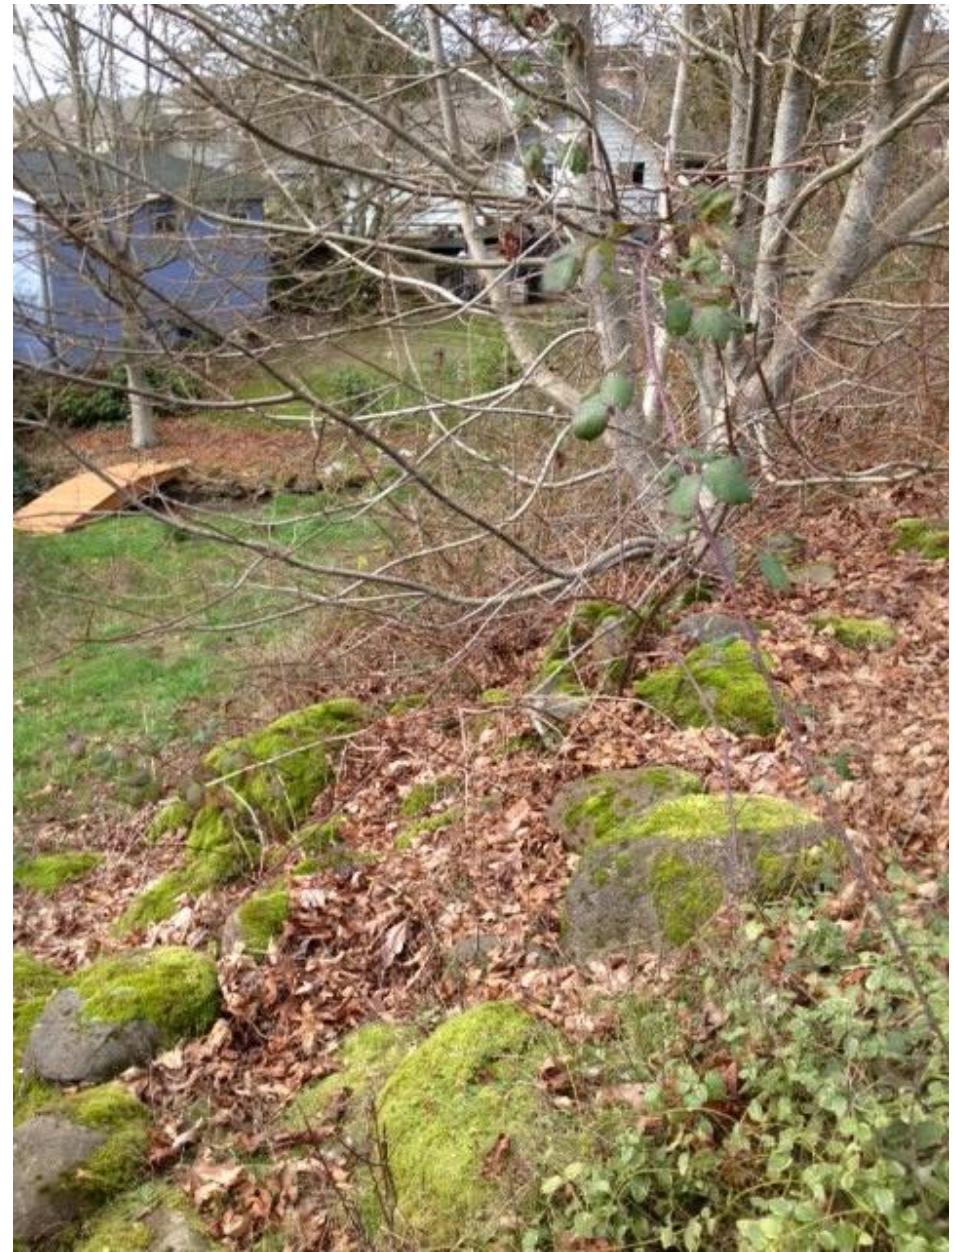
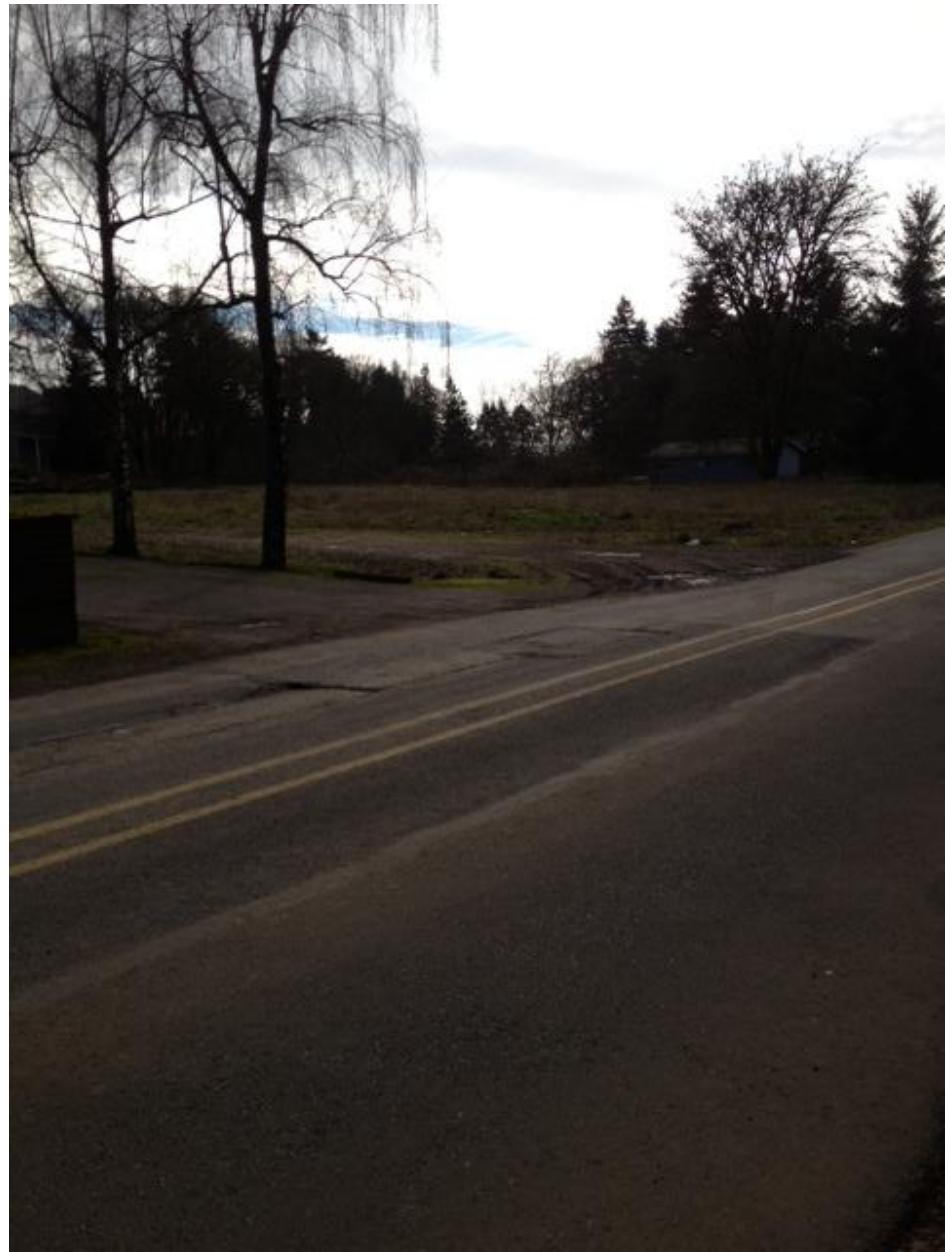
Finding: The applicant has applied for the Type I Verification and has paid the applicable review fee (Exhibit 1). The evidence provided by the applicant and this staff report substantiates that all of the requirements relative to the proposed use are satisfied and the following criteria have been met. Additionally, staff completed a site visit and field verification on February 14, 2013. The results of the field verification and photos are attached as Exhibit 3.

Finding: Complies. The existing rock wall on the southern property line creates a physical barrier between the outfall to the off-site intermittent ditch and the development site. The uppermost point of this wall is approximately 20' from the outfall.

SITE OBSERVATIONS:	YES	NO
1. Has soil or vegetation been disturbed? <u>OLD FILL/</u>	<input type="checkbox"/>	<input type="checkbox"/>
2. Have any hydrologic features been changed?	<input checked="" type="checkbox"/>	<input type="checkbox"/>

3. Are there any swales, drainage courses or streams on or within 200 feet of the site?	<input checked="" type="checkbox"/>	<input type="checkbox"/>
4. Are there any man-made drainage features on the site? <u>STORM PIPES</u>	<input checked="" type="checkbox"/>	<input type="checkbox"/>
