## **Highway 213/Beavercreek Road Improvements Project**

### ***Stormwater Fact Sheet***

**PRIOR TO CONSTRUCTION**  
***Holcomb Creek Culvert Replacement Project***  
**2002—2003**

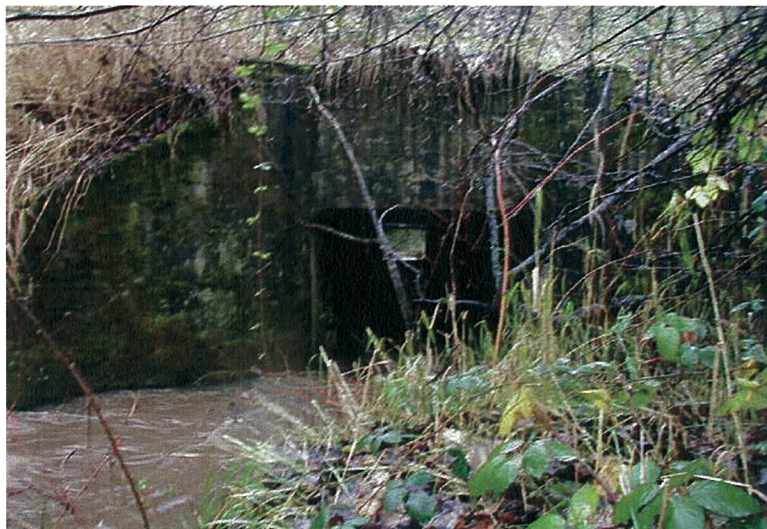
From culvert inlet opening,  
looking downstream through  
the 6'x 6' concrete box culvert

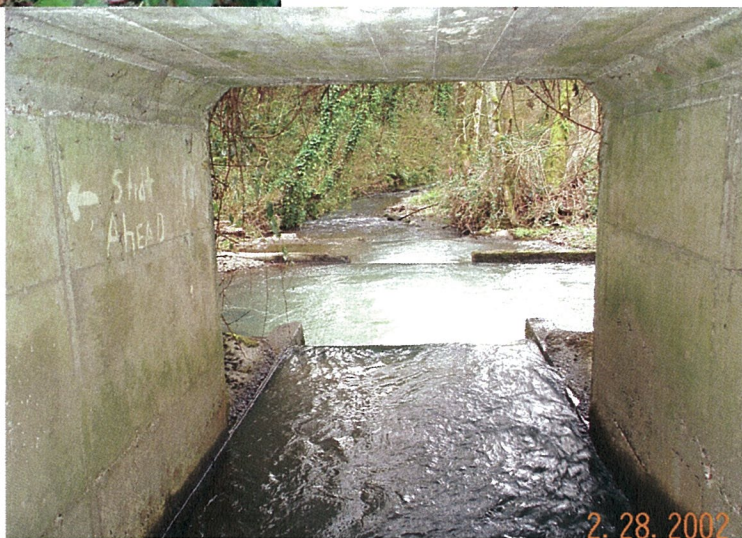
Looking downstream through  
6'x 6' concrete box culvert  
Outlet perched over 1.5',  
creating fish passage barrier.  
Downstream weirs in  
background.

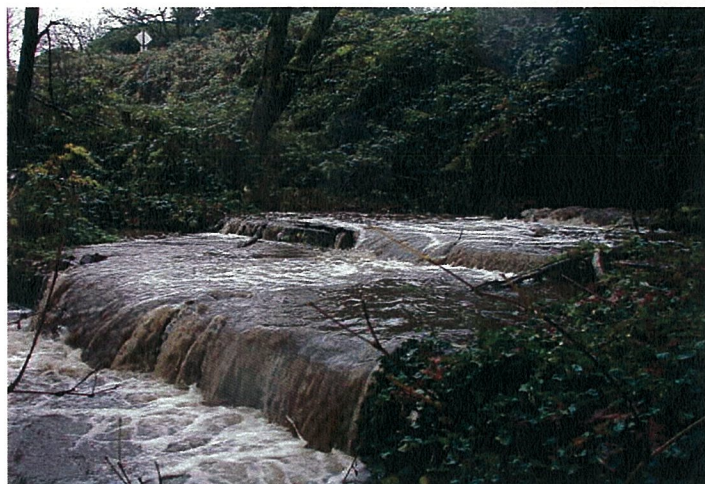
Looking upstream (culvert at right edge  
of photo) series of downstream weirs

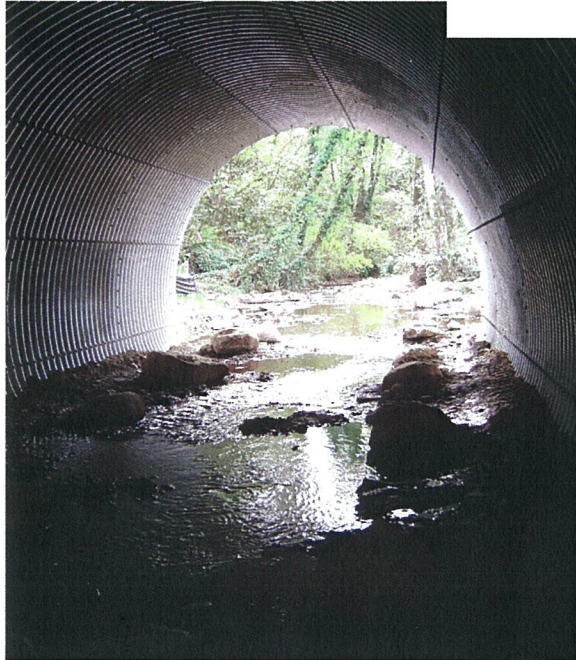
From culvert inlet opening, looking downstream through the multi-plate arched culvert. Culvert is embedded 2 feet below thalweg with native material and fish habitat rocks.

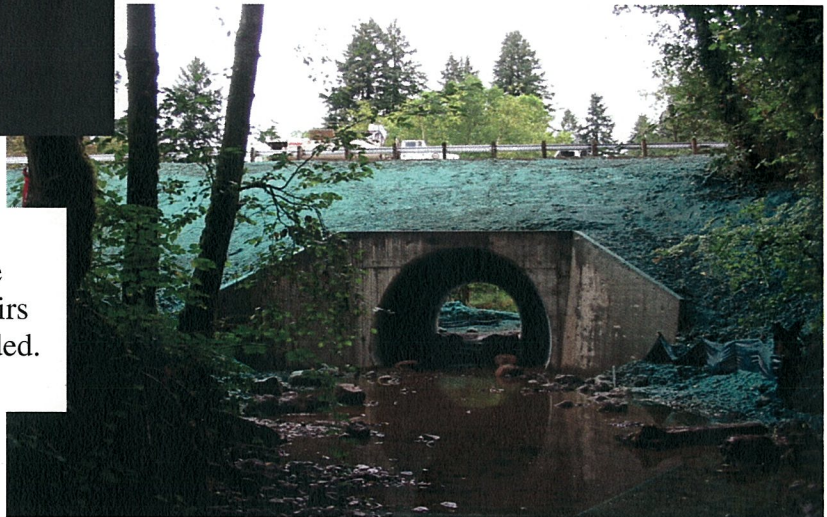
From culvert outlet, looking upstream through the multi-plate arched culvert. Downstream weirs are removed and channel re-graded.

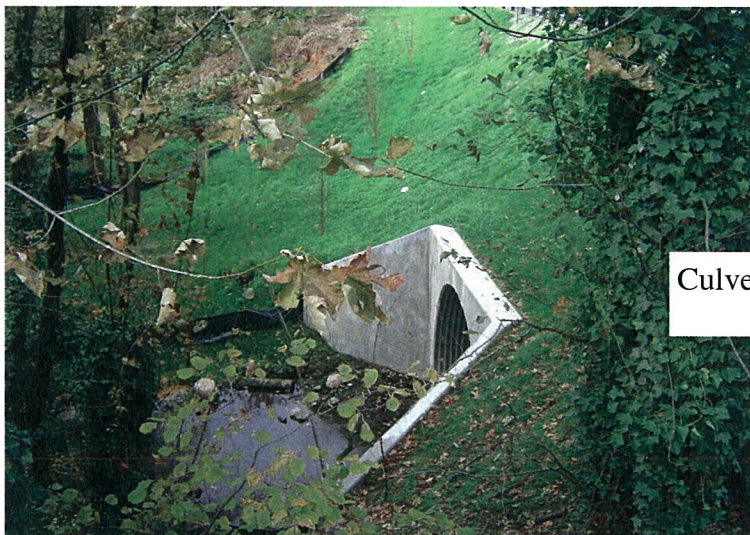
Culvert outlet view from road surface

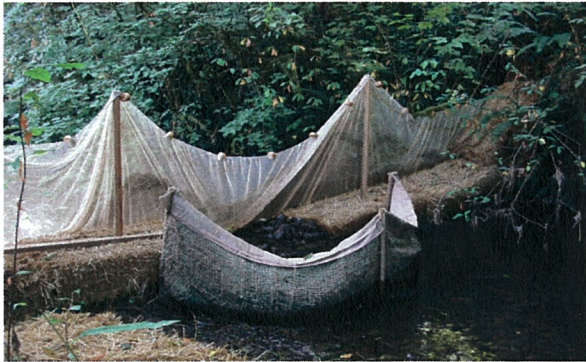
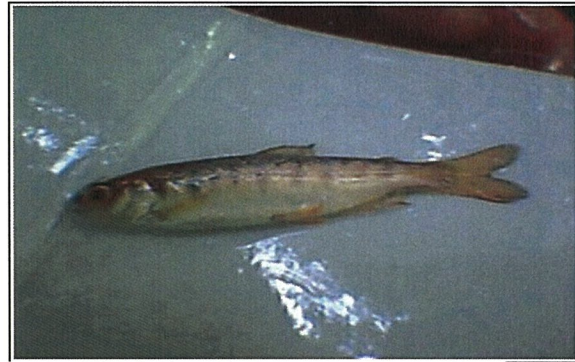
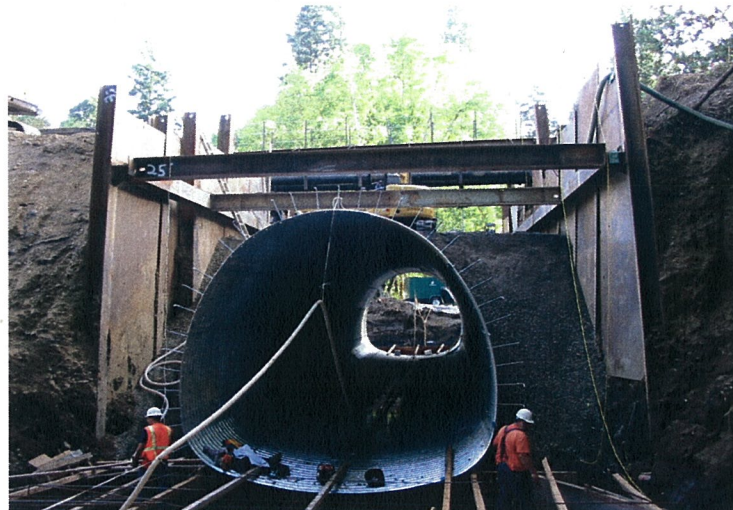
Assembling Multi-plate Arch culvert while stream is being diverted following fish salvaging operation.
