# CANEMAH NEIGHBORHOOD ANALYSIS

**ideasCollaborative**  
DESIGN | PLANNING | ARCHITECTURE  
PORTLAND

# CANEMAH NEIGHBORHOOD

# Historic Homes

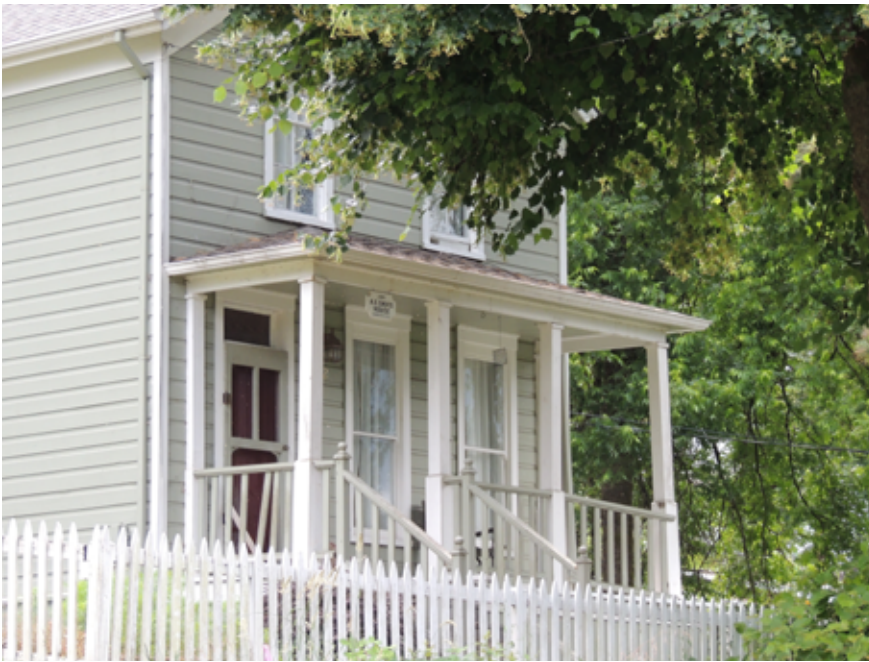
702 4th Ave

Covered front portch with simple raining. Columns simple forms. No ornamentation.

Large pervious parking lot area shared with neighbor in the undeveloped Apperson Street right of way.

2 Stories, no basement  
Rectangular with Rear extension Plan  
Wood Foundation  
Wood Construction  
Gable Roof  
Windows: 1 over 1 Windows, 4 over 4 windows  
Asbestos Shingles Siding (cover originals)  
Pent-roofed with square posts with deocrative capitals, engaged with pilasters at house

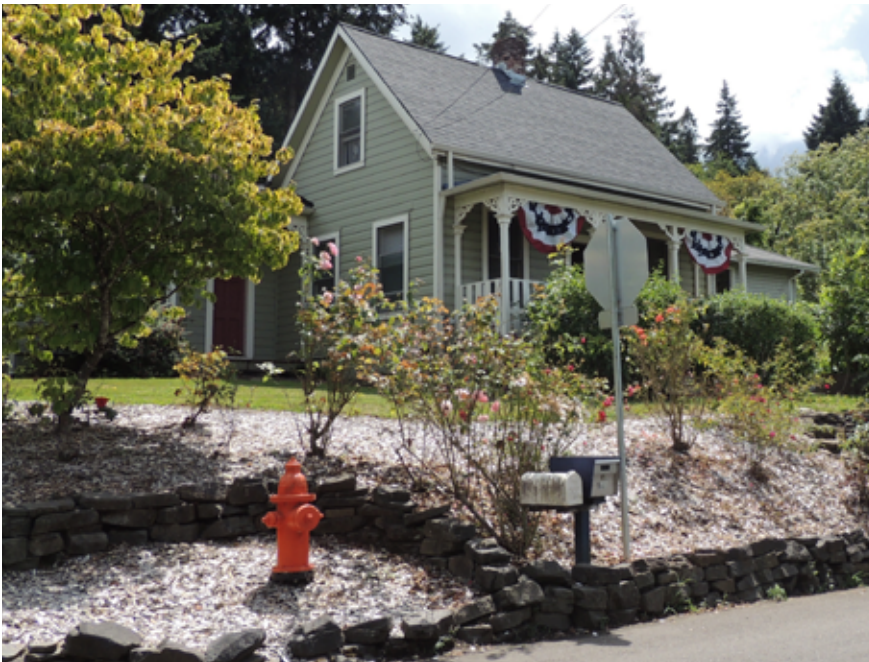
## (A-1 & A-2) 502 4th Ave

Existing home with side addition built within East property line setback.

Additional barn/ADU with covered parking built within set back and lot density greater than allowed by current code.

Covered parking structure crosses property line.

Wide and long impervious paved parking area roughly 16 feet wide and 55 feet long. (880 square feet.) (Our proposed parking area is XXX)

Many different types of windows on each of the (3) individual and separate house/building types on one property. (higher density than proposed development)

Multiple short basalt stone retaining walls around property and through the site.

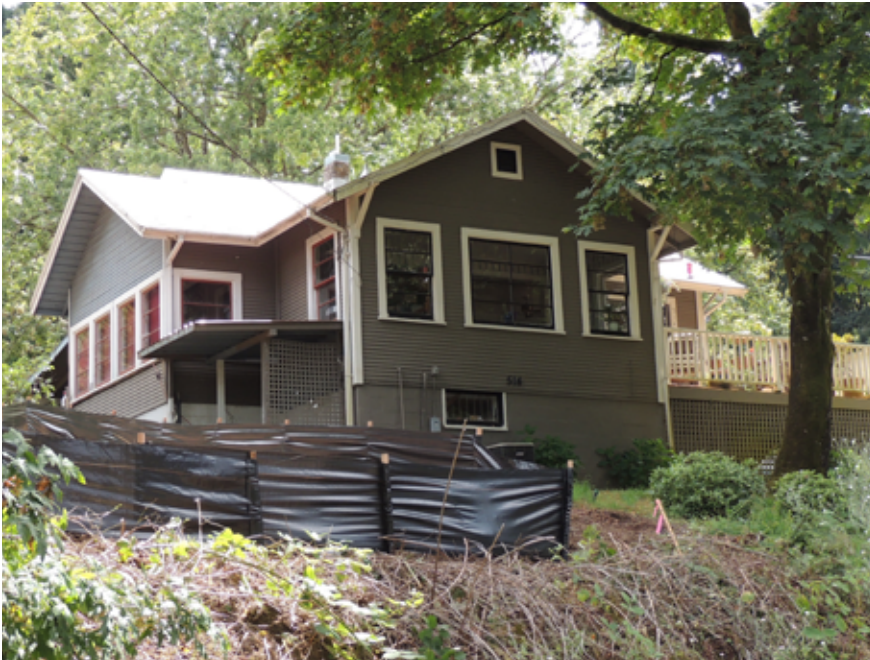
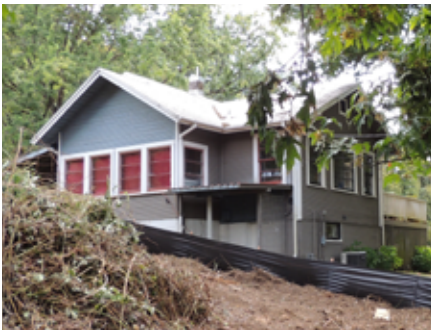
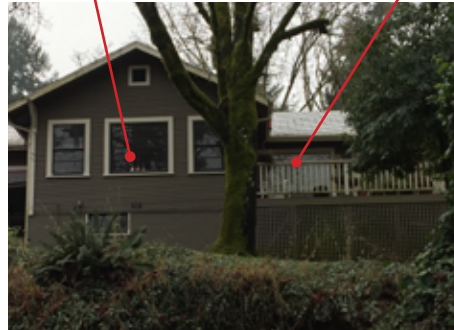
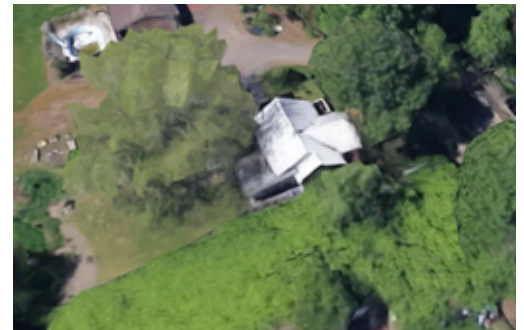
# (H) 514 4th Ave

Bay of windows all along East facade of building turning the corner to the North of the building. This home has a many large window openings.

Basement with one window and exposed cement block foundation wall - painted brown to match the rest of the home to minimize appearance.

Large square window flanked with large rectangular windows on either side of front facade.

Large rectangular window on recessed front facade opening up the entire North facade to views and light.

Large front/side porch without canopy.

Shared parking in undeveloped Jerome Street

Driveway extends in front of proposed development's property and will have to be mitigated when development takes place

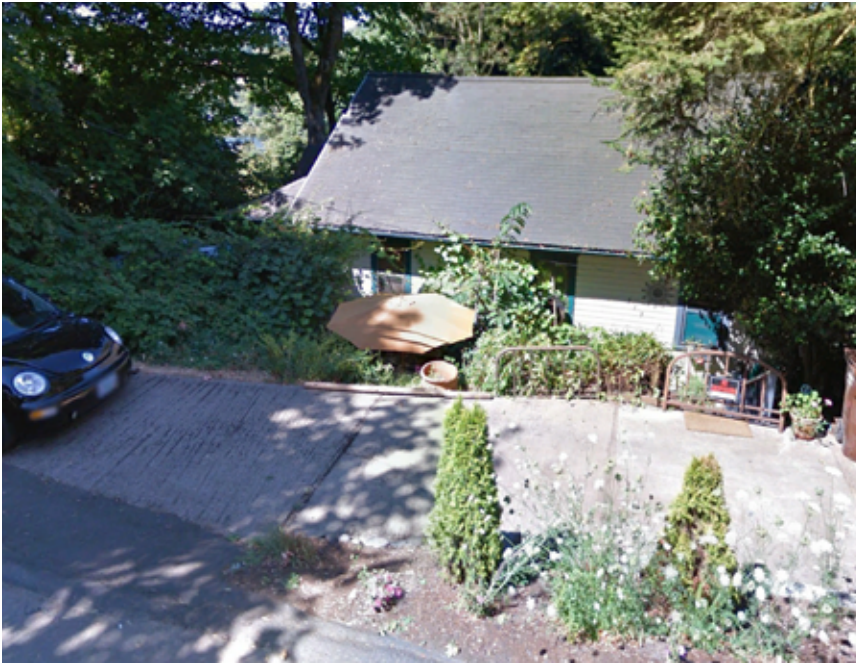
## (E) 515 4th Ave

Only parking for residence is along the side of the street. There is no parking on the site.

Due to environmental circumstances and site conditions home is built over the property line within setback.

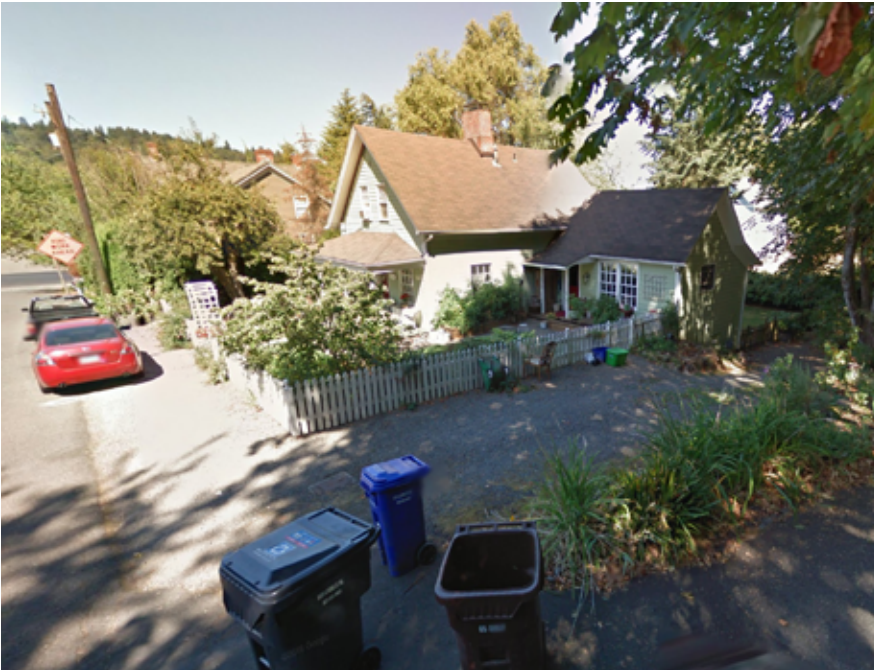
# 215 Miller Street

Parking in and along streetfront

Covered front porch

L-shapped home

On Street Parking

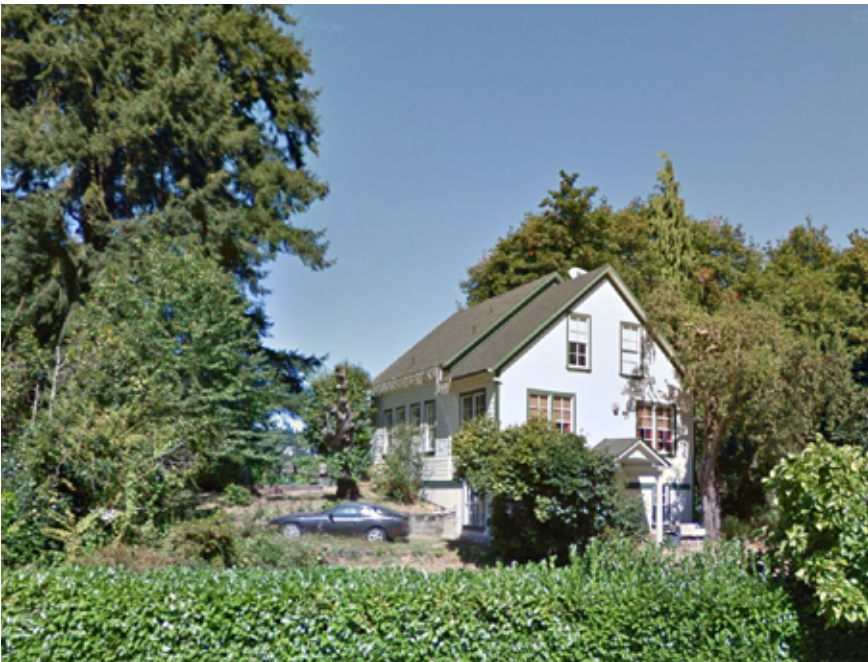
# 211 5th Ave

Parking lot space, Pull through driveway built in right of way

Built in grade  
Site retaining wall built along the side of the house

Large rectangular windows hung along the front and side of the home.

Windows hung side by side creating a larger square shaped openings along the front and side facades of the home.

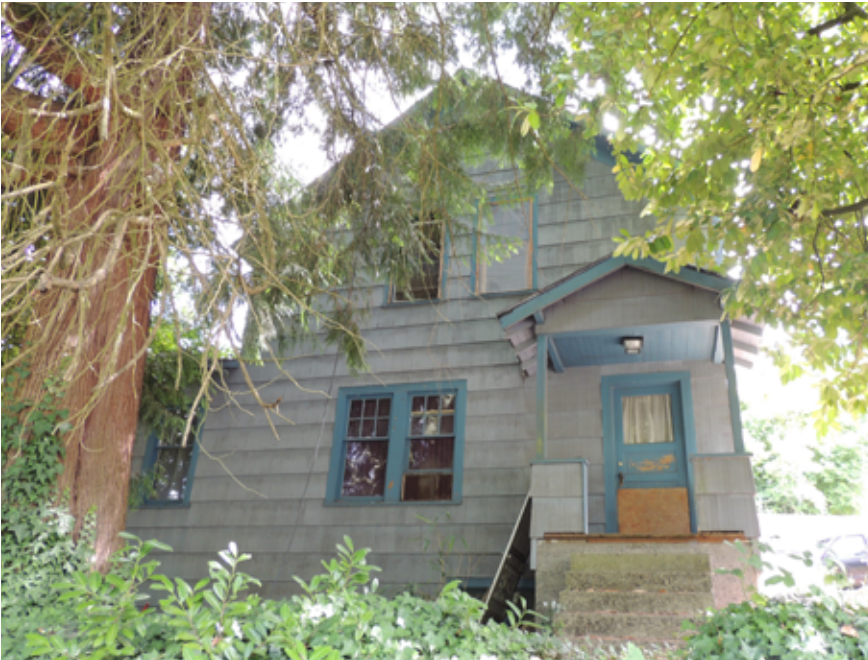
416 4th Ave

Built on setback with garage built over setback within the right of way of the road.

Parking is located along the side of the right of way along with an additional parking area behind the main house,

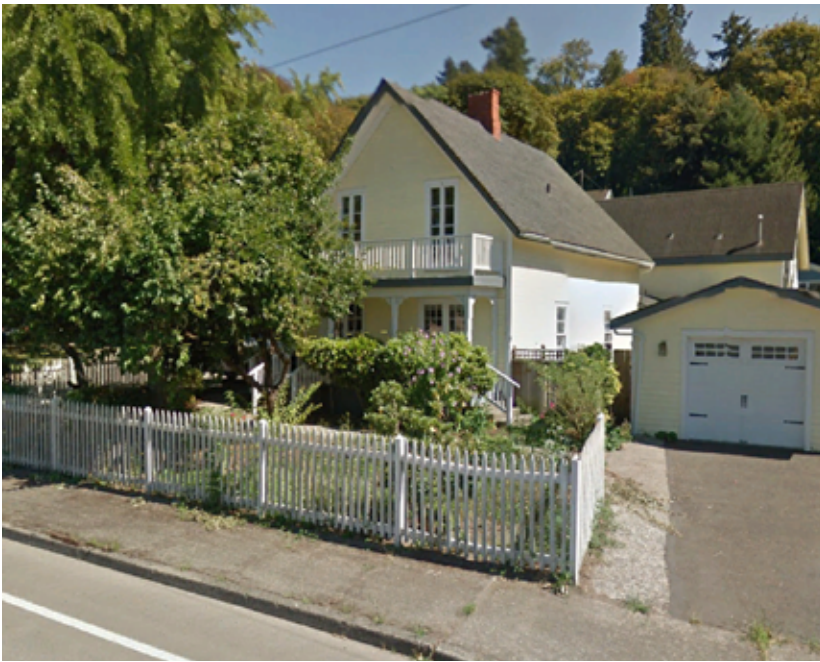
# 402 S. McLoughlin Blvd.

Dense lot coverage  
(more dense than proposed development)

New additions to house

Multi car parking area off Hedges Street  
(impervious parking along street with no planting buffer 6 90degree parking spaces with additional cars parked parallel to road)

Unique long skinny windows

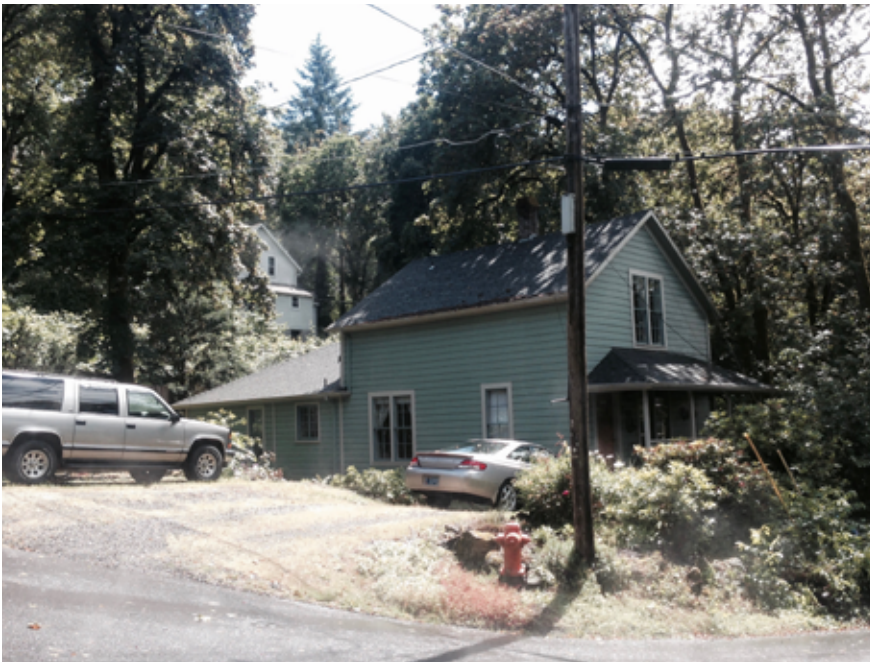
216 3rd Ave

Various Window Styles

Pervious Large Parking area directly off of the street.

No planting buffer.

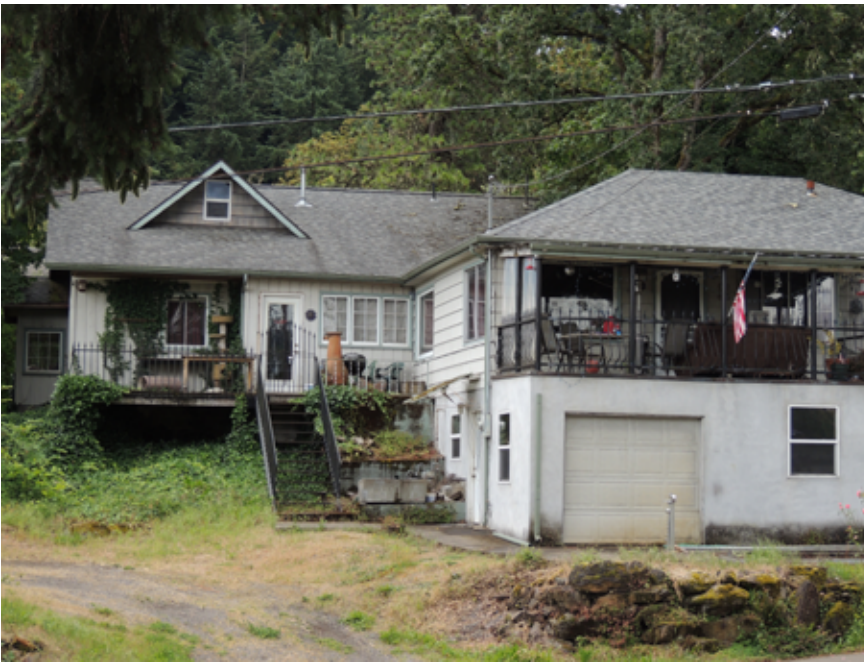
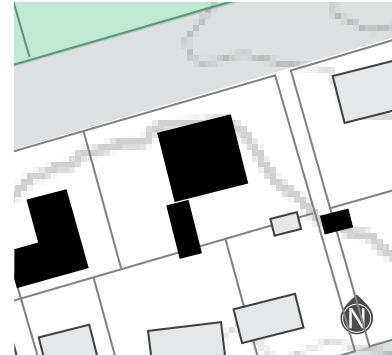
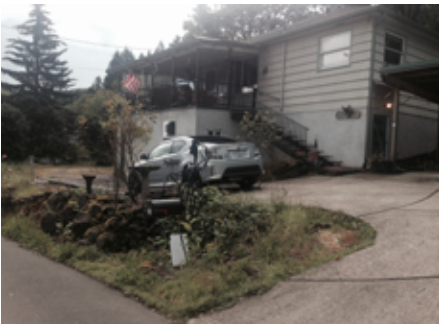
# 814 4th Ave

Pull through driveway and parking

Retaining wall/Basement  
Foundation Wall

2nd story porch

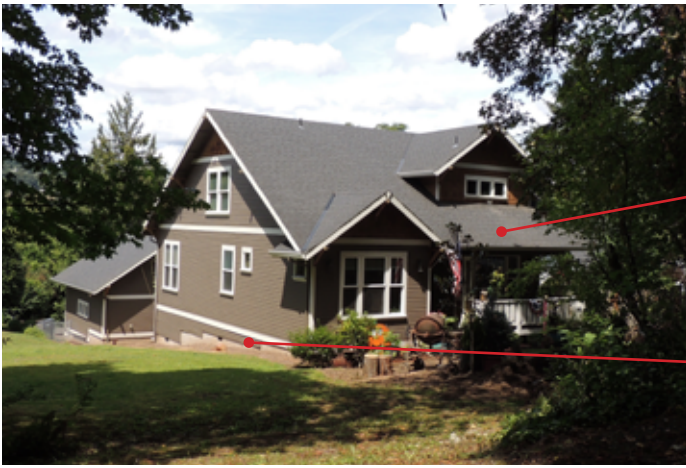
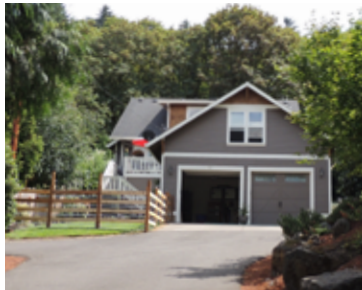
421 5th Ave

extended roof overhang  
providing cover for porch

exposed stepping up  
foundation from bottom  
level to main level of  
home

Extended roof overhang providing cover for porch  
Home built into side of hill with stepping up foundation  
around bottom level of the home.

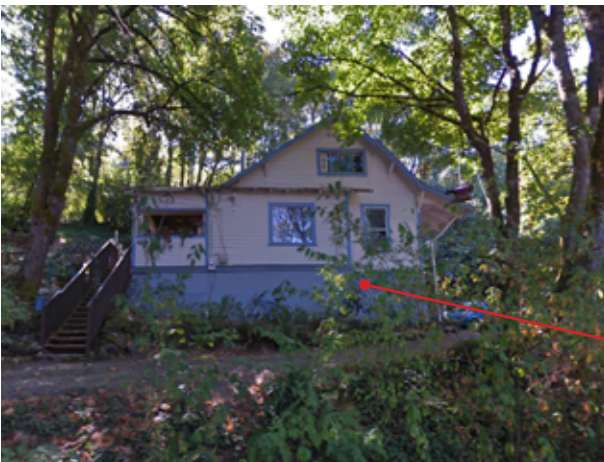
## 402 5th Ave

**Tall concrete retaining wall foundation**

**Raised porch**

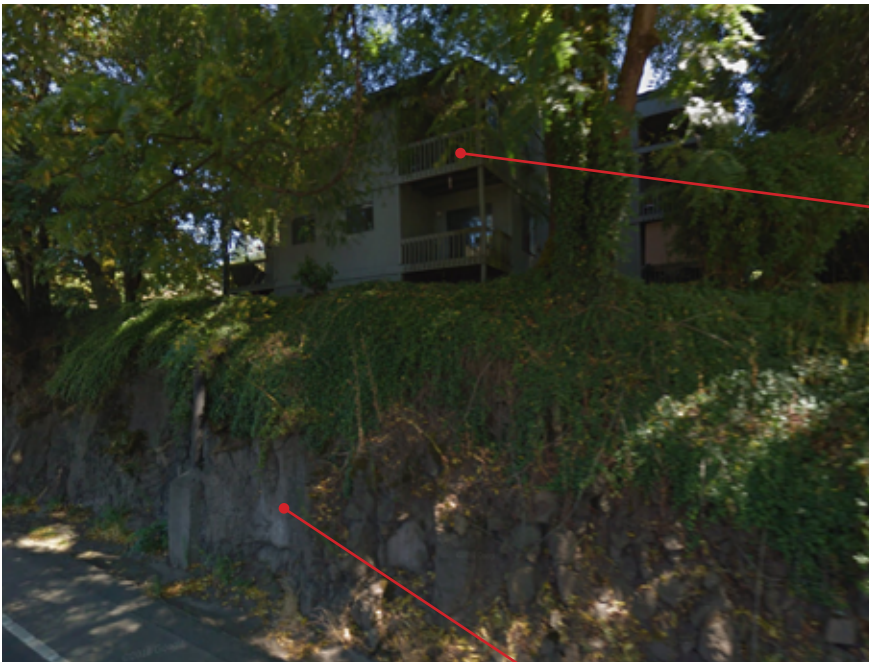
# 801 3rd Ave

Upper level balcony  
covering first level

Tall concrete retaining  
wall

Large Parking area

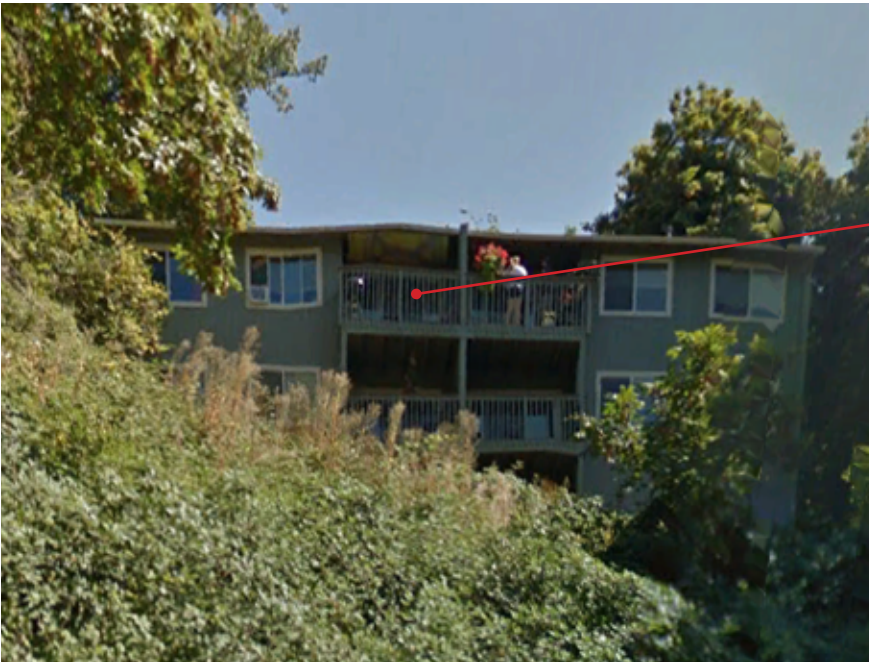
## 205 3rd Ave

Upper level balcony  
covering first level

Large Parking area

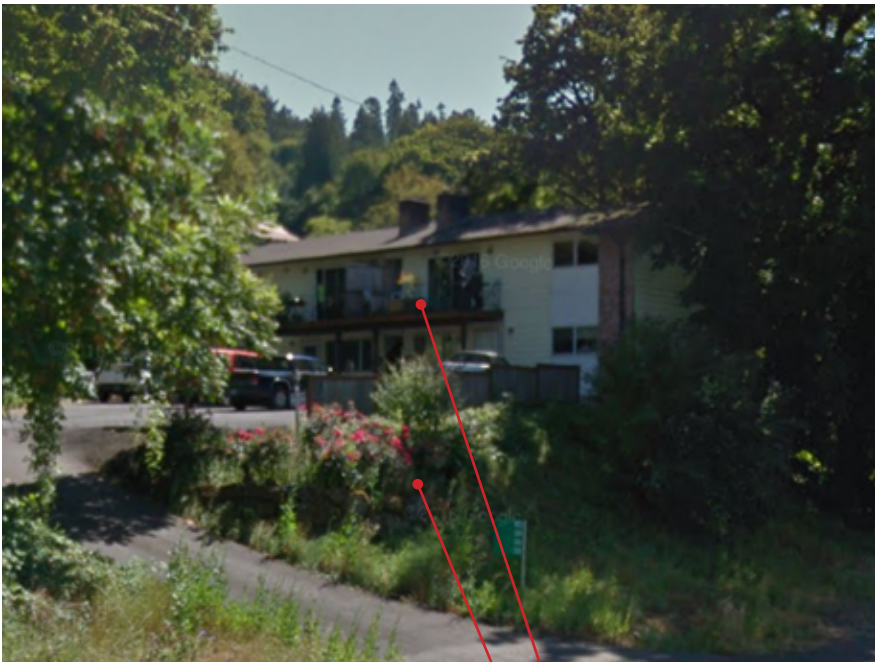
# 302 S McLoughlin Blvd

Upper level balcony covering first level

Tall concrete retaining wall

Large Parking area
