PROPOSED TRANSPORTATION MAINTENANCE FACILITY

PHASE I ENVIRONMENTAL SITE ASSESSMENT

10.53-Acre Parcel
Northwest of Meyers Road and High School Avenue
Oregon City, Oregon

GeoDesign Project: ArchBBL-3-01

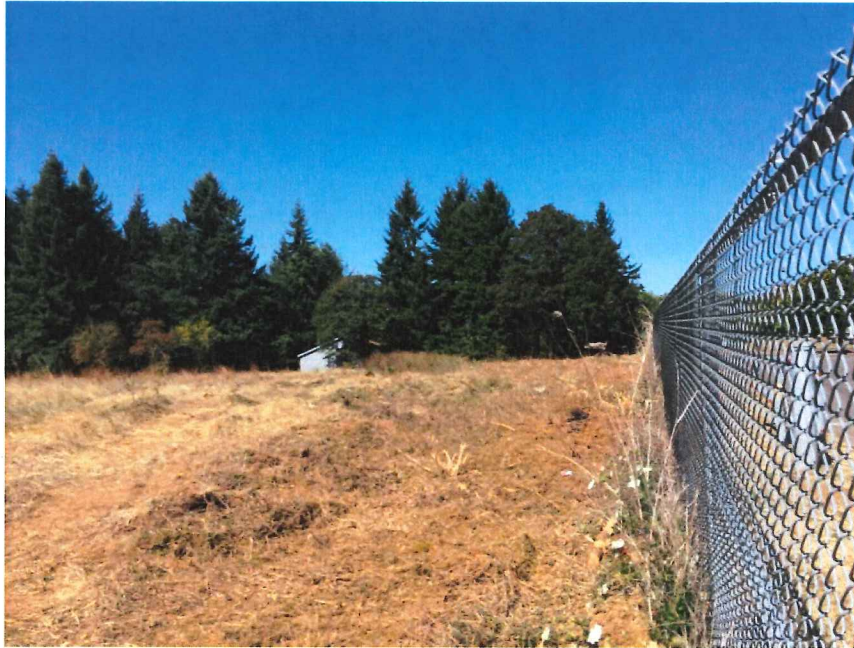
VIEW OF THE SOUTHERN PORTION OF THE PROJECT SITE. PHOTOGRAPH TAKEN FACING NORTH.

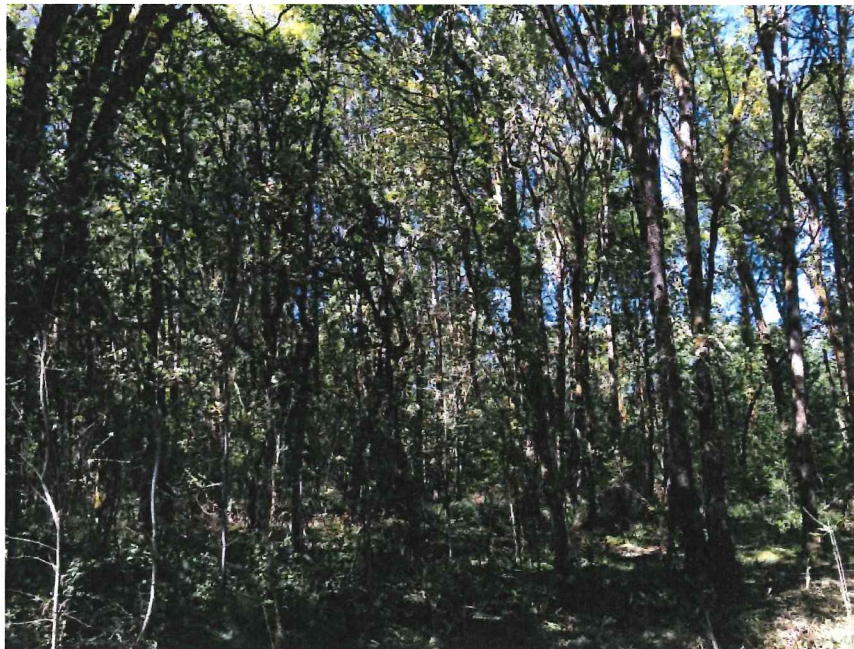
VIEW OF THE NORTHERN PORTION OF THE PROJECT SITE. PHOTOGRAPH TAKEN FACING WEST.

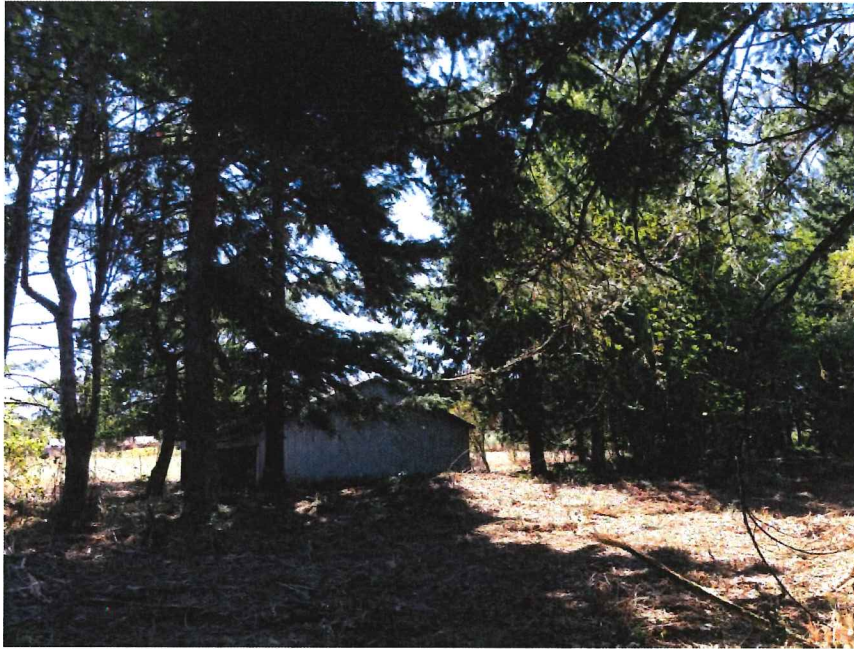
An approximately 10-cubic-yard fill pile was observed north of the barn. Evidence of deleterious material was not observed among the fill.

VIEW OF THE BARN AND FILL STOCKPILE. PHOTOGRAPH TAKEN FACING SOUTH.

We did not observe evidence of deleterious material among the fill pile present at the project site. If hazardous material is found in the fill pile, it should be separated, characterized, and properly disposed.

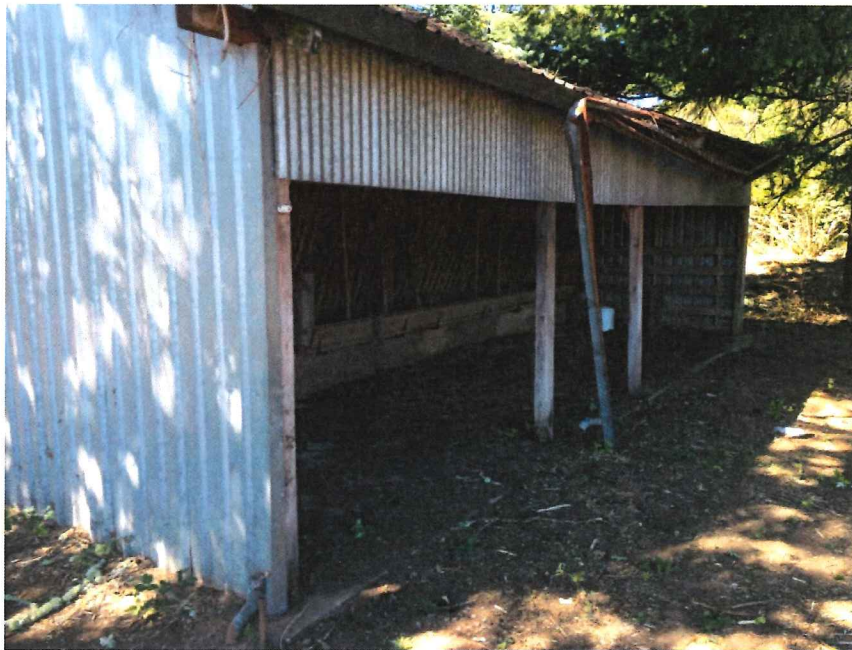
The approximately 1,200-square-foot, wood-framed barn was constructed with a concrete slab-on-grade foundation, corrugated metal siding, and corrugated metal roofing.

VIEW OF THE BARN. PHOTOGRAPH TAKEN FACING NORTH.
