Natural Resource Overlay District Report

Phase 1 of The Cove Development Plan

in Oregon City, Oregon

PHS Project Number: 5511

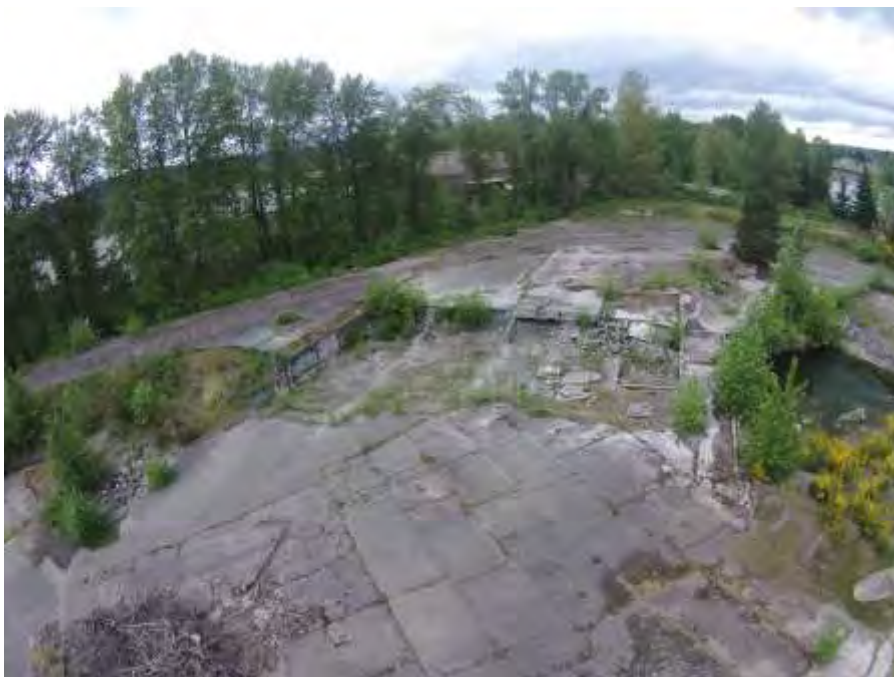
Aerial Photo, Showing Pond and Concrete Debris, North End of Site

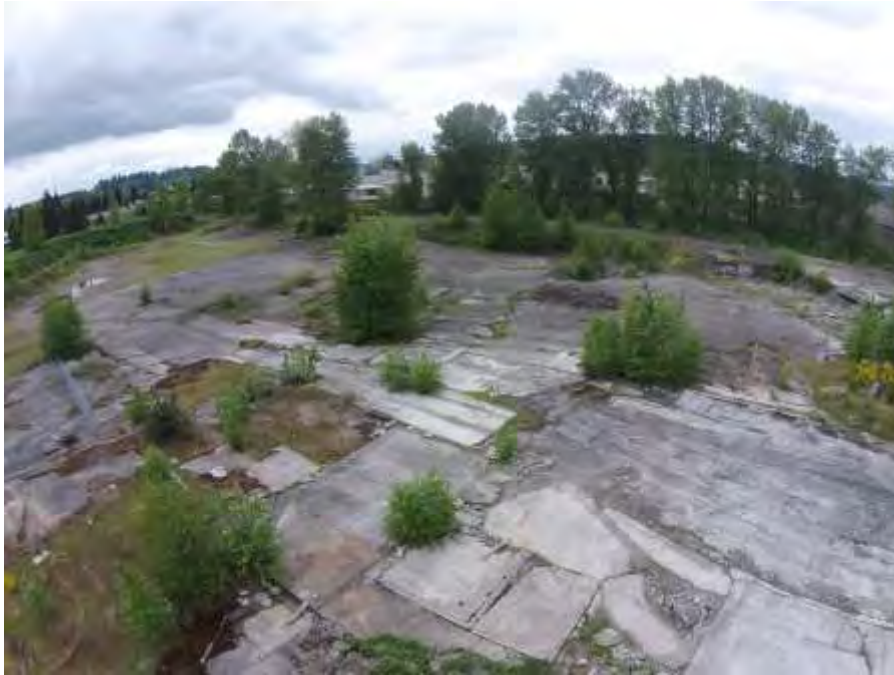
Aerial Photo, Facing West, Showing Concrete Fill

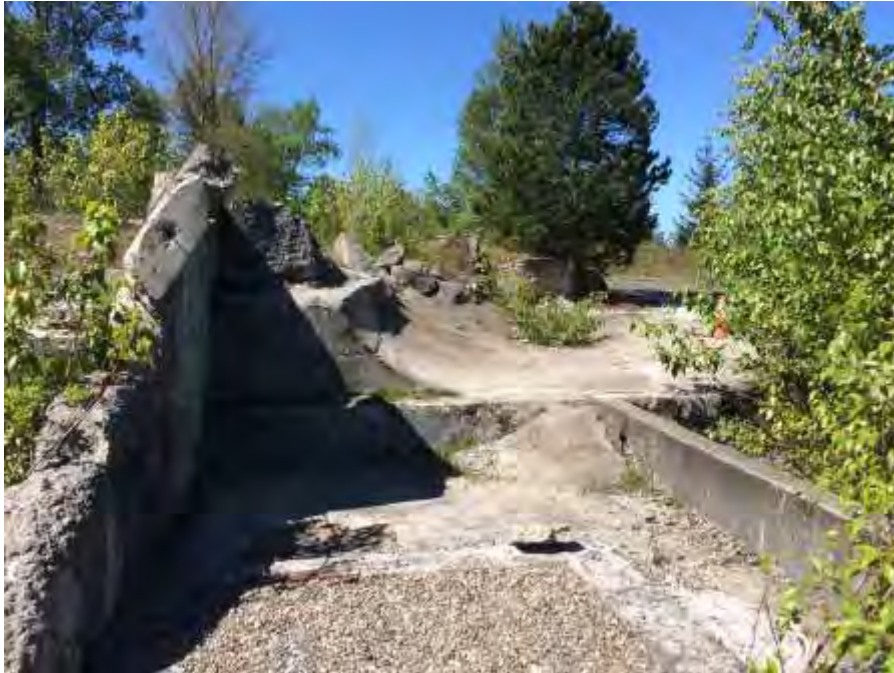
North End of Site, Old Building Foundation

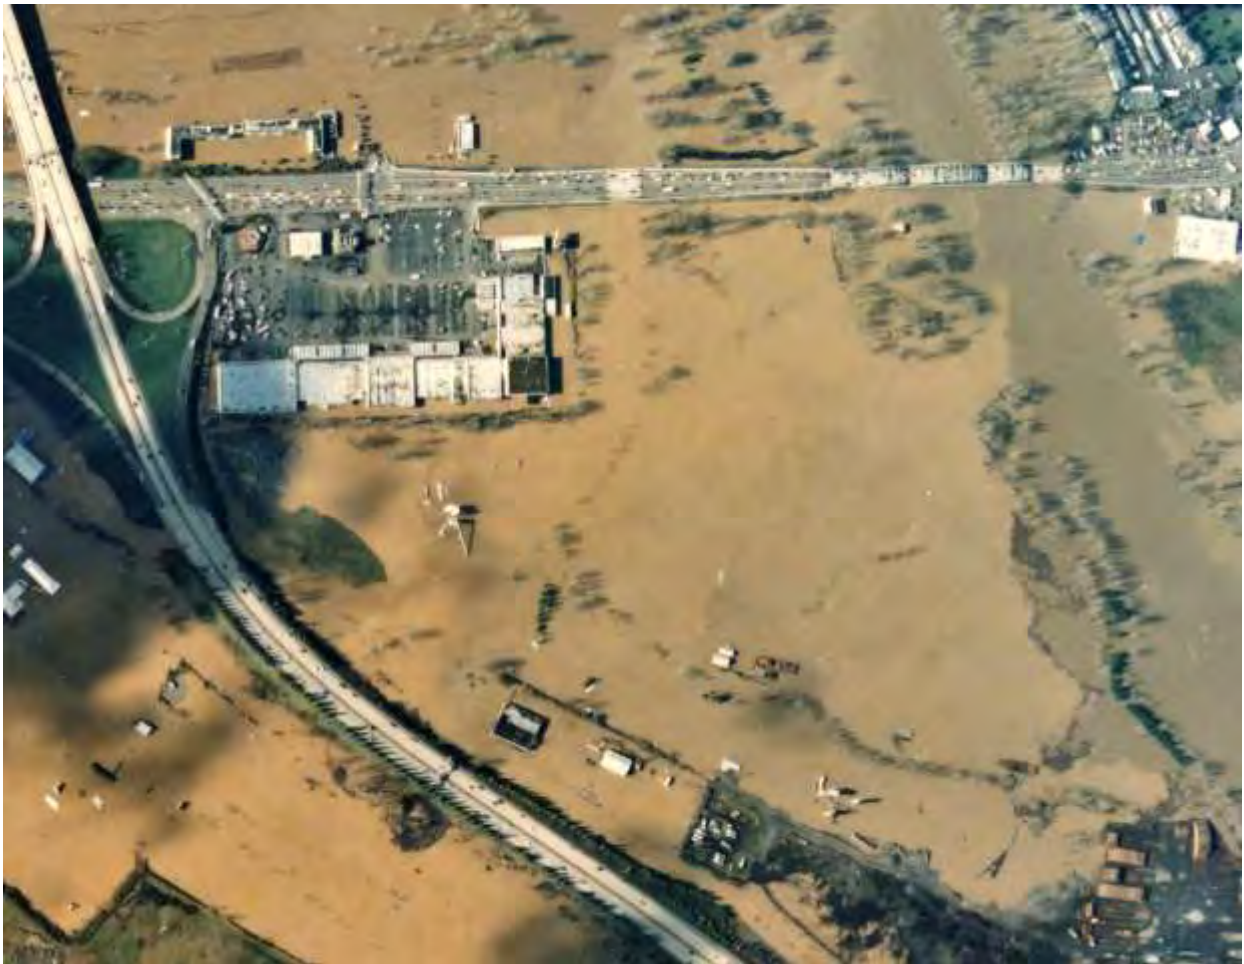
1996, North at Right, During 100-Year Flood Event
