Re: Updated Geologic Hazard Evaluation
OCMC Chap 17.44 Geologic Hazards
The Cove Development
Oregon City, Oregon
1195-00

Apex Companies, LLC (formerly Ash Creek Associates) has prepared this letter to address specific requirements of the City of Oregon City Municipal Code (OCMC) with respect to Geologic and Geotechnical Hazards.

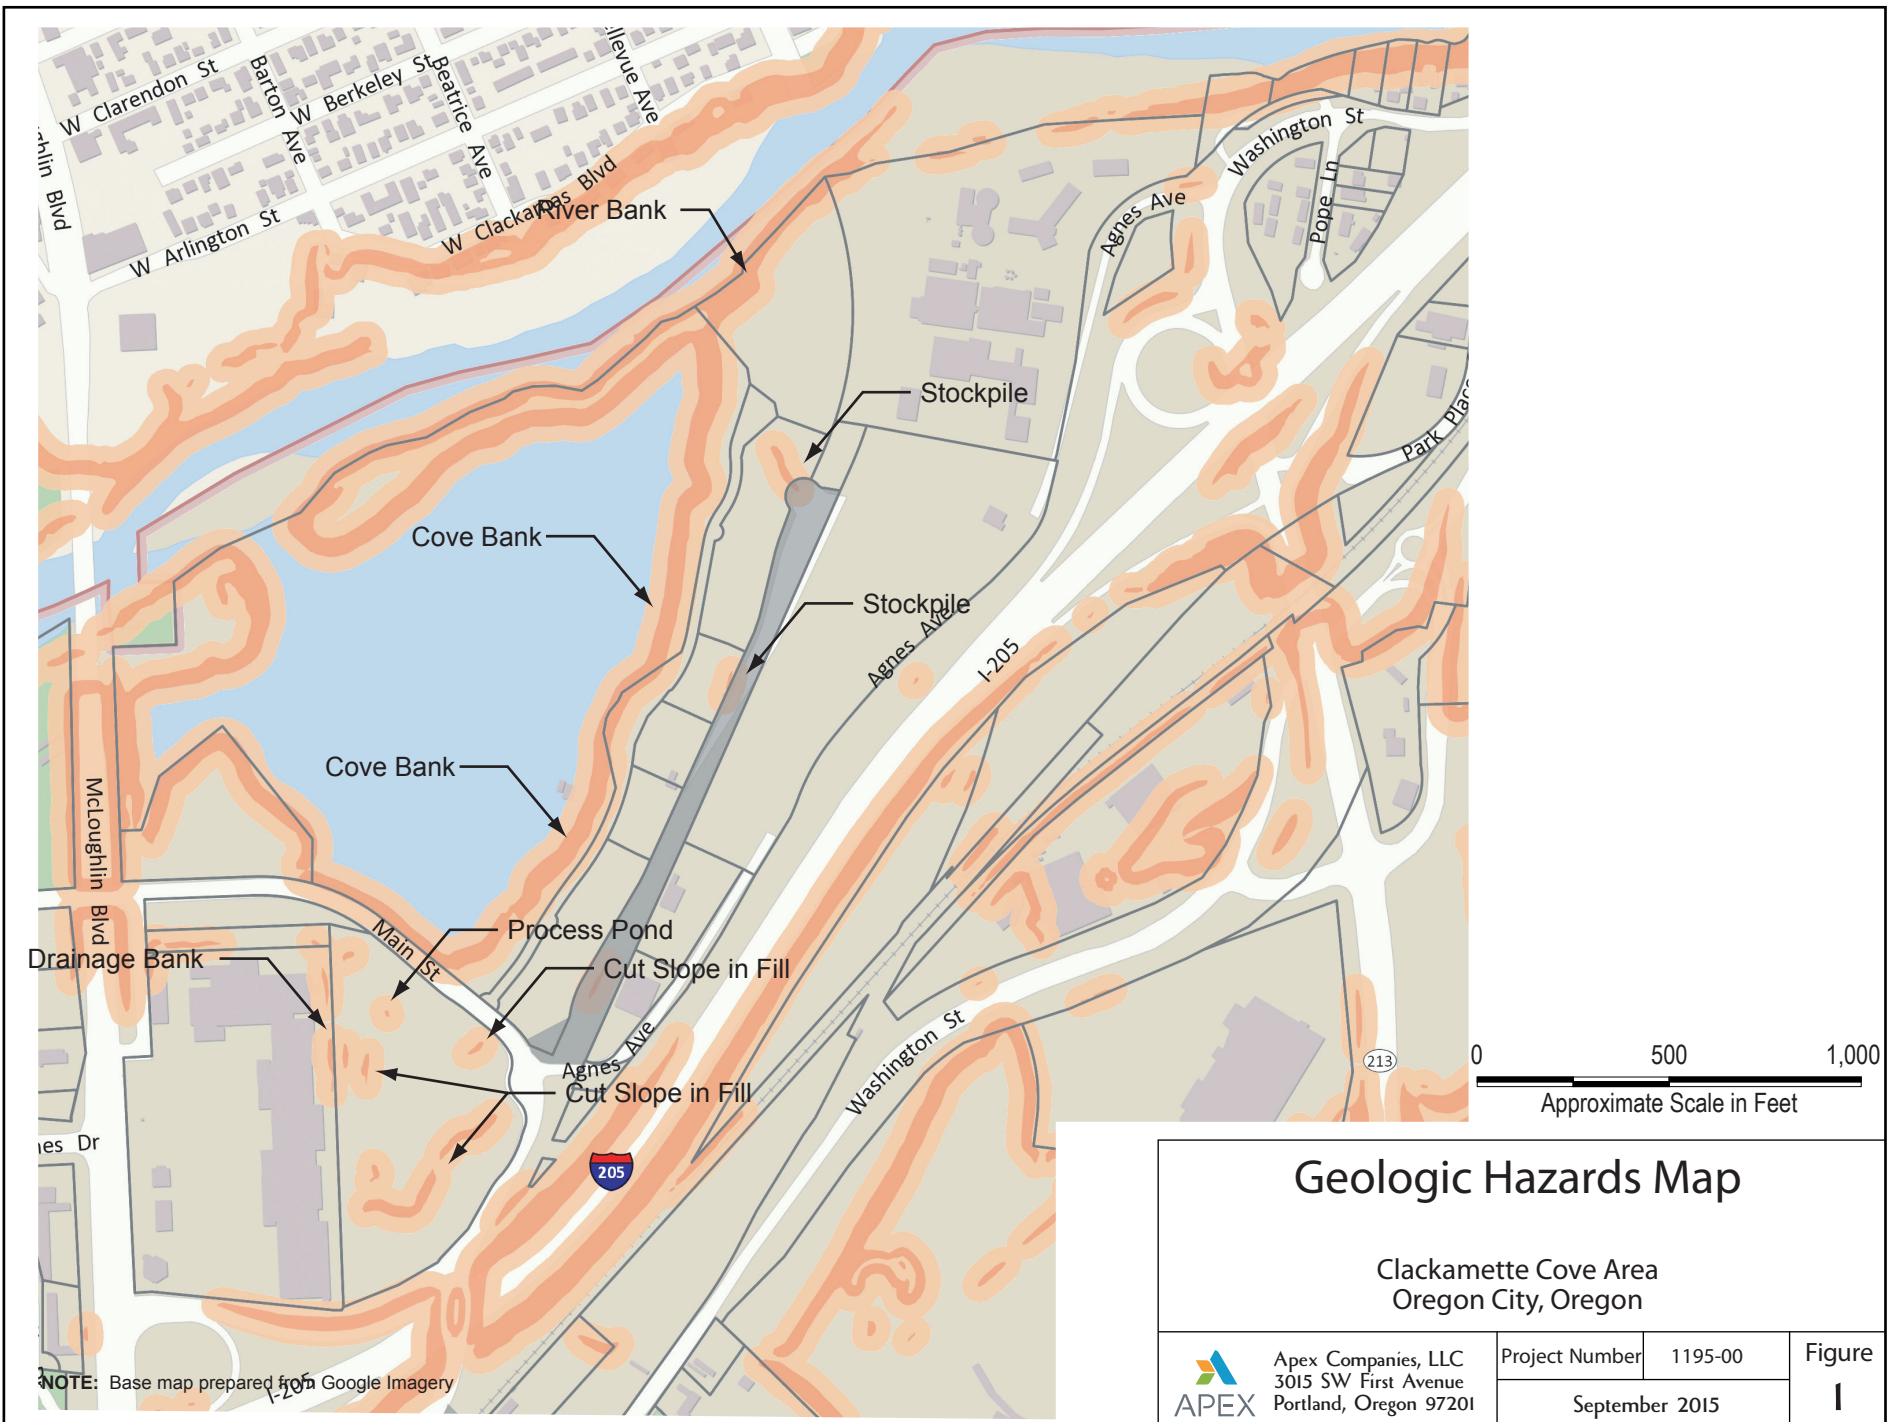
The attached Figure 1 is excerpted from the 2015 edition of the City of Oregon City's Geologic Hazards Map. The map indicates steep slopes and buffer zones developed from aerial photography interpretation. We have annotated each of the slope hazards by their source and provided a discussion of each.

Stockpiles. A number of large, temporary fill stockpiles are present throughout the site. These stockpiles were placed at their angle of repose and as such, feature steep sides that trigger the geologic hazard designation. The geologic hazards associated with stockpiles will be completely eliminated through removal. The stockpiles will be excavated and where appropriate, the materials will be placed as compacted, engineered fills.

Cut Slopes in Fill. The Garden Apartments site has been extensively filled. Those fills continued above the adjacent road grades. Over time as the batch plant was developed, The perimeter fills were excavated to expand the working area and to provide fill. This borrowing generally occurred near the perimeter of the site, and resulted in steep cut slopes in random fill. Those cut slopes also trigger the geologic hazard designation. The geologic hazards associated with stockpiles will be completely eliminated through removal. The grading plan indicates that the slopes will be excavated to provide fill for the lower portions of the site.

Cove Banks. The banks of Clackamette Cove generally consist of granular fills that were dumped or pushed into the original quarry excavation in order to create upland. The banks generally raveled off into final slopes of approximately 1.5V:1H or steeper. Vegetation eventually established itself and the Cove banks have, for the most part, been as found today for decades, in spite of periodic inundation such as during the 1996 floods. Over the past 10 years during which Apex representatives have been associated the project, the banks have shown little to no evidence of sloughing or erosion. The steepness of the banks triggers the Geologic Hazard Designation.

River Bank. The south bank of the Clackamas River intersects the far northern edge of the project site. The oversteepened nature of this bank triggers the hazard designation. The required setbacks from the Clackamas will result in avoidance of this slope and as such, it will not impact the project.

Drainage Bank. As previously noted, the Garden Apartments site has been extensively filled. On the west border of the site, those fills were completed short of the property boundary with the adjacent shopping center. This resulted in a steep drainage ditch that provides surface water conveyance for the site. The steepness of the fill slopes triggers the geologic hazard designation. The Garden Apartments site will address impacts of that slope through retaining walls and grading.
