CANEMAH NEIGHBORHOOD ANALYSIS

ideasCollaborative
DESIGN | PLANNING | ARCHITECTURE
PORTLAND

Historic Homes

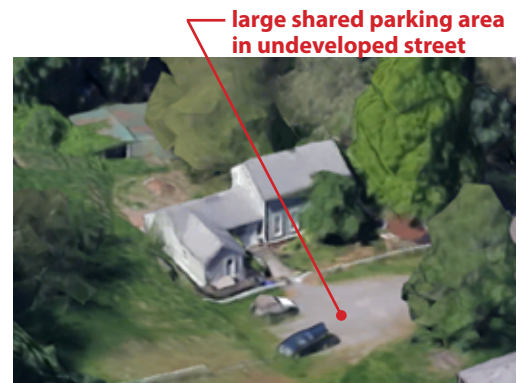
2 Stories, no basement
Rectangular with Rear extension Plan
Wood Foundation
Wood Construction
Gable Roof
Windows: 1 over 1 Windows, 4 over 4 windows
Asbestos Shingles Siding (cover originals)
Pent-roofed with square posts with deocrative capitals, engaged with pilasters at house

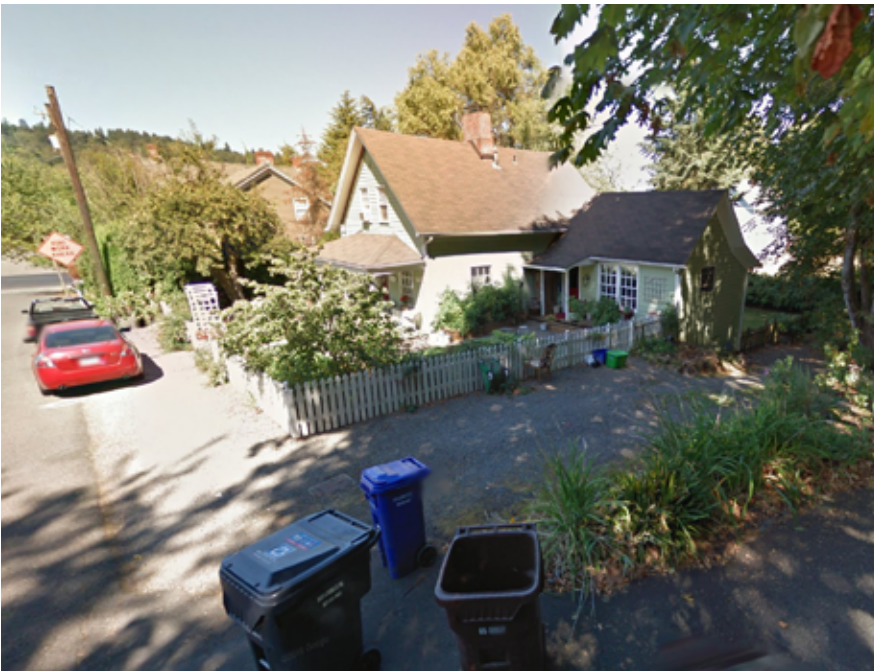
215 Miller Street

Parking in and along streetfront

Covered front porch

L-shapped home

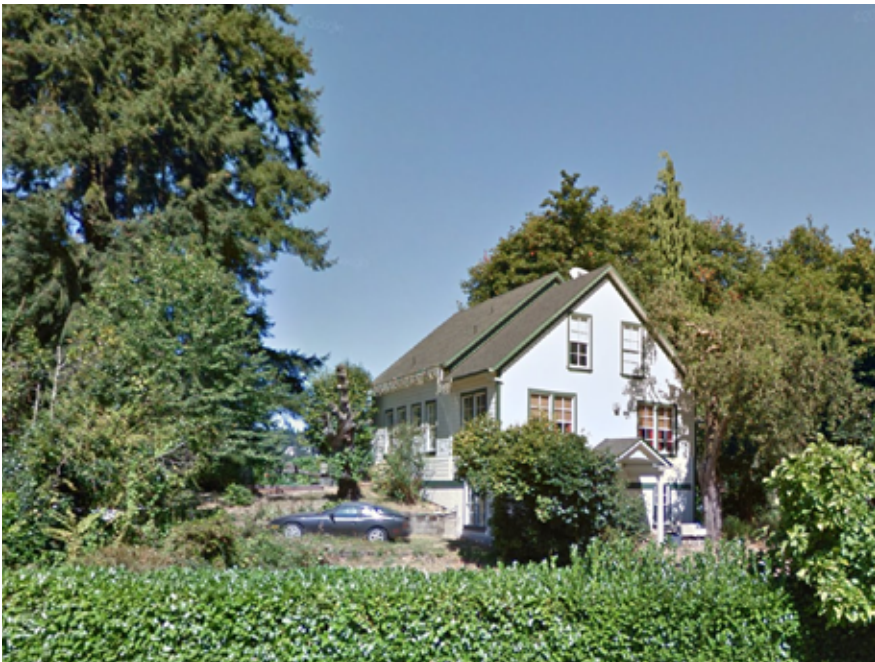
211 5th Ave

Parking lot space, Pull through driveway built in right of way

Built in grade
Site retaining wall built along the side of the house

Large rectangular windows hung along the front and side of the home.

Windows hung side by side creating a larger square shaped openings along the front and side facades of the home.

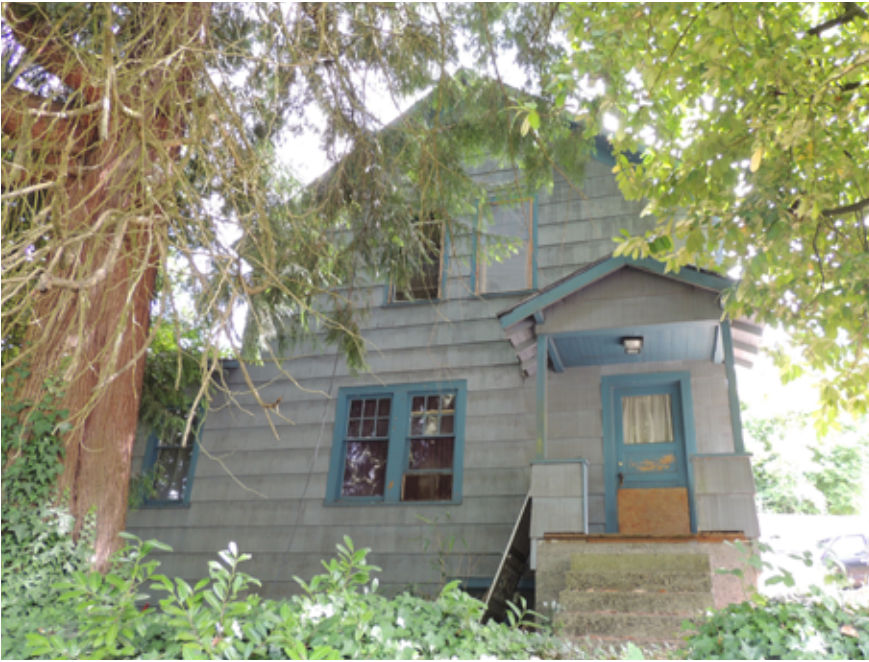
416 4th Ave

Built on setback with garage built over setback within the right of way of the road.

Parking is located along the side of the right of way along with an additional parking area behind the main house,

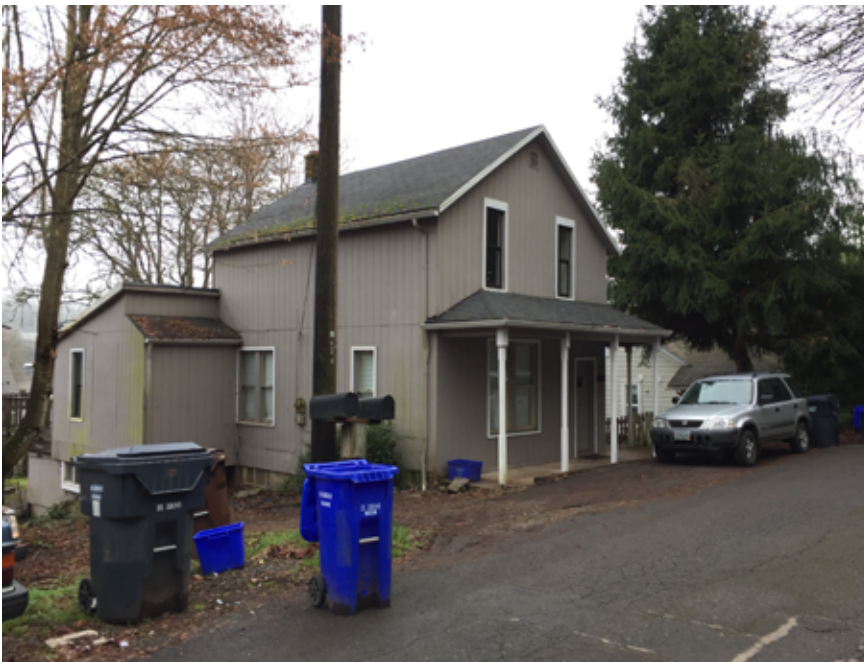
605 3rd Ave

Vertical Siding

2nd story balcony on back of house

The home is built on the property line with parking directly in front of the entrance within the side street.

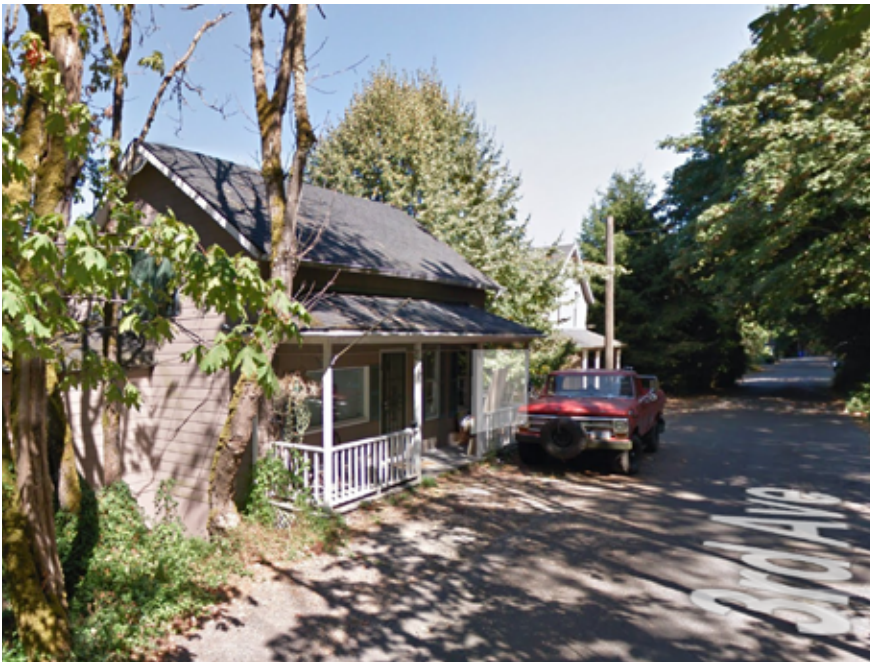
609 3rd Ave

Home is built on the property line with parking in front of the home along the side of the street. Within the setback.

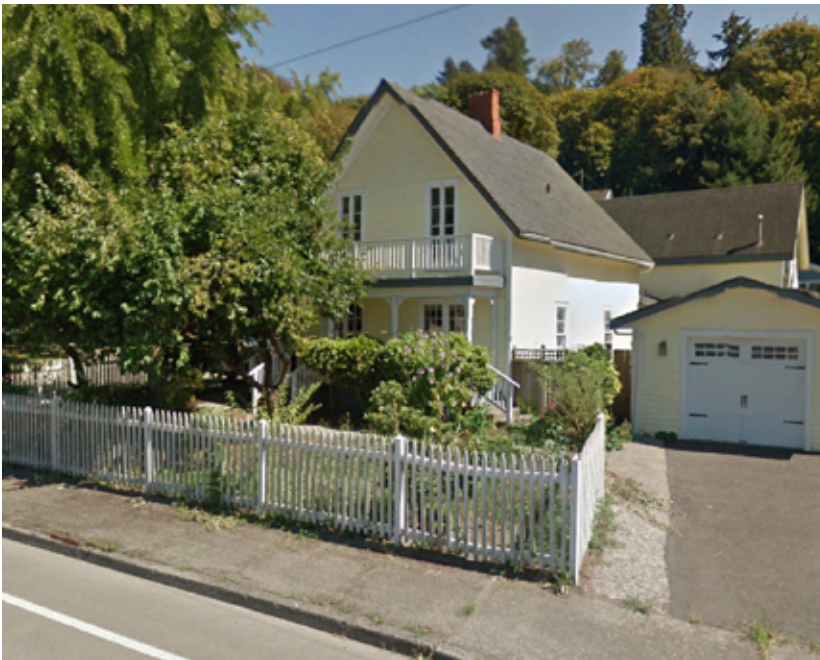
402 S. McLoughlin Blvd.

Dense lot coverage
(more dense than proposed development)

New additions to house

Multi car parking area off Hedges Street
(impervious parking along street with no planting buffer 6 90degree parking spaces with additional cars parked parallel to road)

Unique long skinny windows

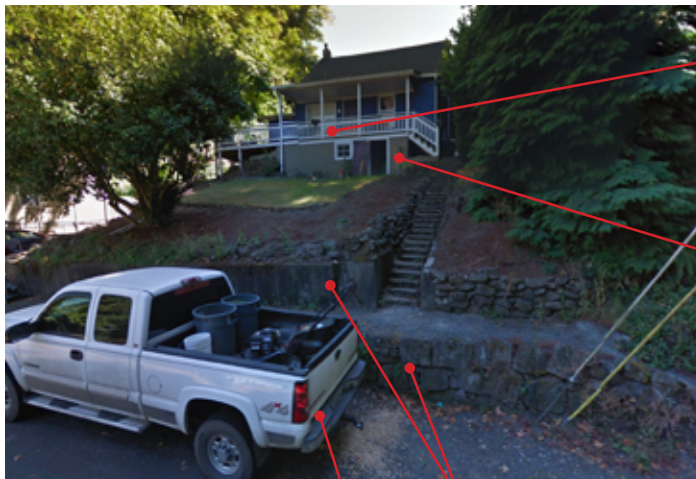
large wrap
around upper
story porch
- partially
covered

bottom floor
opening
built into the
hillside with a
large concrete
foundation
exposed

stepping back retaining
walls to height of 8 feet

parking in front of
house off street

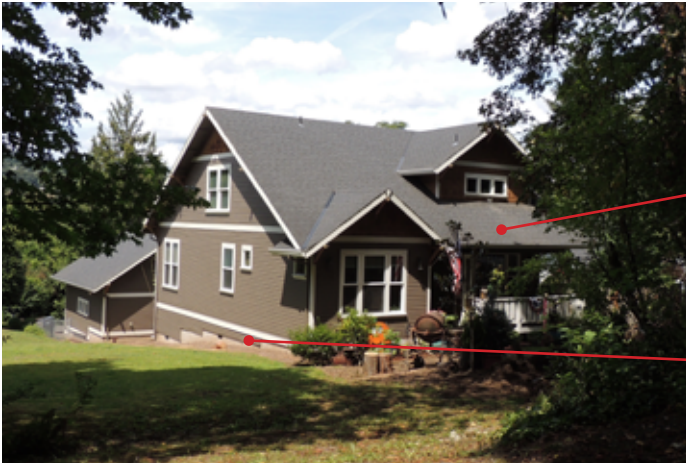
421 5th Ave

extended roof overhang
providing cover for porch

exposed stepping up
foundation from bottom
level to main level of
home

Extended roof overhang providing cover for porch
Home built into side of hill with stepping up foundation
around bottom level of the home.

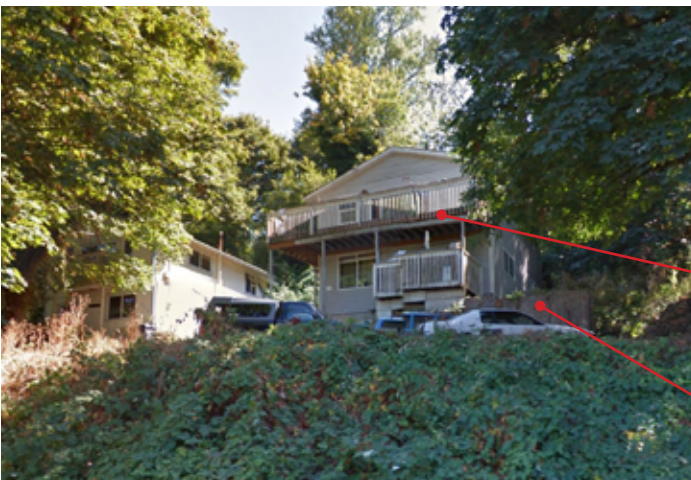
606 3rd Ave

Upper level balcony
covering first level

Tall concrete retaining
wall

Second story porch
Retaining Wall

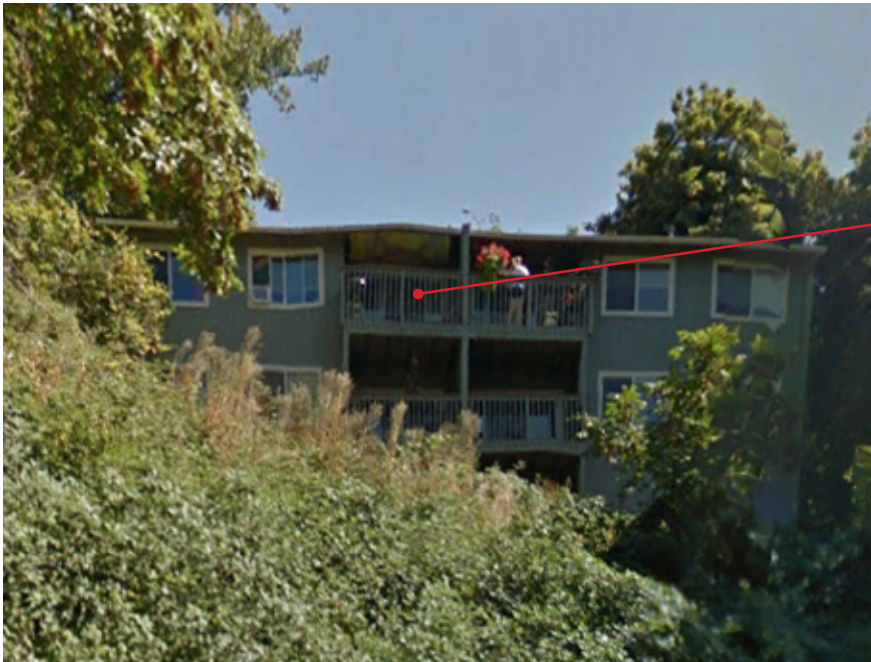
205 3rd Ave

Upper level balcony
covering first level

Large Parking area
