# Clackamette Cove Water Quality and Habitat Improvement Feasibility Study

REVIEW DRAFT  
December 15, 2016

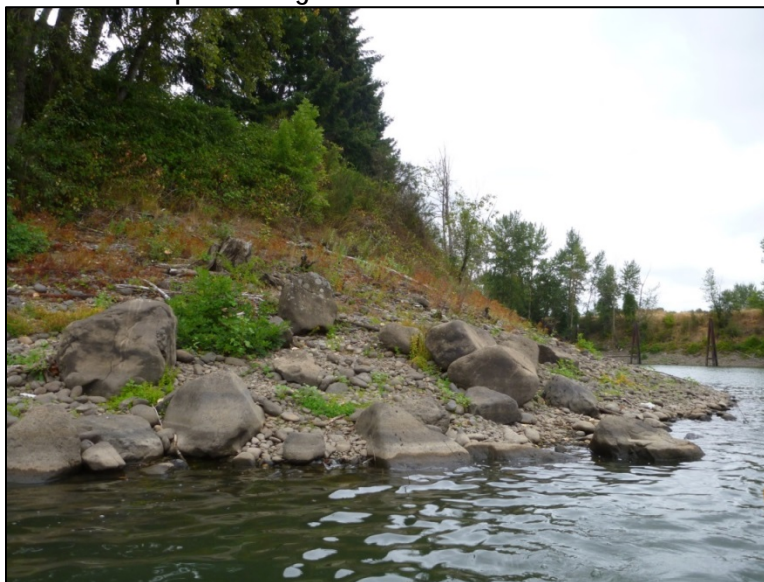
<sup>9</sup> Ash Creek Associates, Inc. 2011. Geotechnical Assessment Clackamette Cove Development Oregon City, Oregon, Ash Creek Associates, Portland, OR.  
[https://www.orcity.org/sites/default/files/fileattachments/planning/project/6059/exhibit\\_g.2\\_geotechnical\\_assessment\\_0.pdf](https://www.orcity.org/sites/default/files/fileattachments/planning/project/6059/exhibit_g.2_geotechnical_assessment_0.pdf)
