# Clackamette Cove Water Quality and Habitat Improvement Feasibility Study

REVIEW DRAFT

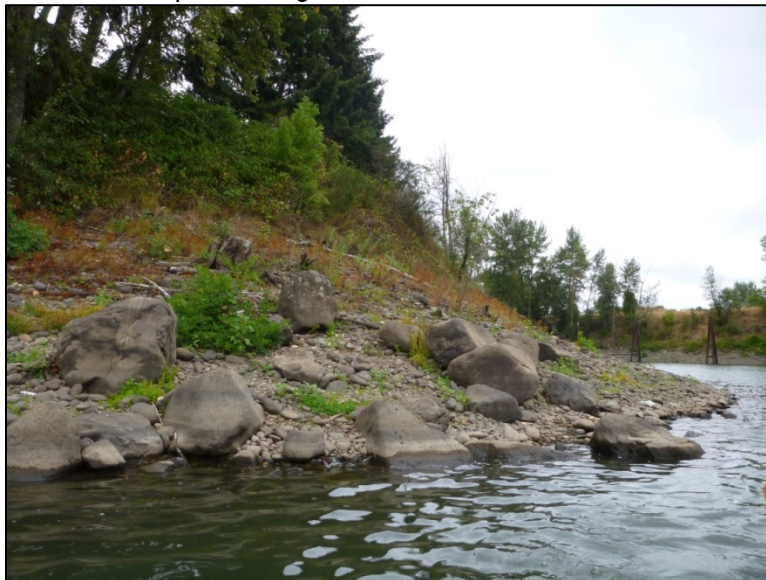
<sup>9</sup> Ash Creek Associates, Inc. 2011. Geotechnical Assessment Clackamette Cove Development Oregon City, Oregon, Ash Creek Associates, Portland, OR.  
[https://www.orcity.org/sites/default/files/fileattachments/planning/project/6059/exhibit\\_g.2\\_geotechnical\\_assessment\\_0.pdf](https://www.orcity.org/sites/default/files/fileattachments/planning/project/6059/exhibit_g.2_geotechnical_assessment_0.pdf)

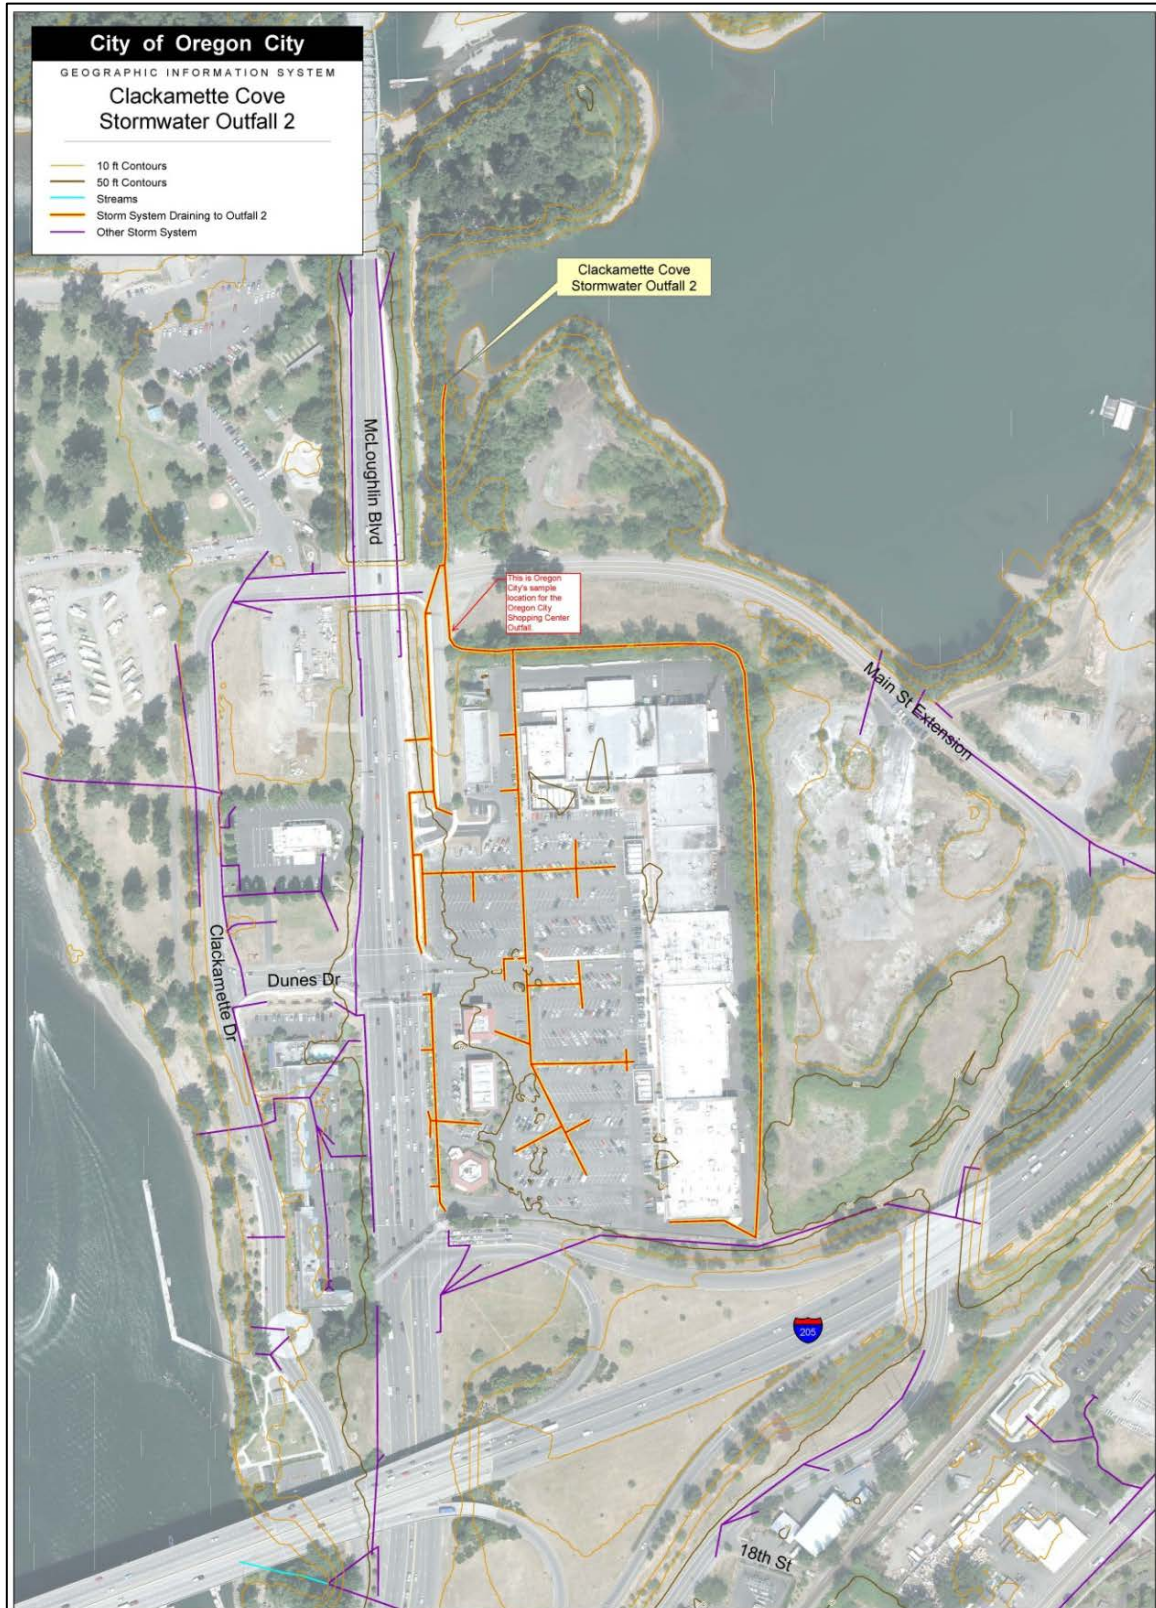
## ***Groundwater Contamination***

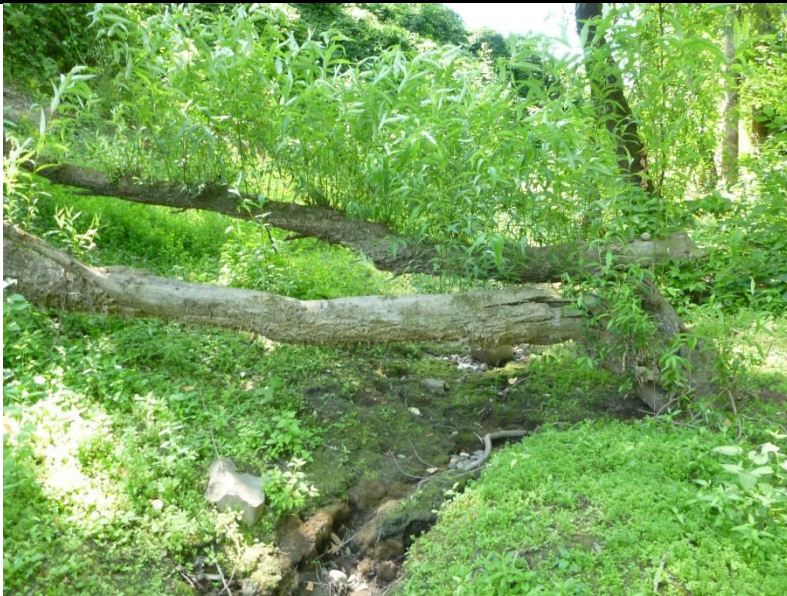
**Photo point 4. Photo 1.** From drainage into the Cove looking 165° upstream at vegetation community #2: Pacific Willow/Redosier Dogwood/Birdsfoot Trefoil-Spatulaleaf Loosestrife Scrub-Shrub Wetland.

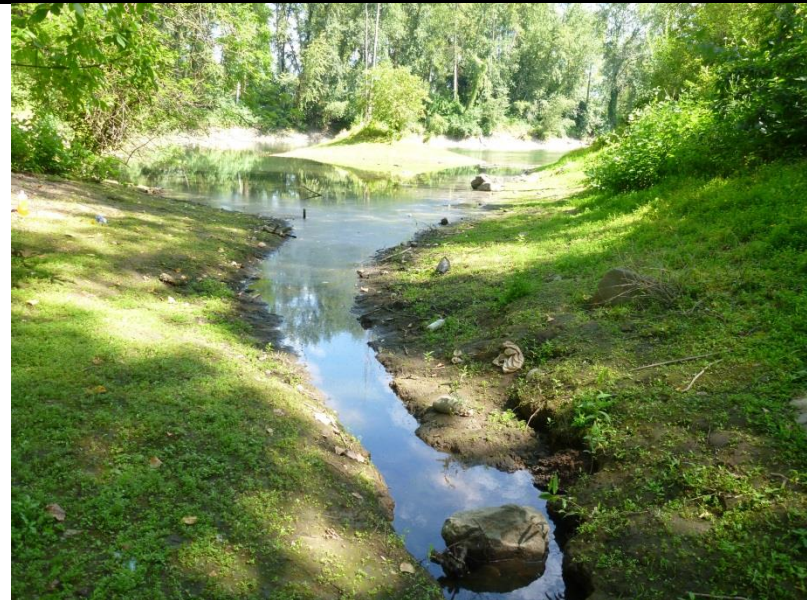
**Photo point 4. Photo 2.** From drainage into the Cove looking 200° downstream at vegetation community #2.
