Natural Resource Overlay District Report

Phase 2 of The Cove Development Plan

in Oregon City, Oregon

August 6, 2018

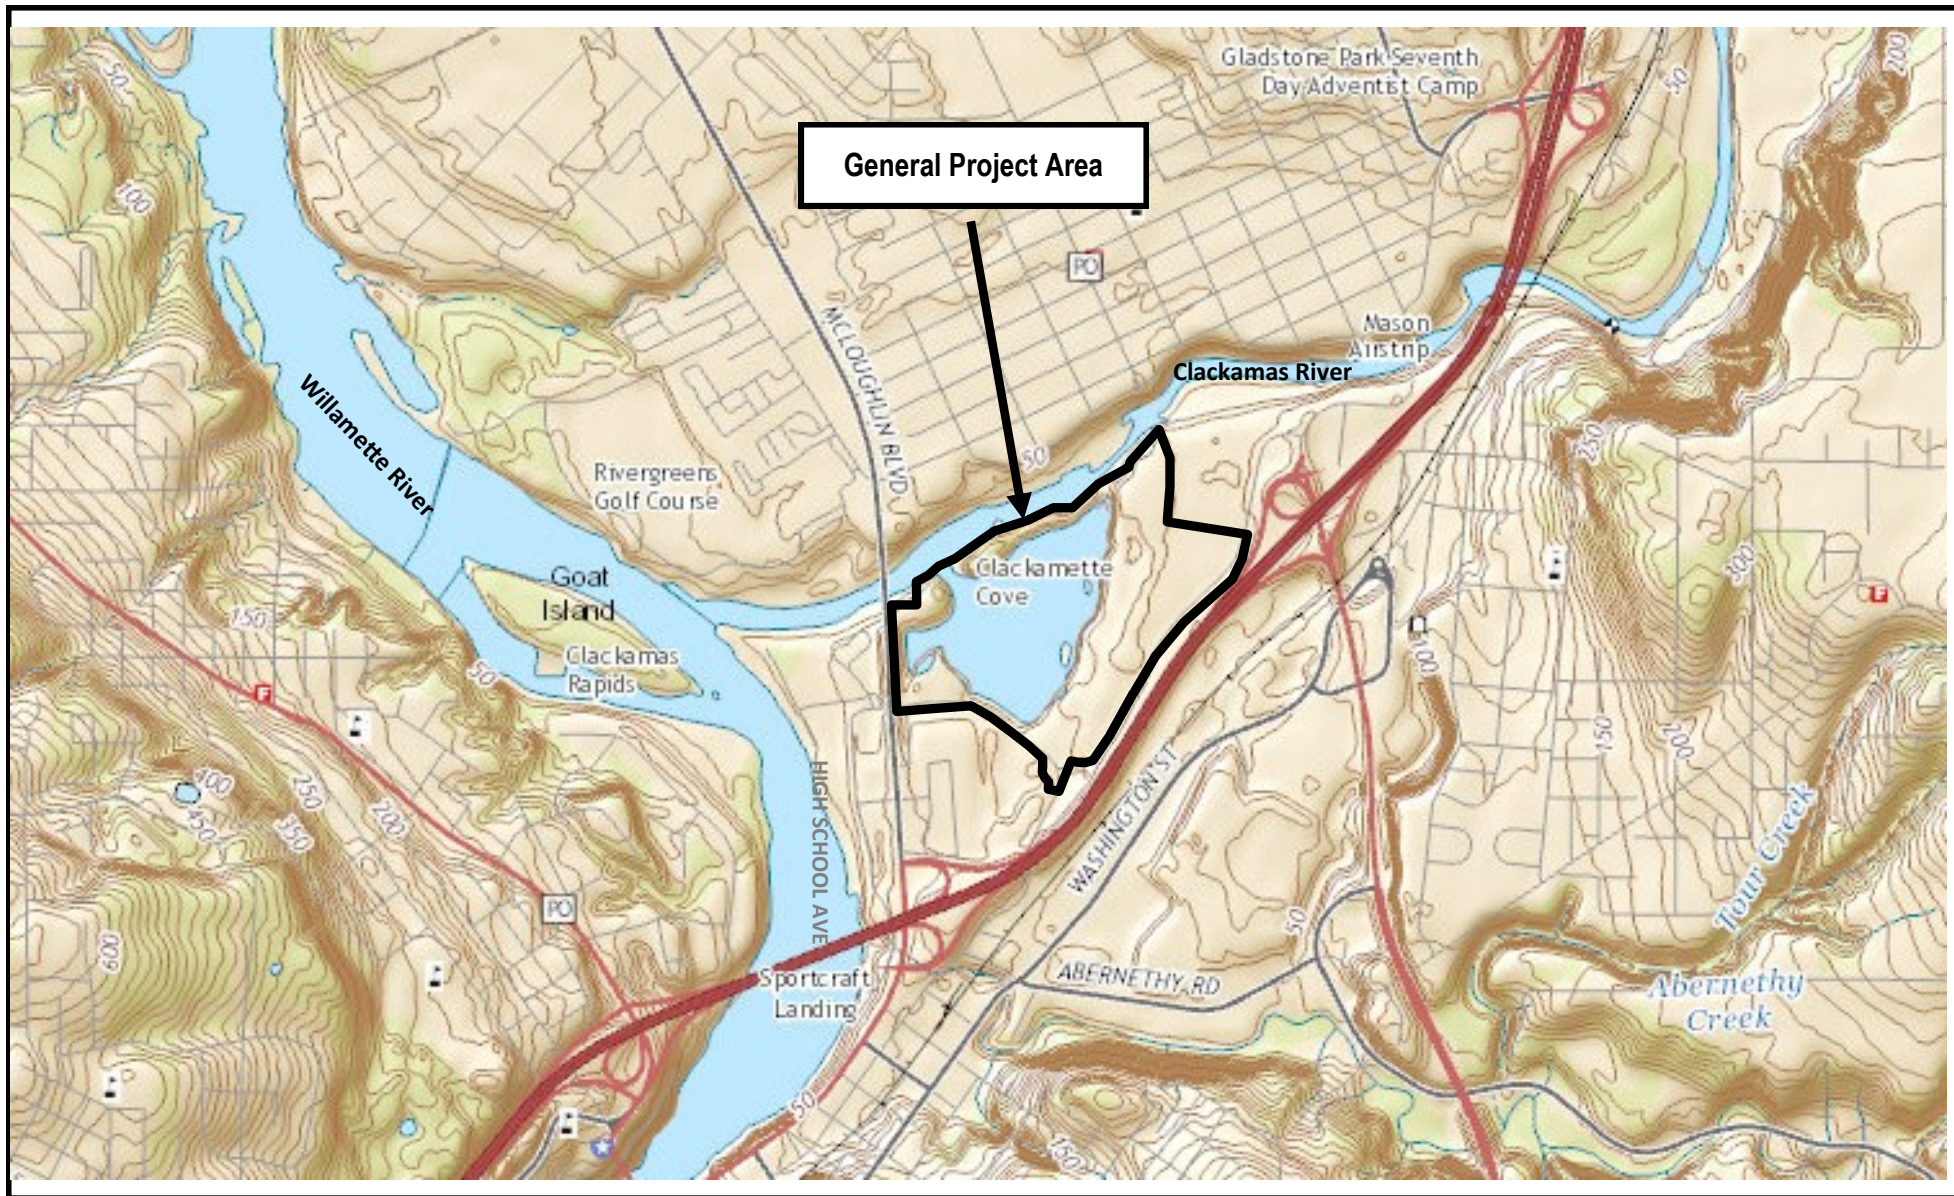
Pacific Habitat Services, Inc. (PHS) has prepared this report for Phase 2 of the Cove Development Plan (Project) in Oregon City, Oregon. Figure 1 and Figures 2A-2B (Appendix A) show the project vicinity and limits of the study area. All figures are in Appendix A.

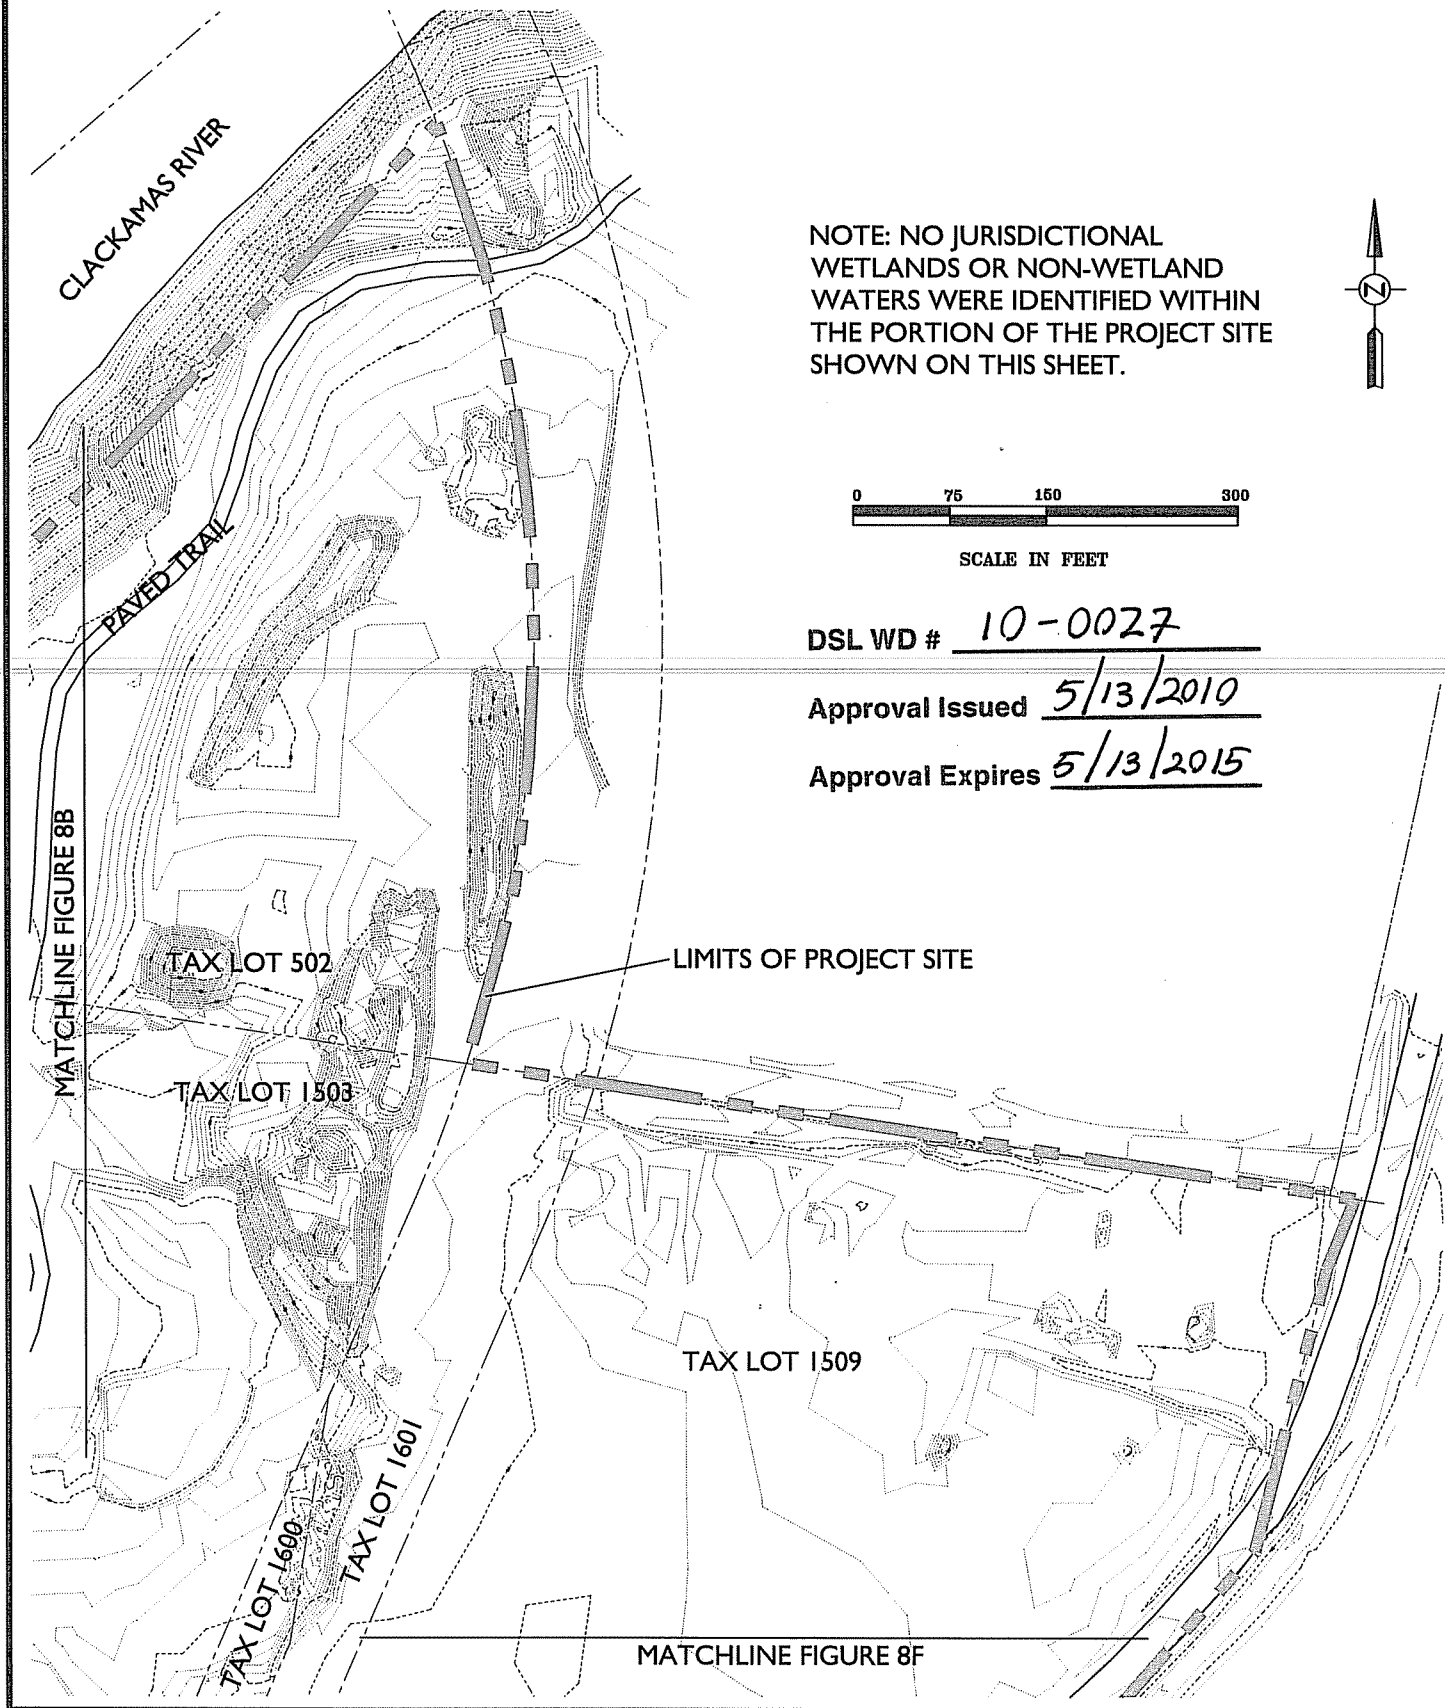
FIGURE
8C

NOTE: NO JURISDICTIONAL
WETLANDS OR NON-WETLAND
WATERS WERE IDENTIFIED WITHIN
THE PORTION OF THE PROJECT SITE
SHOWN ON THIS SHEET.

Existing conditions, data point locations, and photo-documentation points for The Cove site in Oregon City, Oregon. Survey and base map provided by CardnoWRG. Estimated survey accuracy is sub-centimeter.

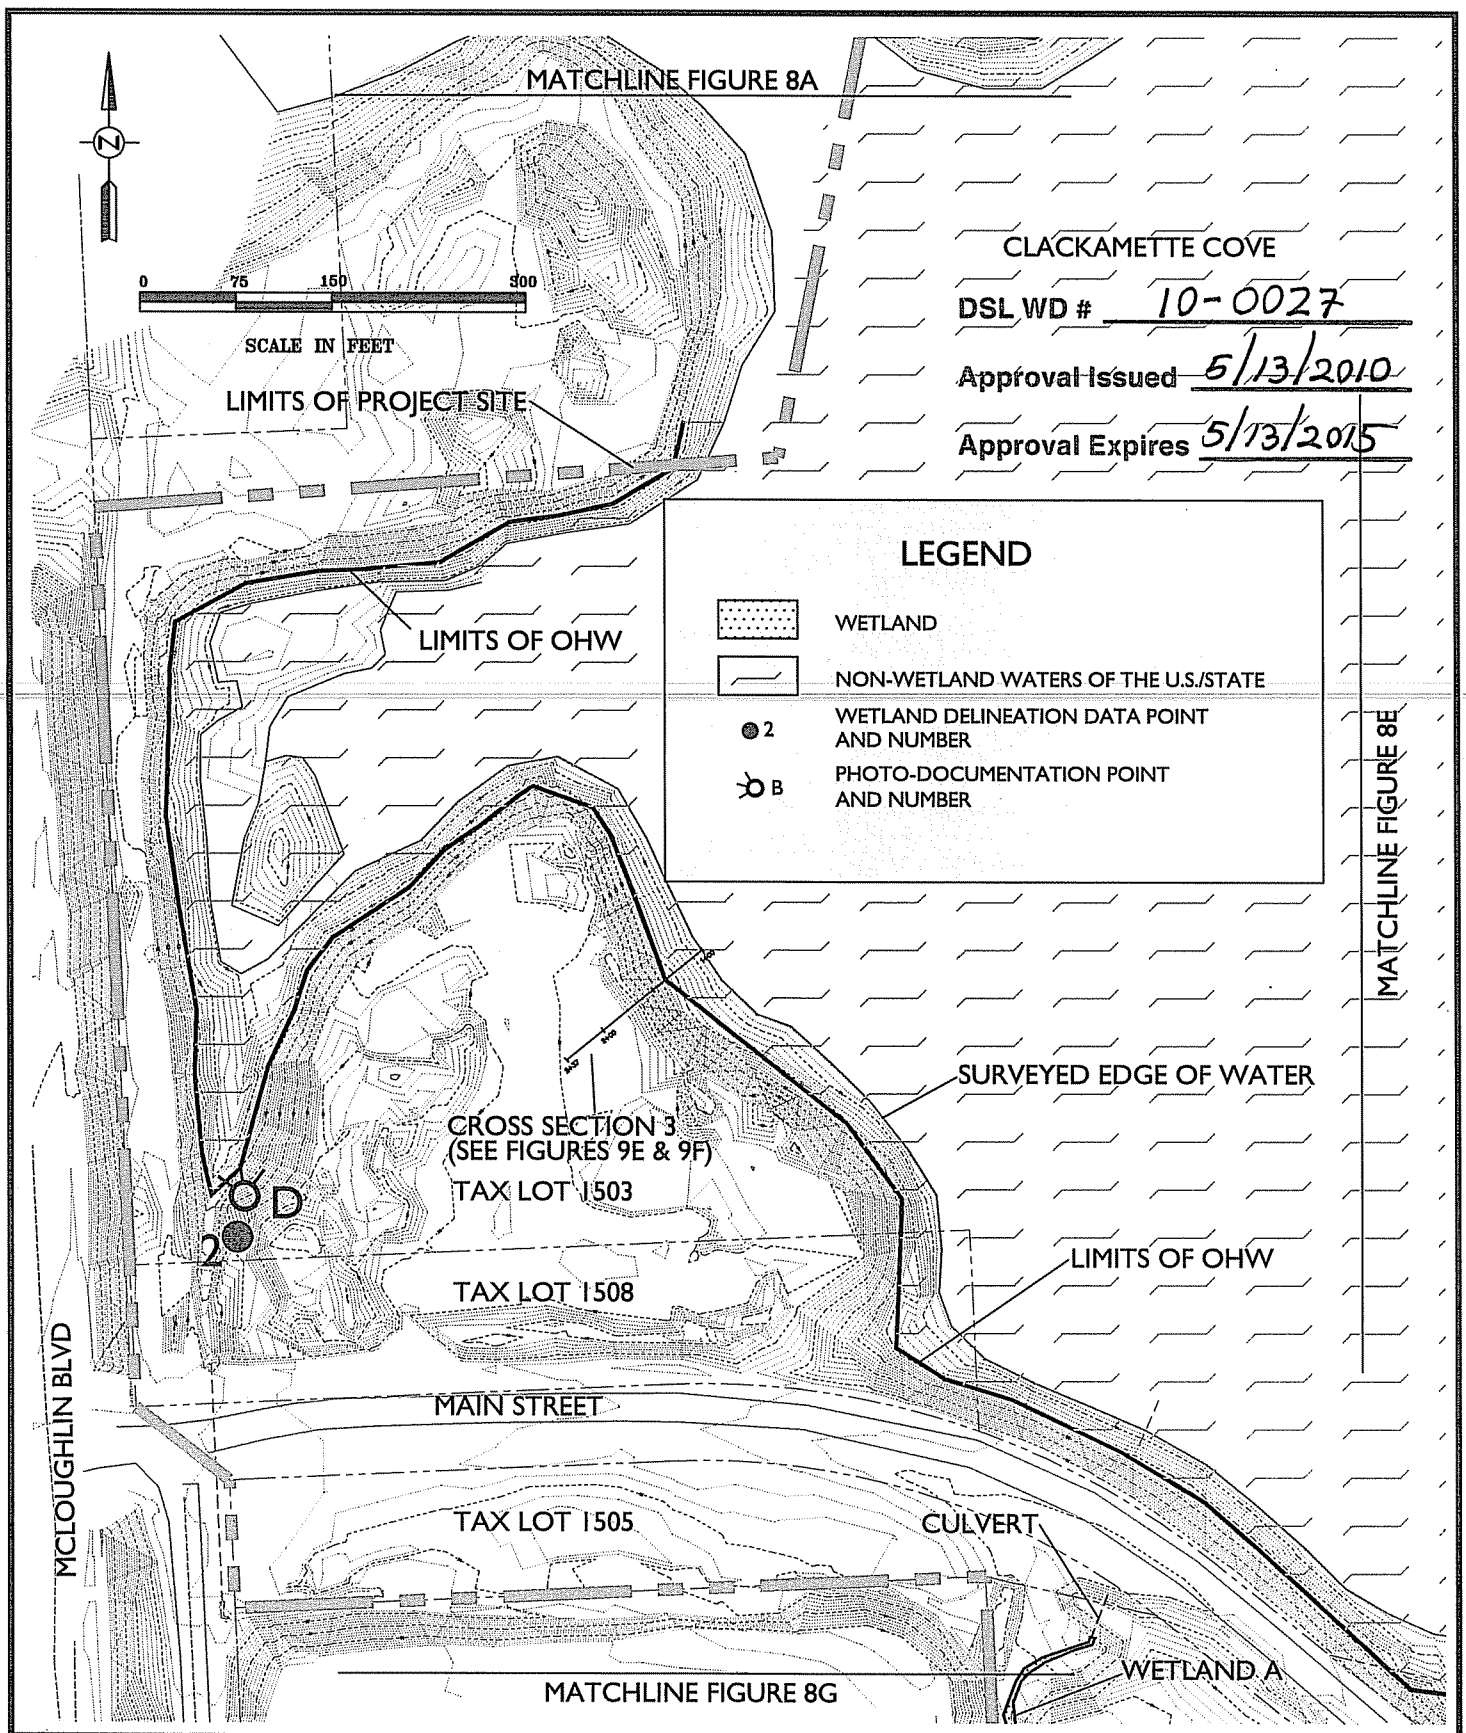
FIGURE
8D

Existing conditions, data point locations, and photo-documentation points for The Cove site in Oregon City, Oregon. Survey and base map provided by CardnoWRG. Estimated survey accuracy is sub-centimeter.

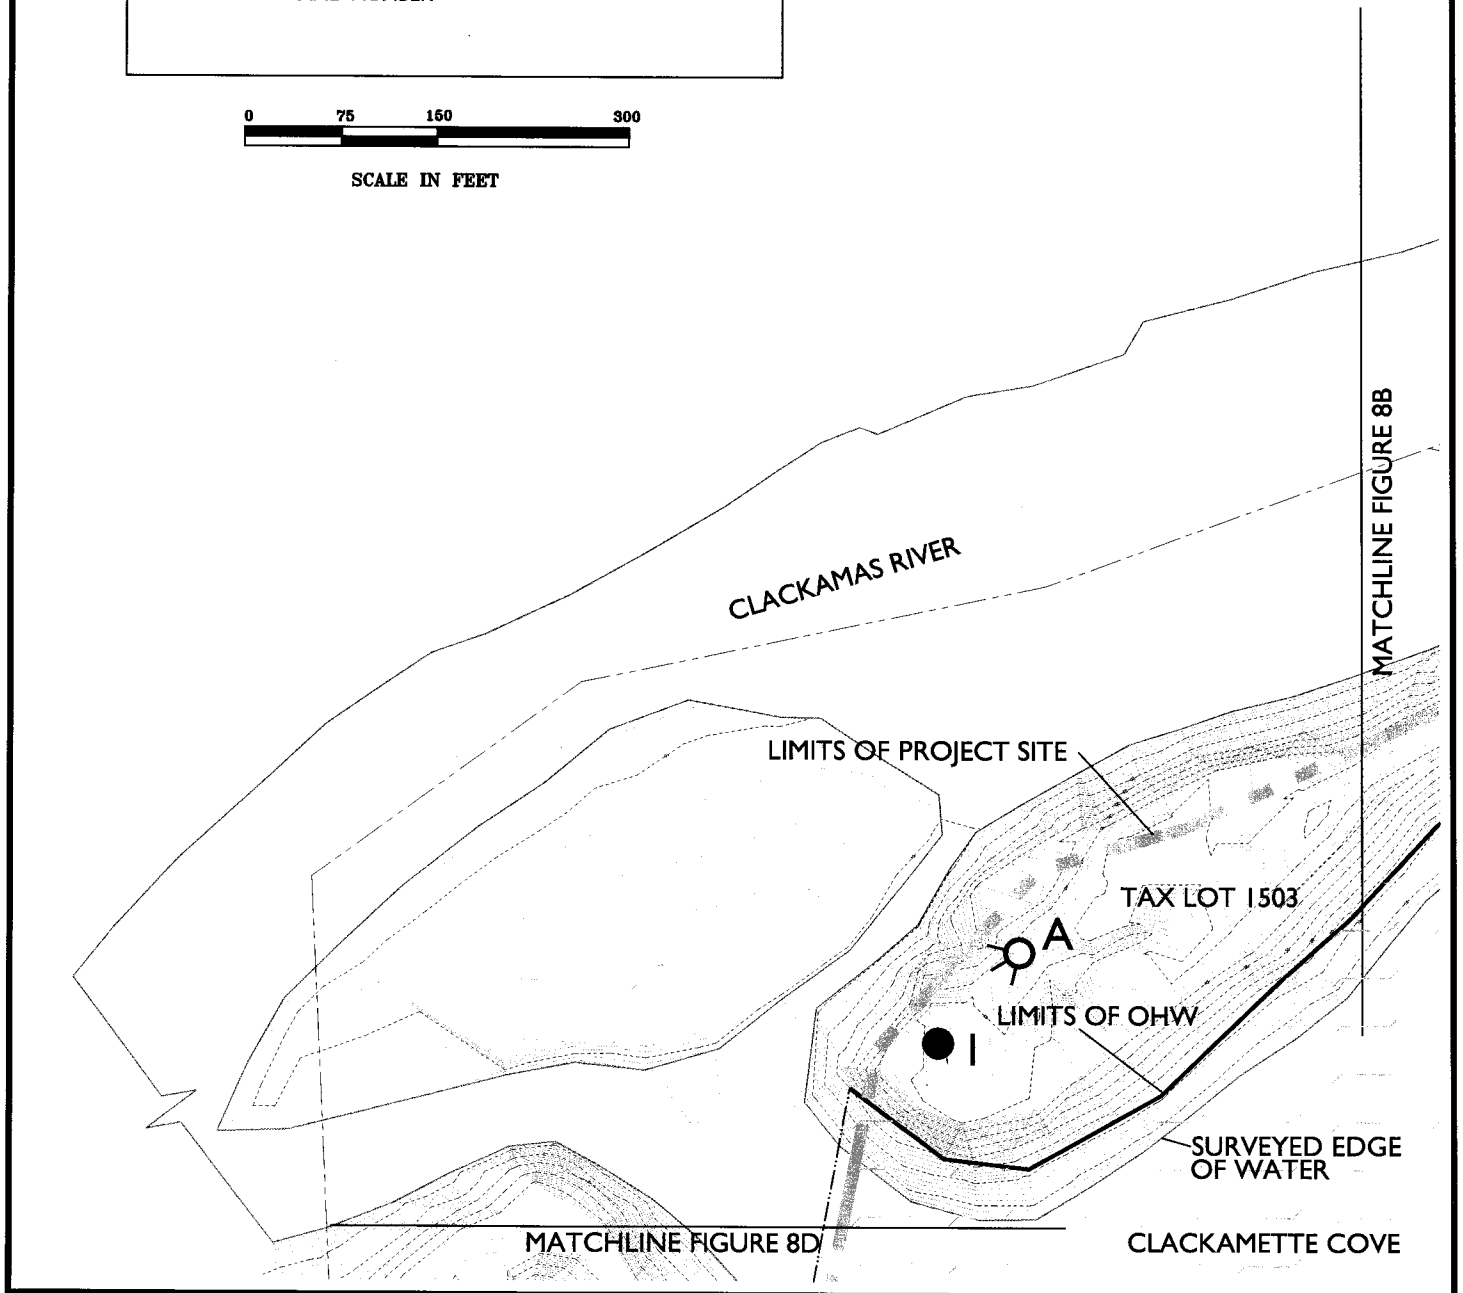
FIGURE
8A

Existing conditions, data point locations, and photo-documentation points for The Cove site in Oregon City, Oregon. Survey and base map provided by CardnoWRG. Estimated survey accuracy is sub-centimeter.

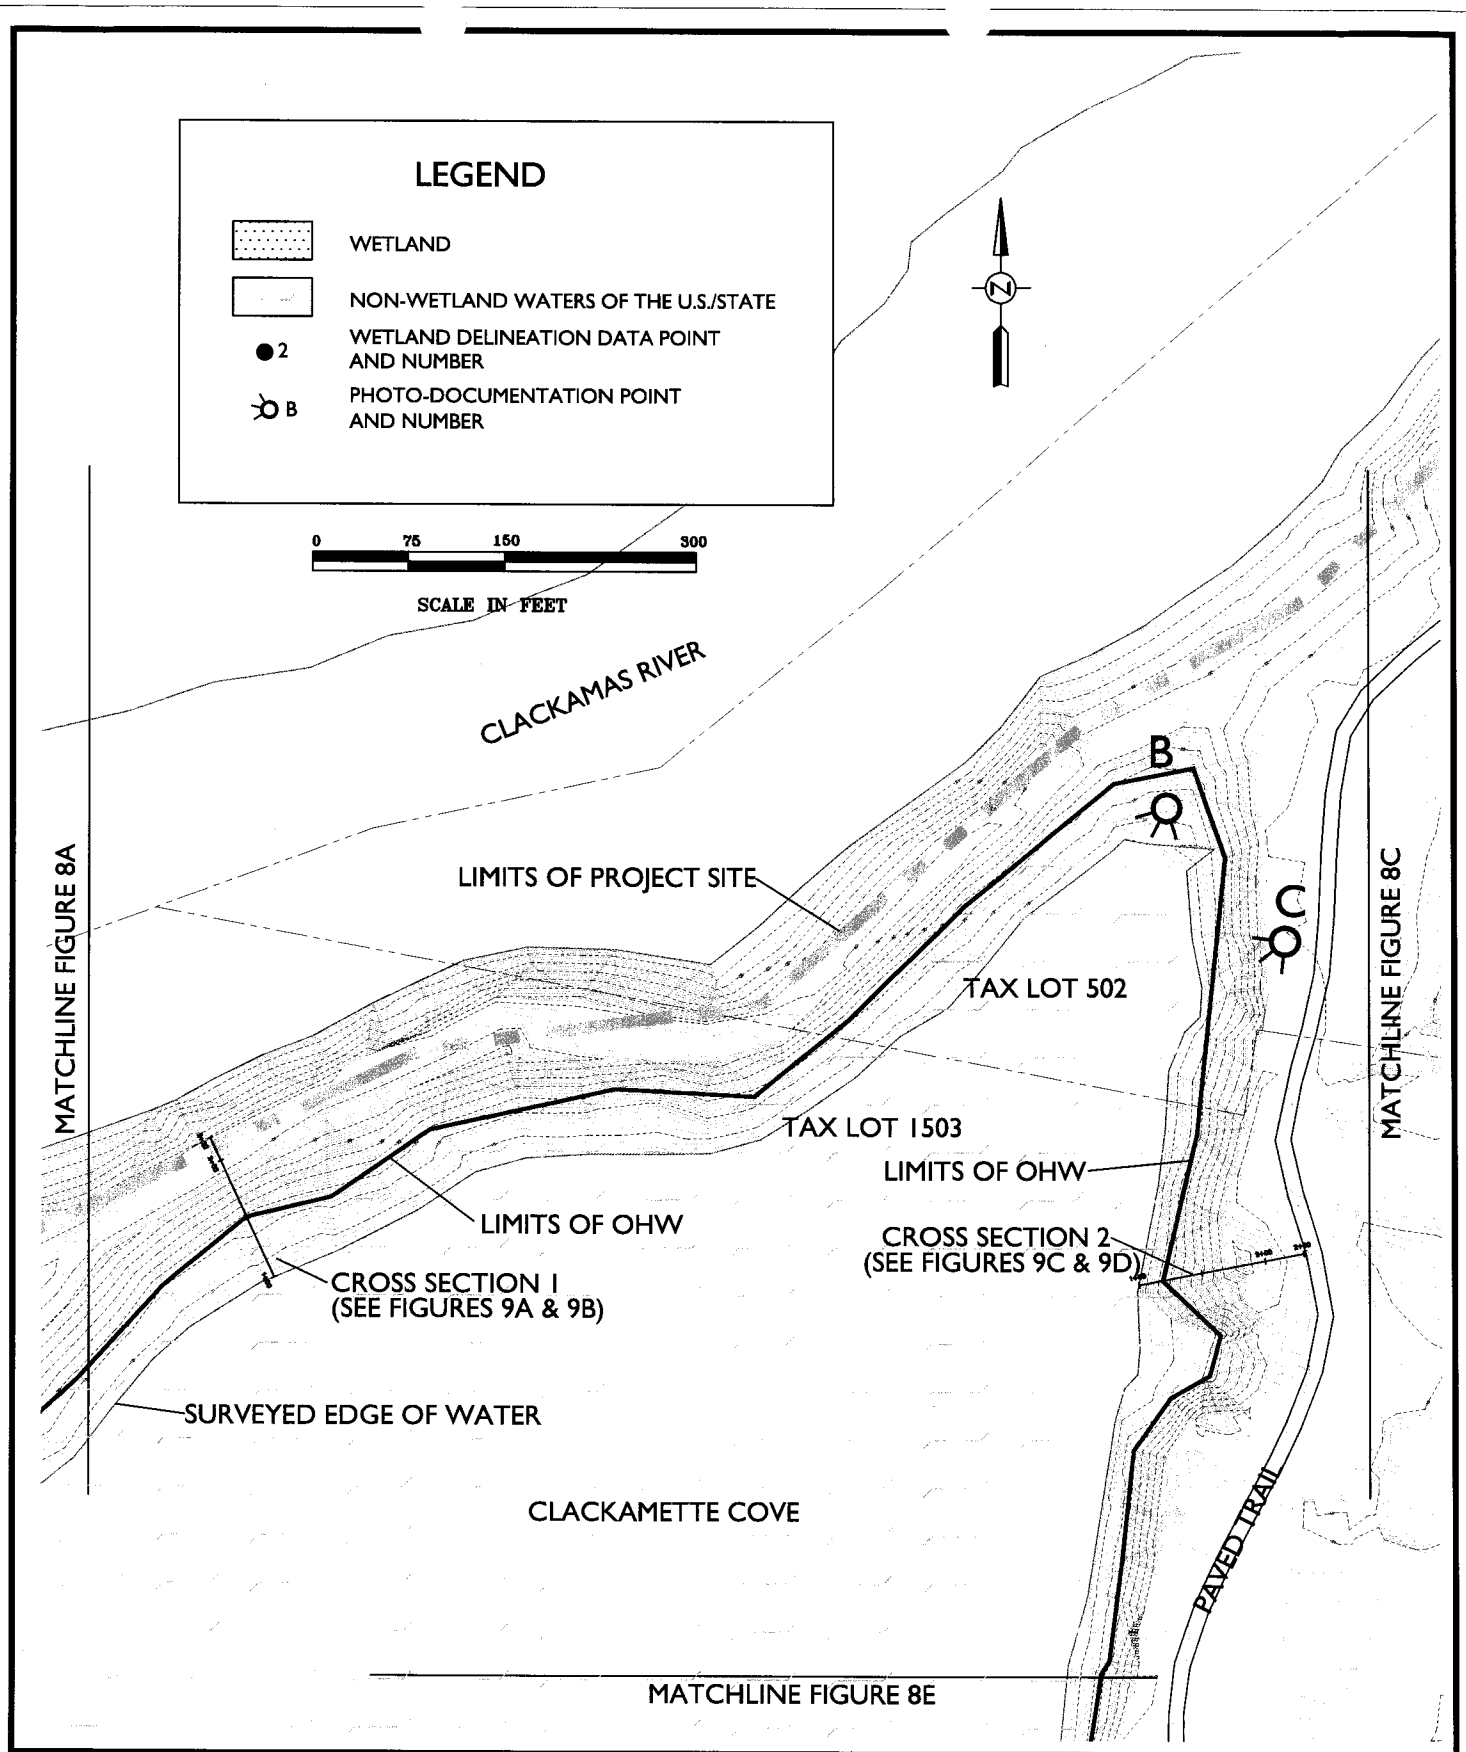
FIGURE
8B

Existing conditions, data point locations, and photo-documentation points for The Cove site in Oregon City, Oregon. Survey and base map provided by CardnoWRG. Estimated survey accuracy is sub-centimeter.

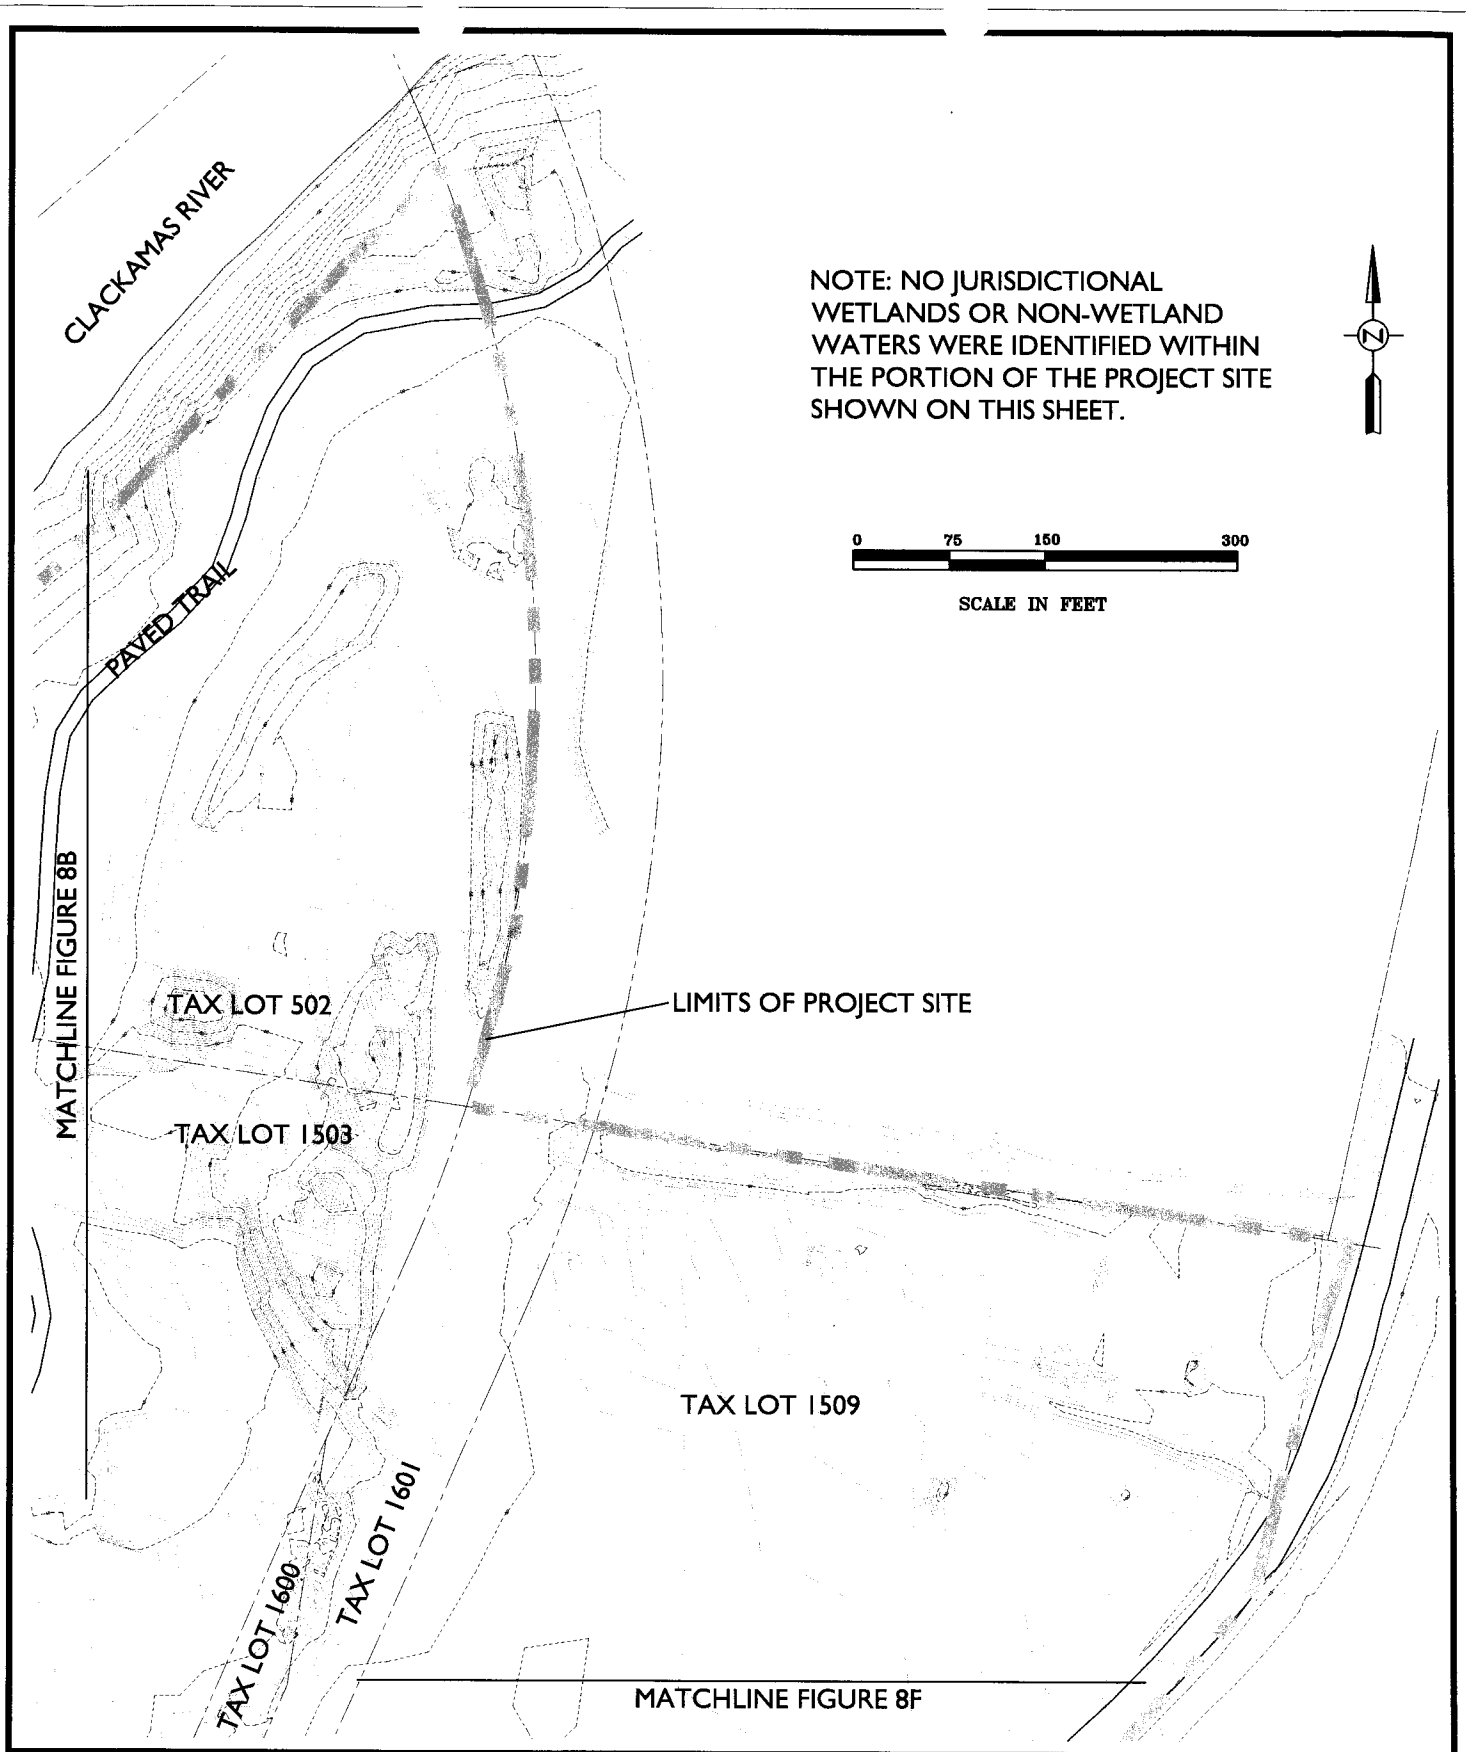
FIGURE
8C

Existing conditions, data point locations, and photo-documentation points for The Cove site in Oregon City, Oregon. Survey and base map provided by CardnoWRG. Estimated survey accuracy is sub-centimeter.

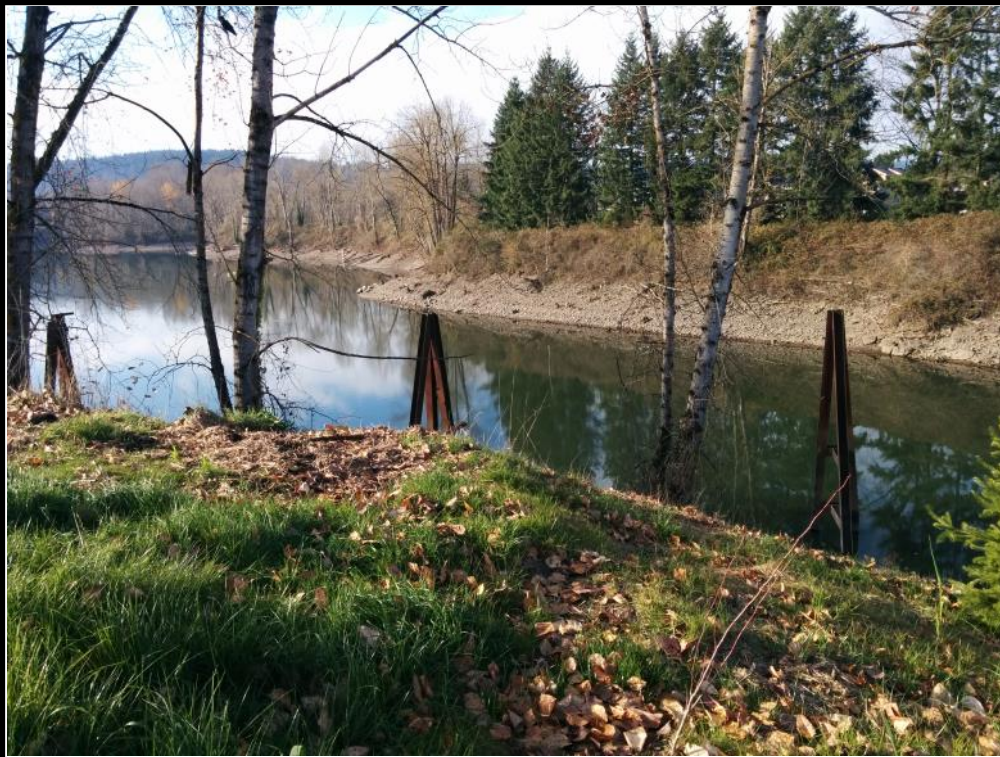
Photo A:

View to the southwest of the existing bank in the northeastern portion of the Cove.

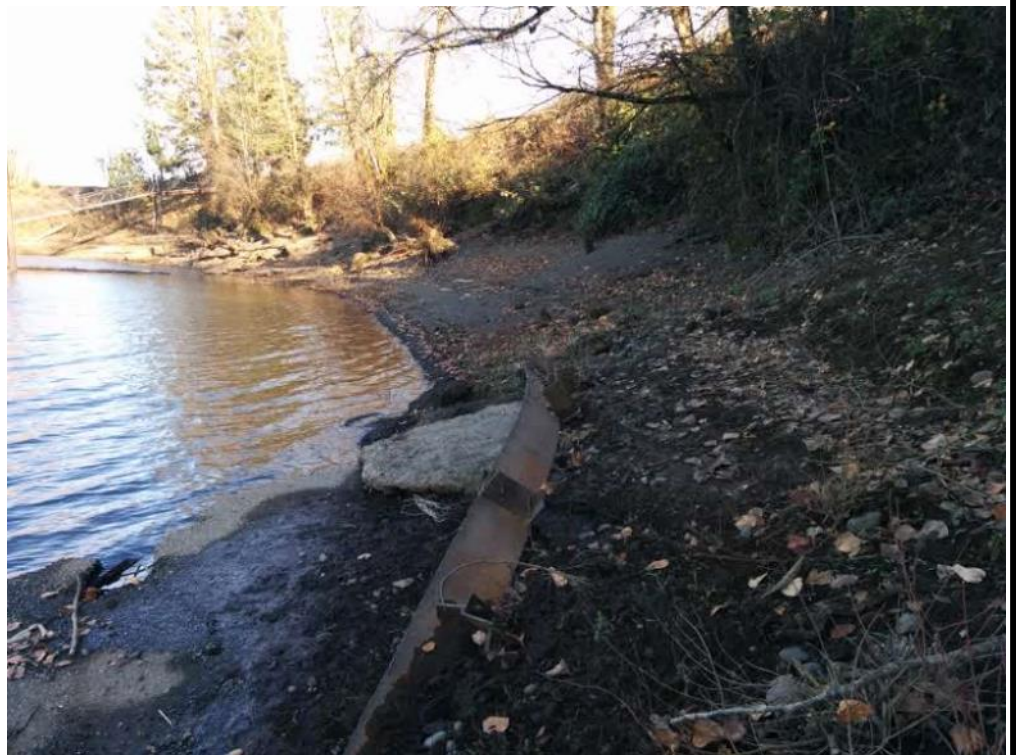
Photo B:

View to the northeast of the steep banks and debris present along the Cove shoreline.

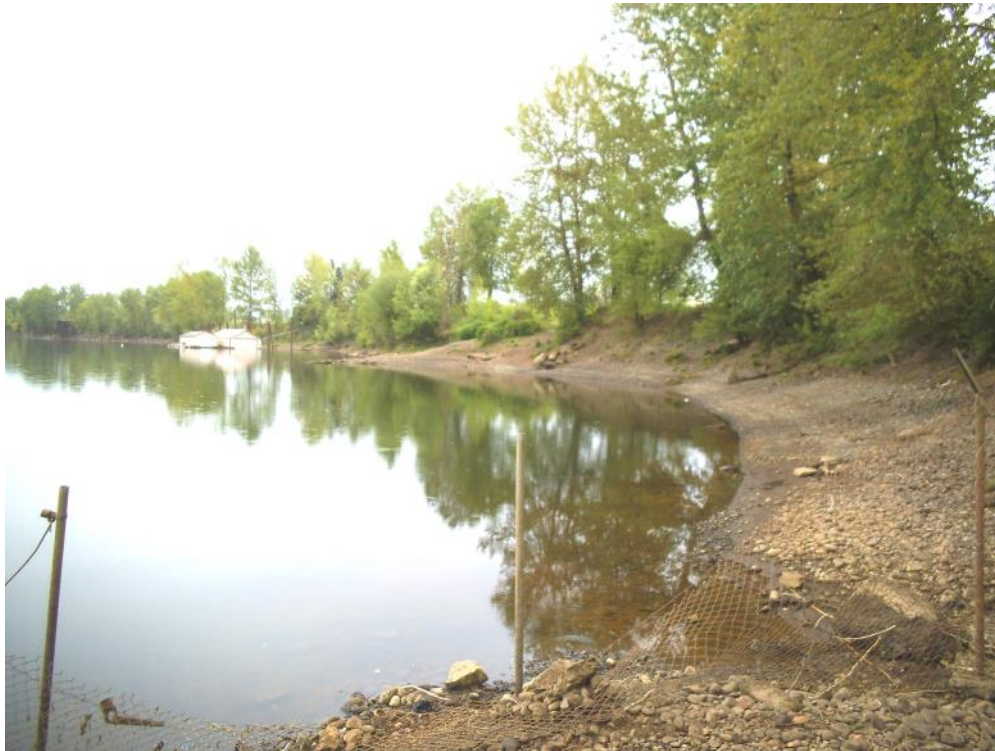
Photo C:

View to the northeast of the steep banks and debris present along the Cove shoreline.

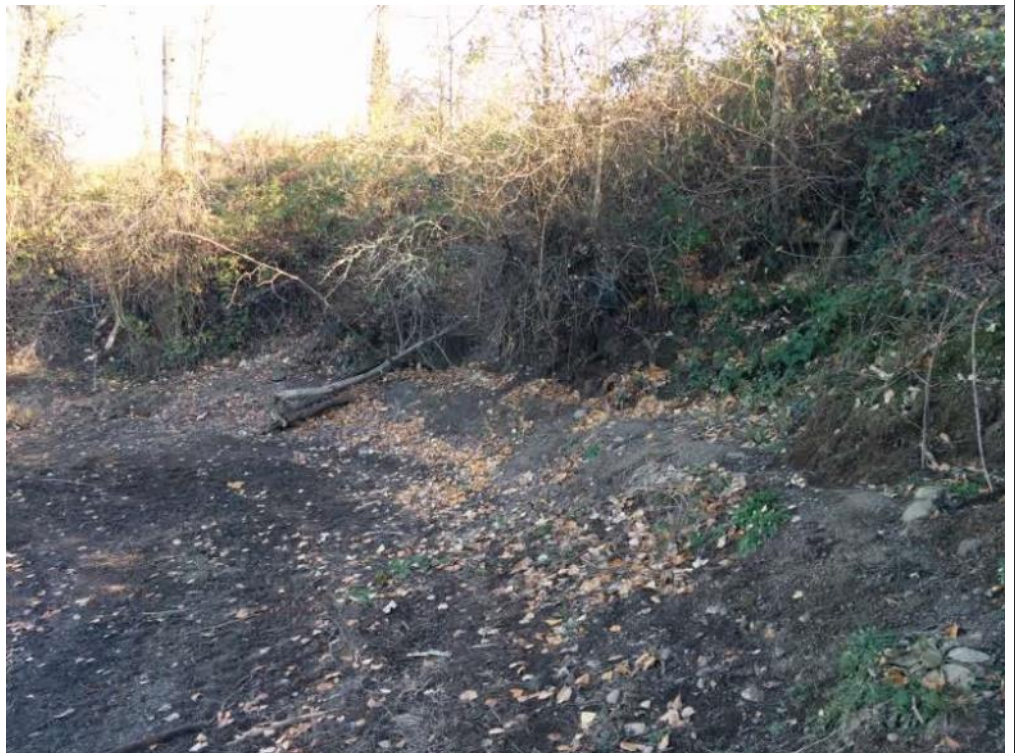
Photo D

View to the northeast of the existing steep banks along the Cove shoreline.
