CITY OF OREGON CITY

Historic Preservation Renovation Grant Application

Site Address: 415 Jefferson Street

Historic Name: Ferdinand and Sarah McCown House Architectural Style: Colonial Revival

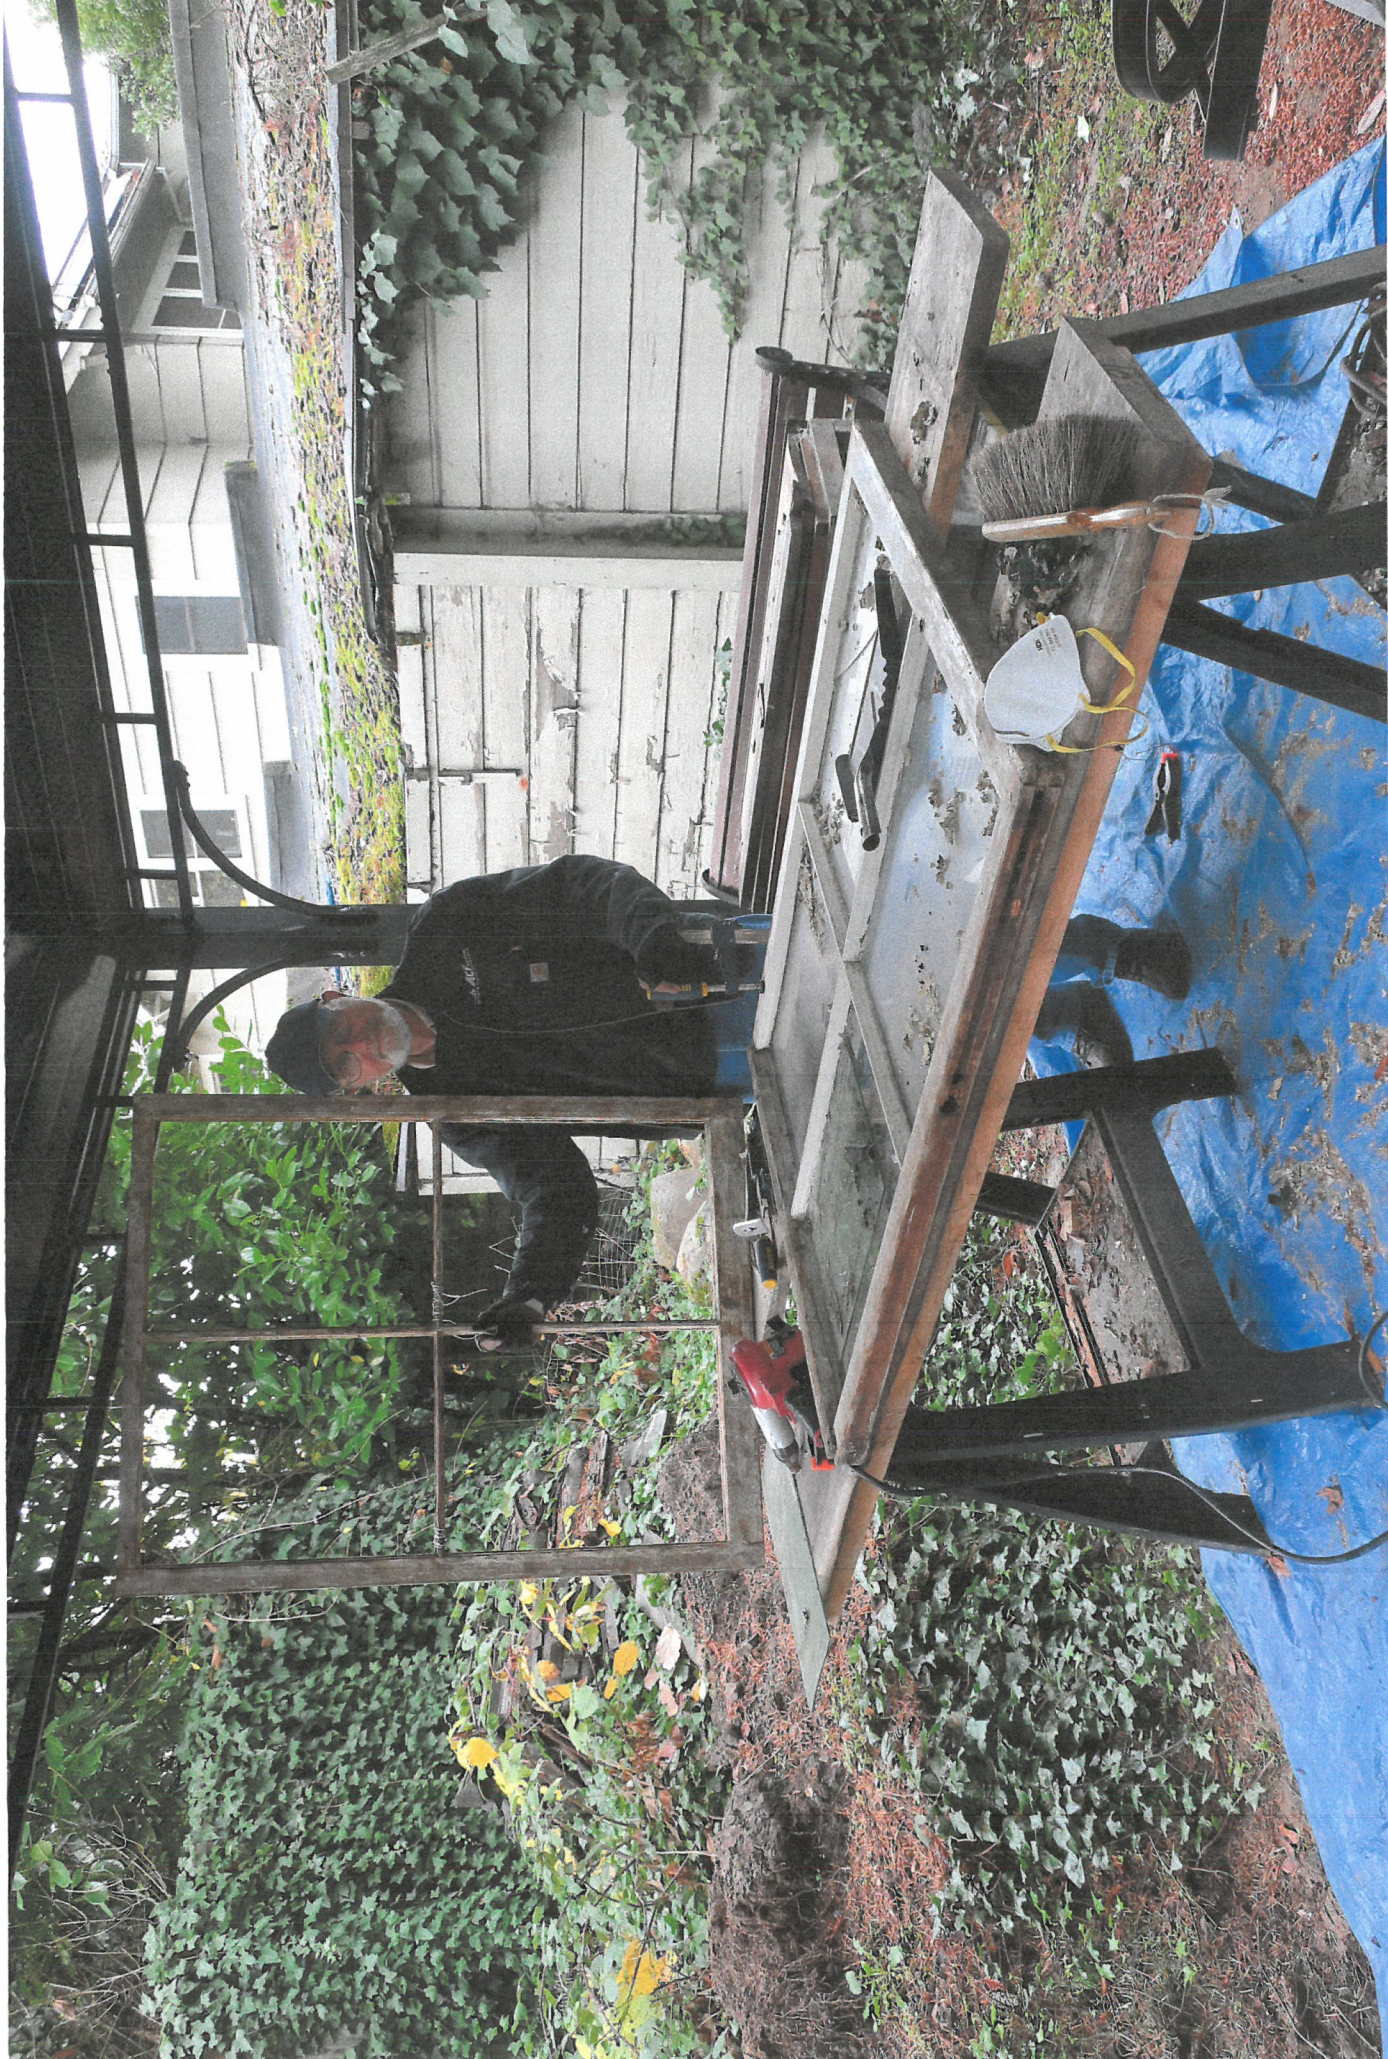
Window from south elevation - upper floor

- Replacement of an existing 4/4 double hung wood window. The window will be replicated exactly to match the original window. This window is on the south elevation of the house and had deteriorated beyond repair. This elevation of the house is buffeted by the brunt of weather.
The bids outline a replacement window to match the existing 4/4 double hung windows throughout the house.
- Construction and installation of storm windows for the entire house. These windows will protect the original wood windows especially those to be placed on the south elevation.

Based on what I can see from the photos the damage to this sash looks pretty extensive.

I would recommend a complete reproduction. The top sash at the checkrail corners is just gone.

The rot has gone up the sides and leaves you nothing to attach the check rail to. The bottom sash is in poor shape, would not last in a repair. The mutton bar is held together with sting and badly rotten.

The hope of the bar to hold glass just is not there.

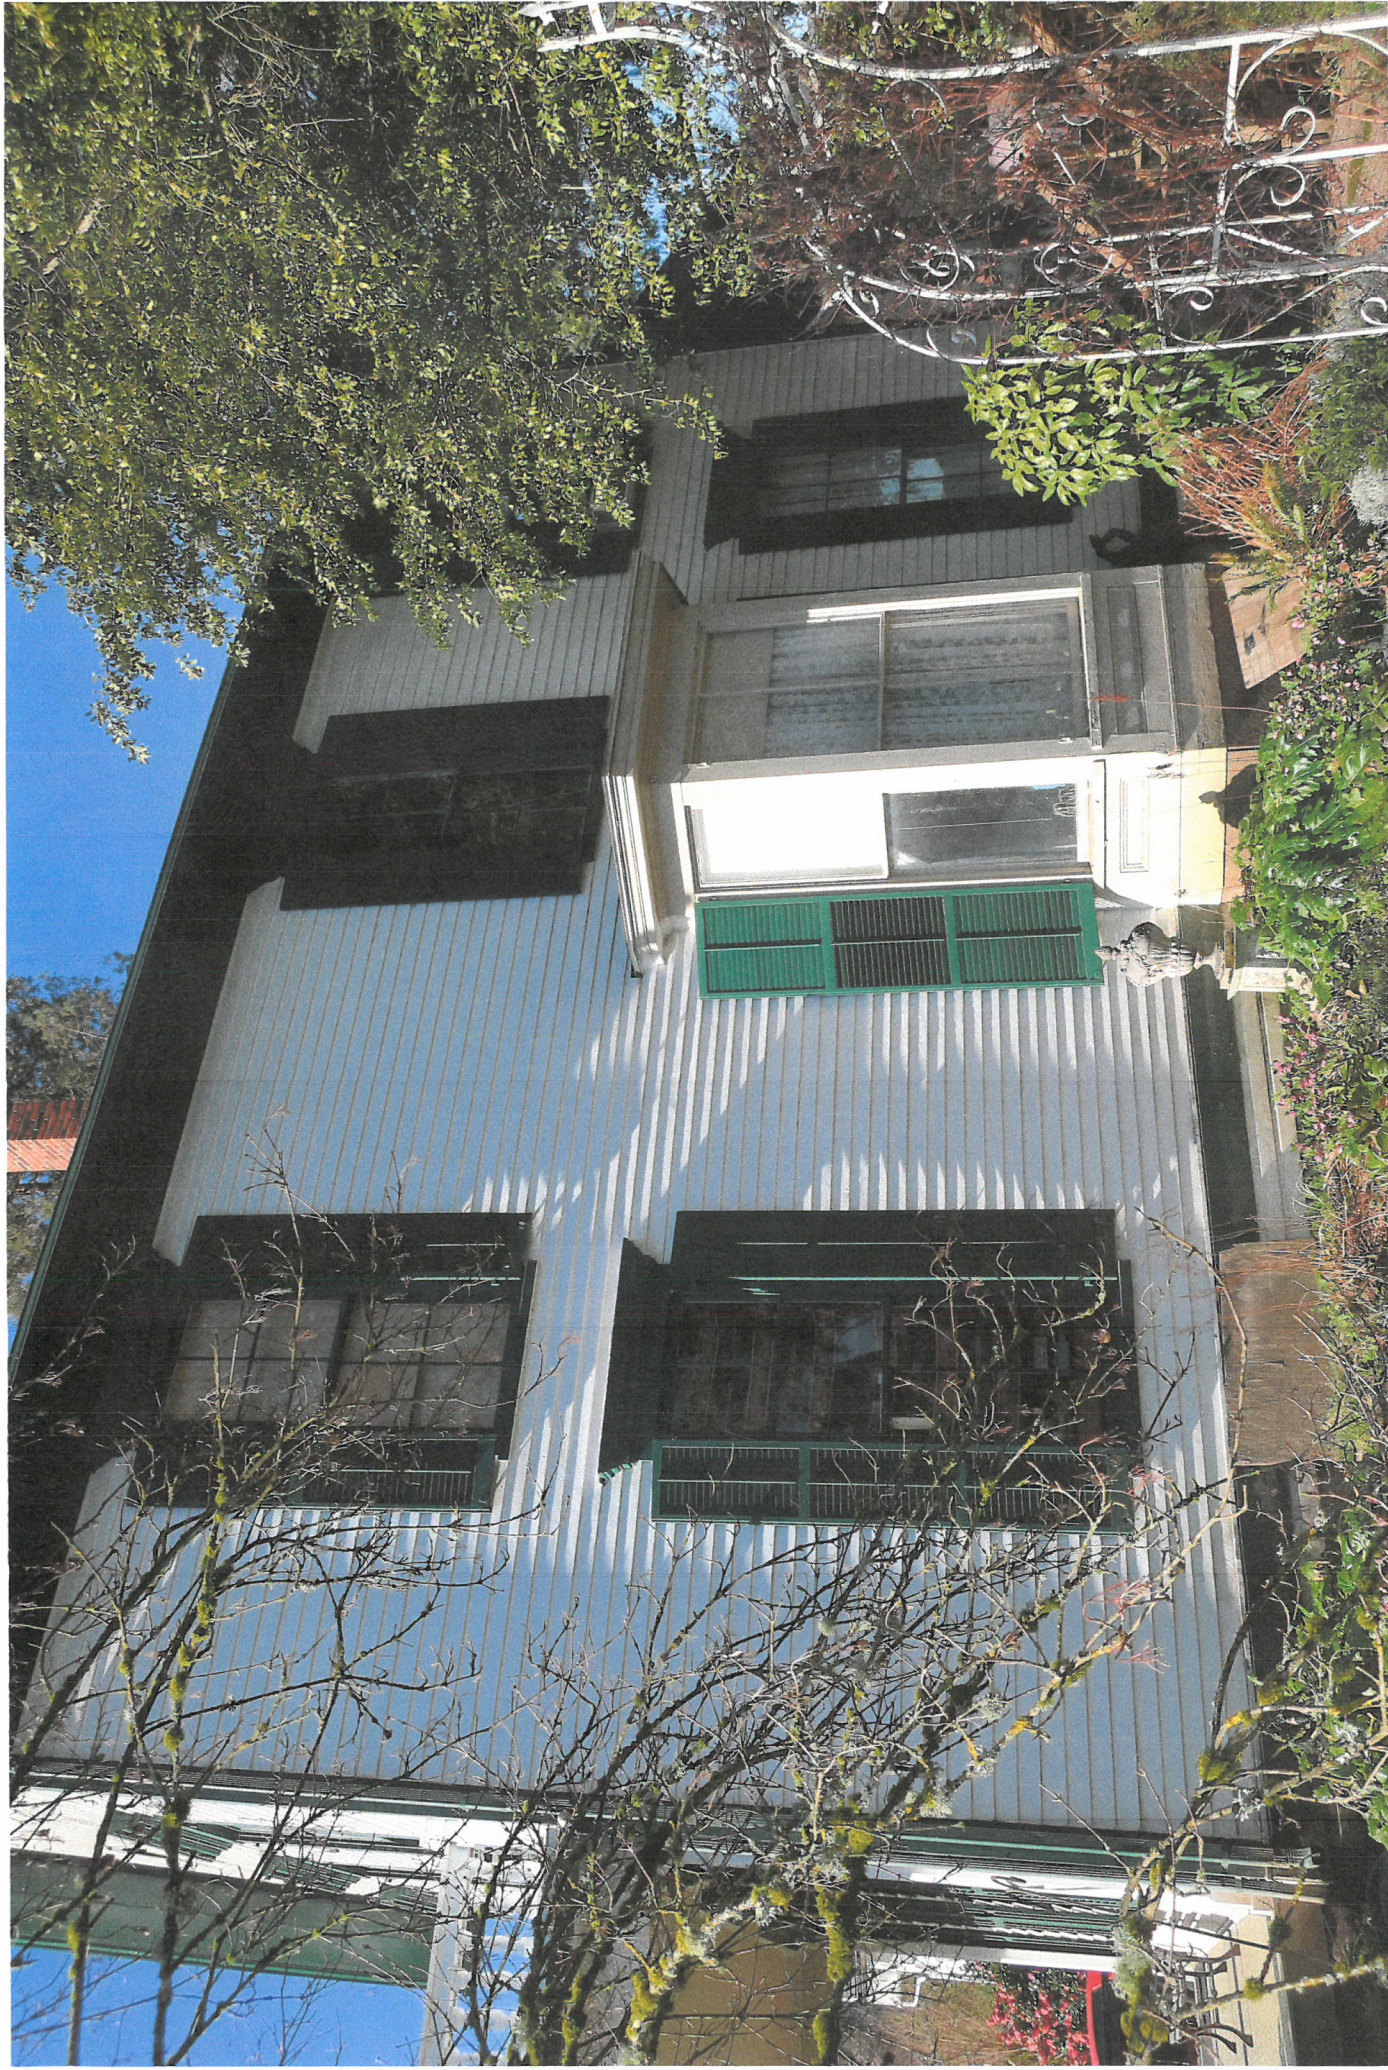
North elevation - right side

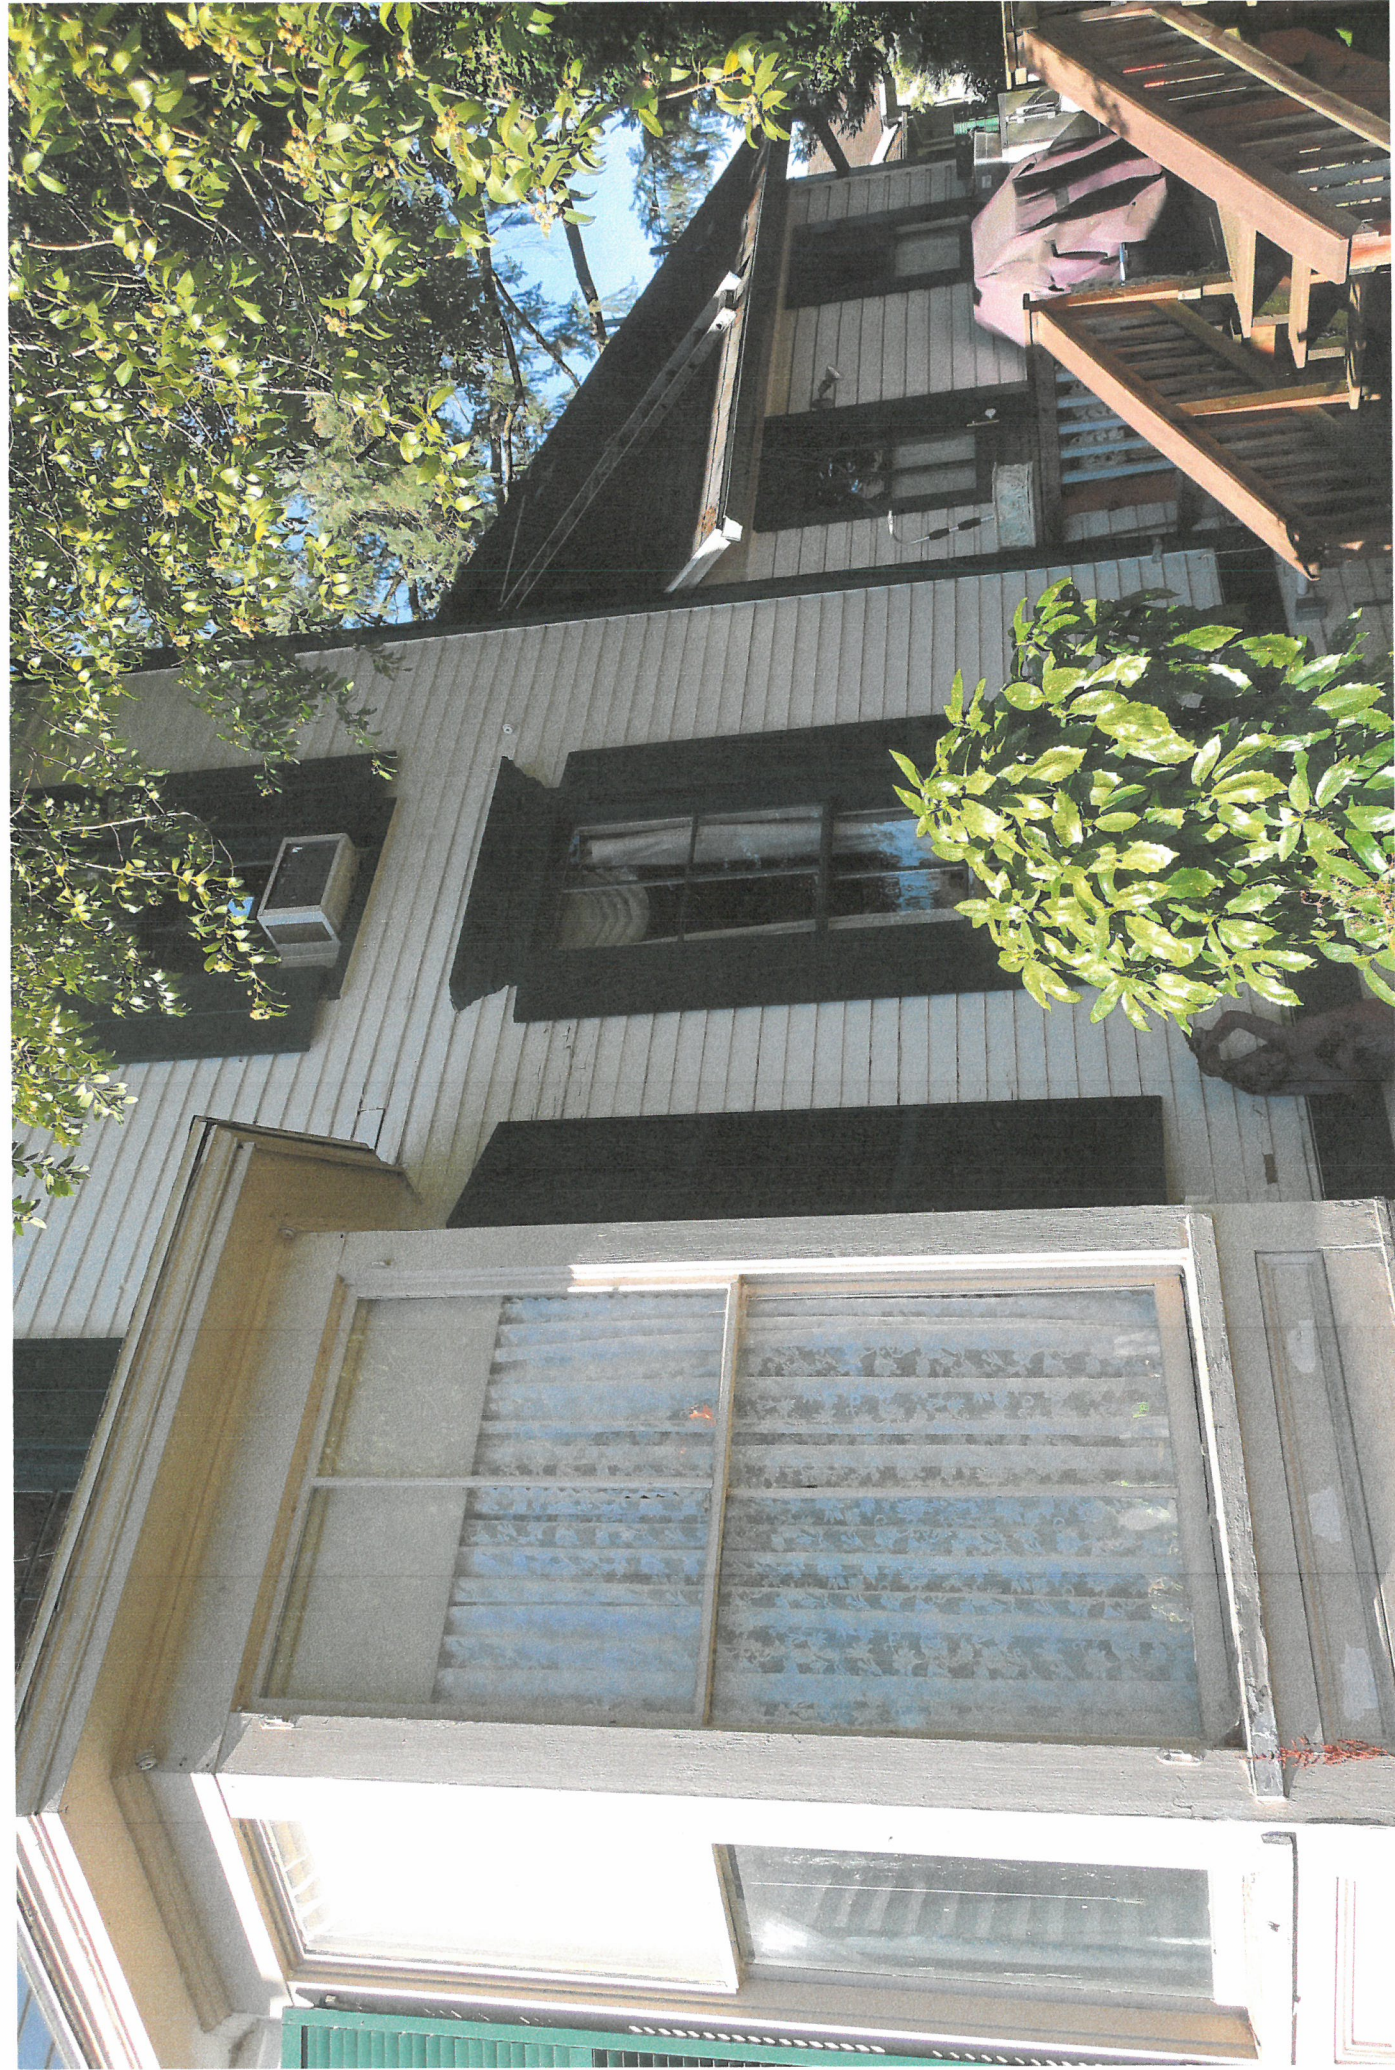
closeup - north elevation - right side

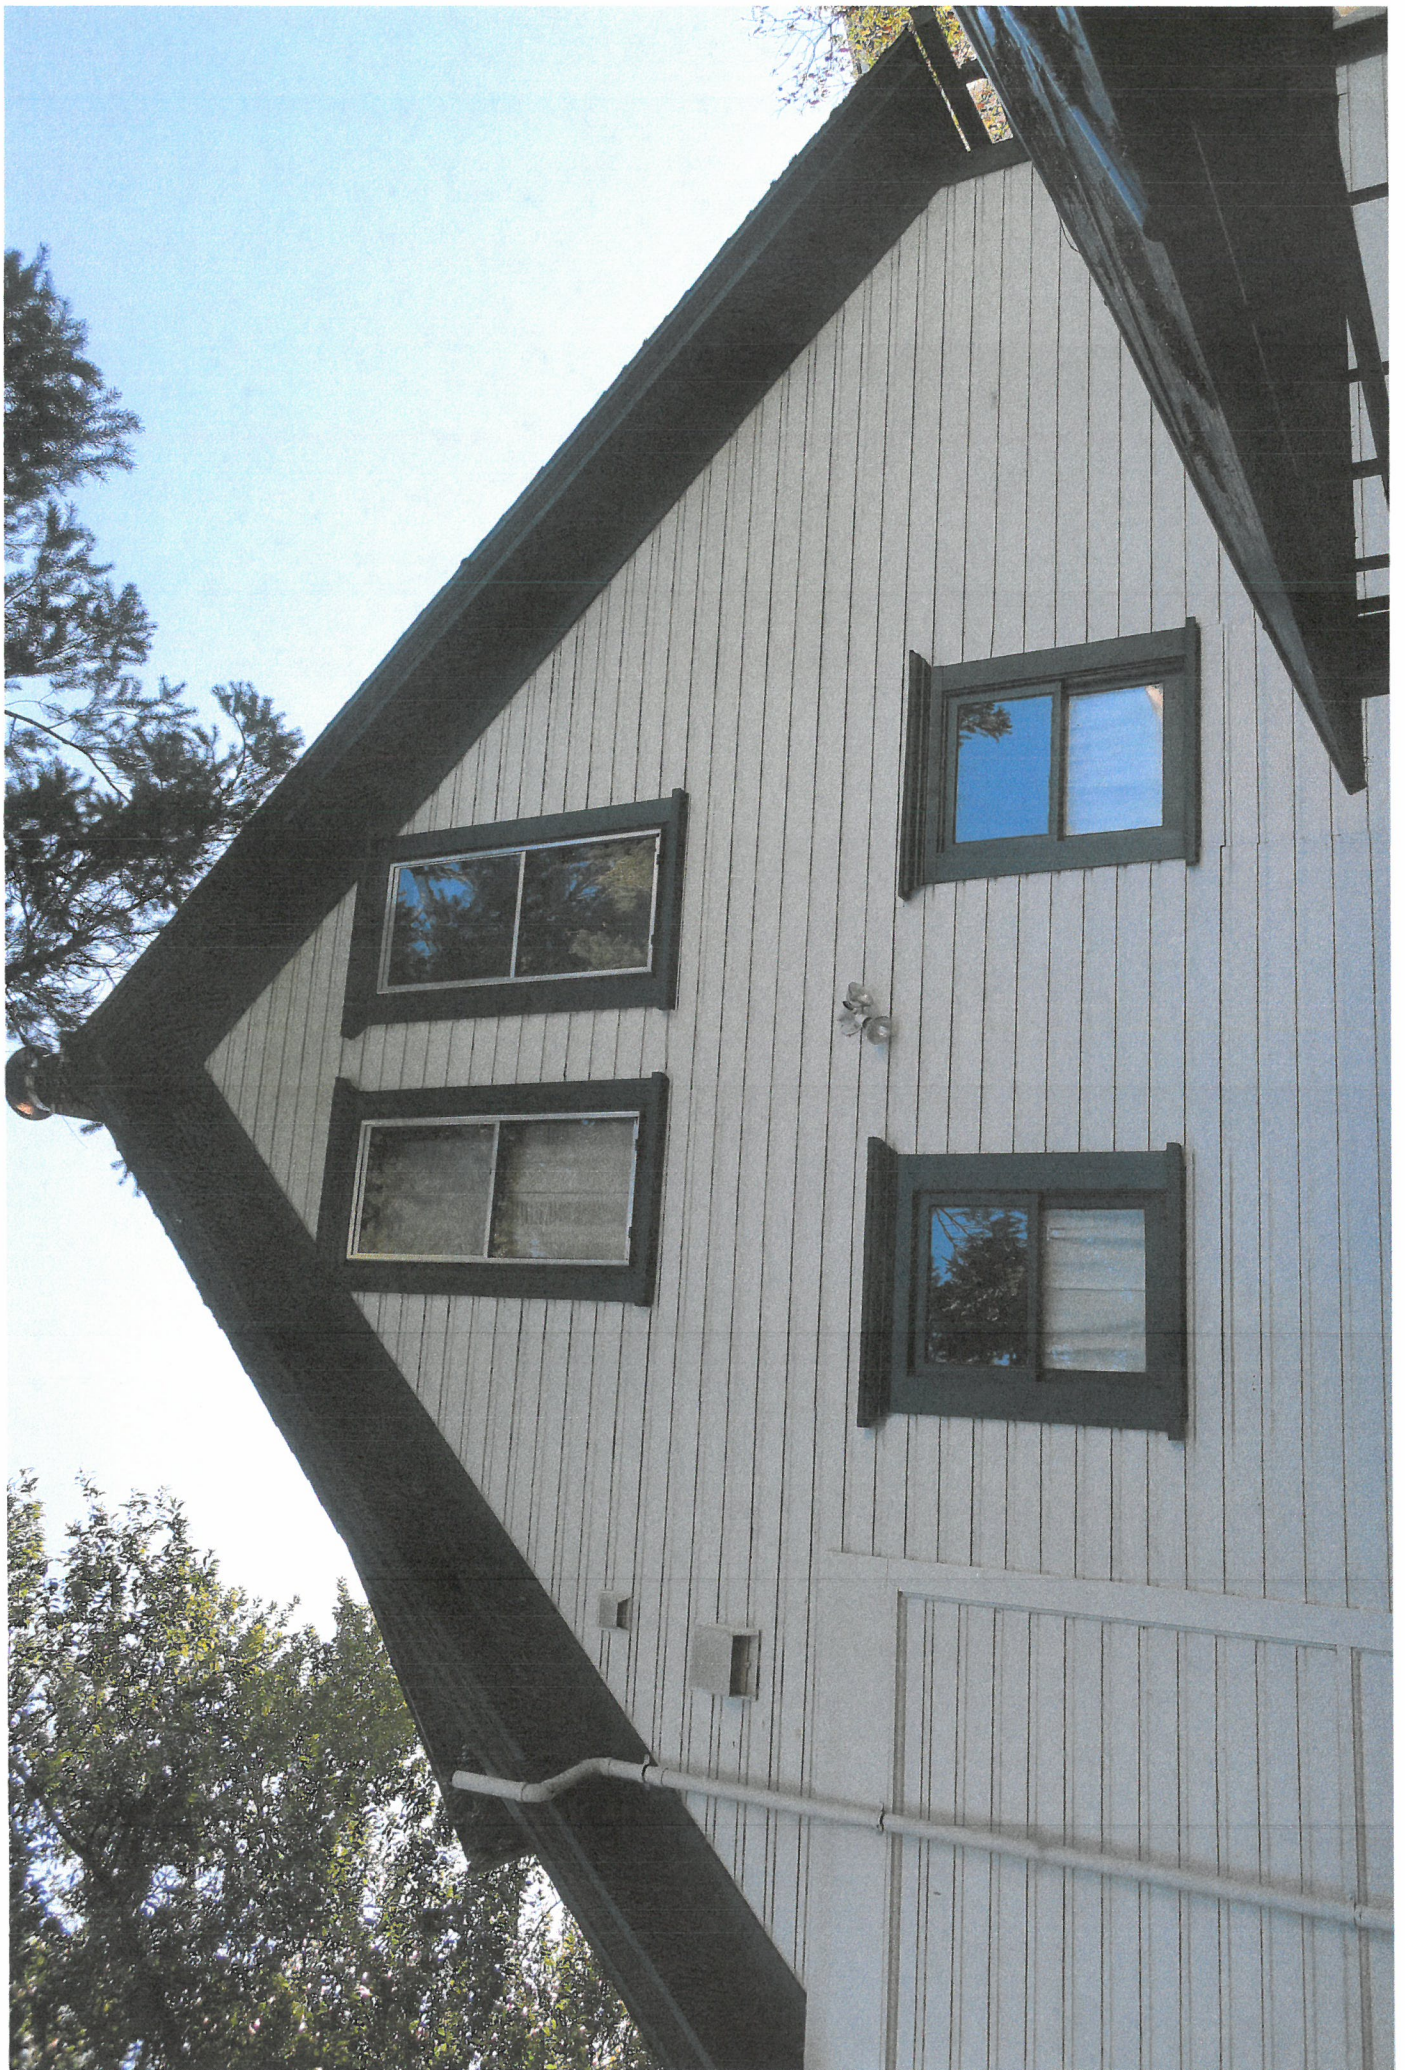
west elevation - rear

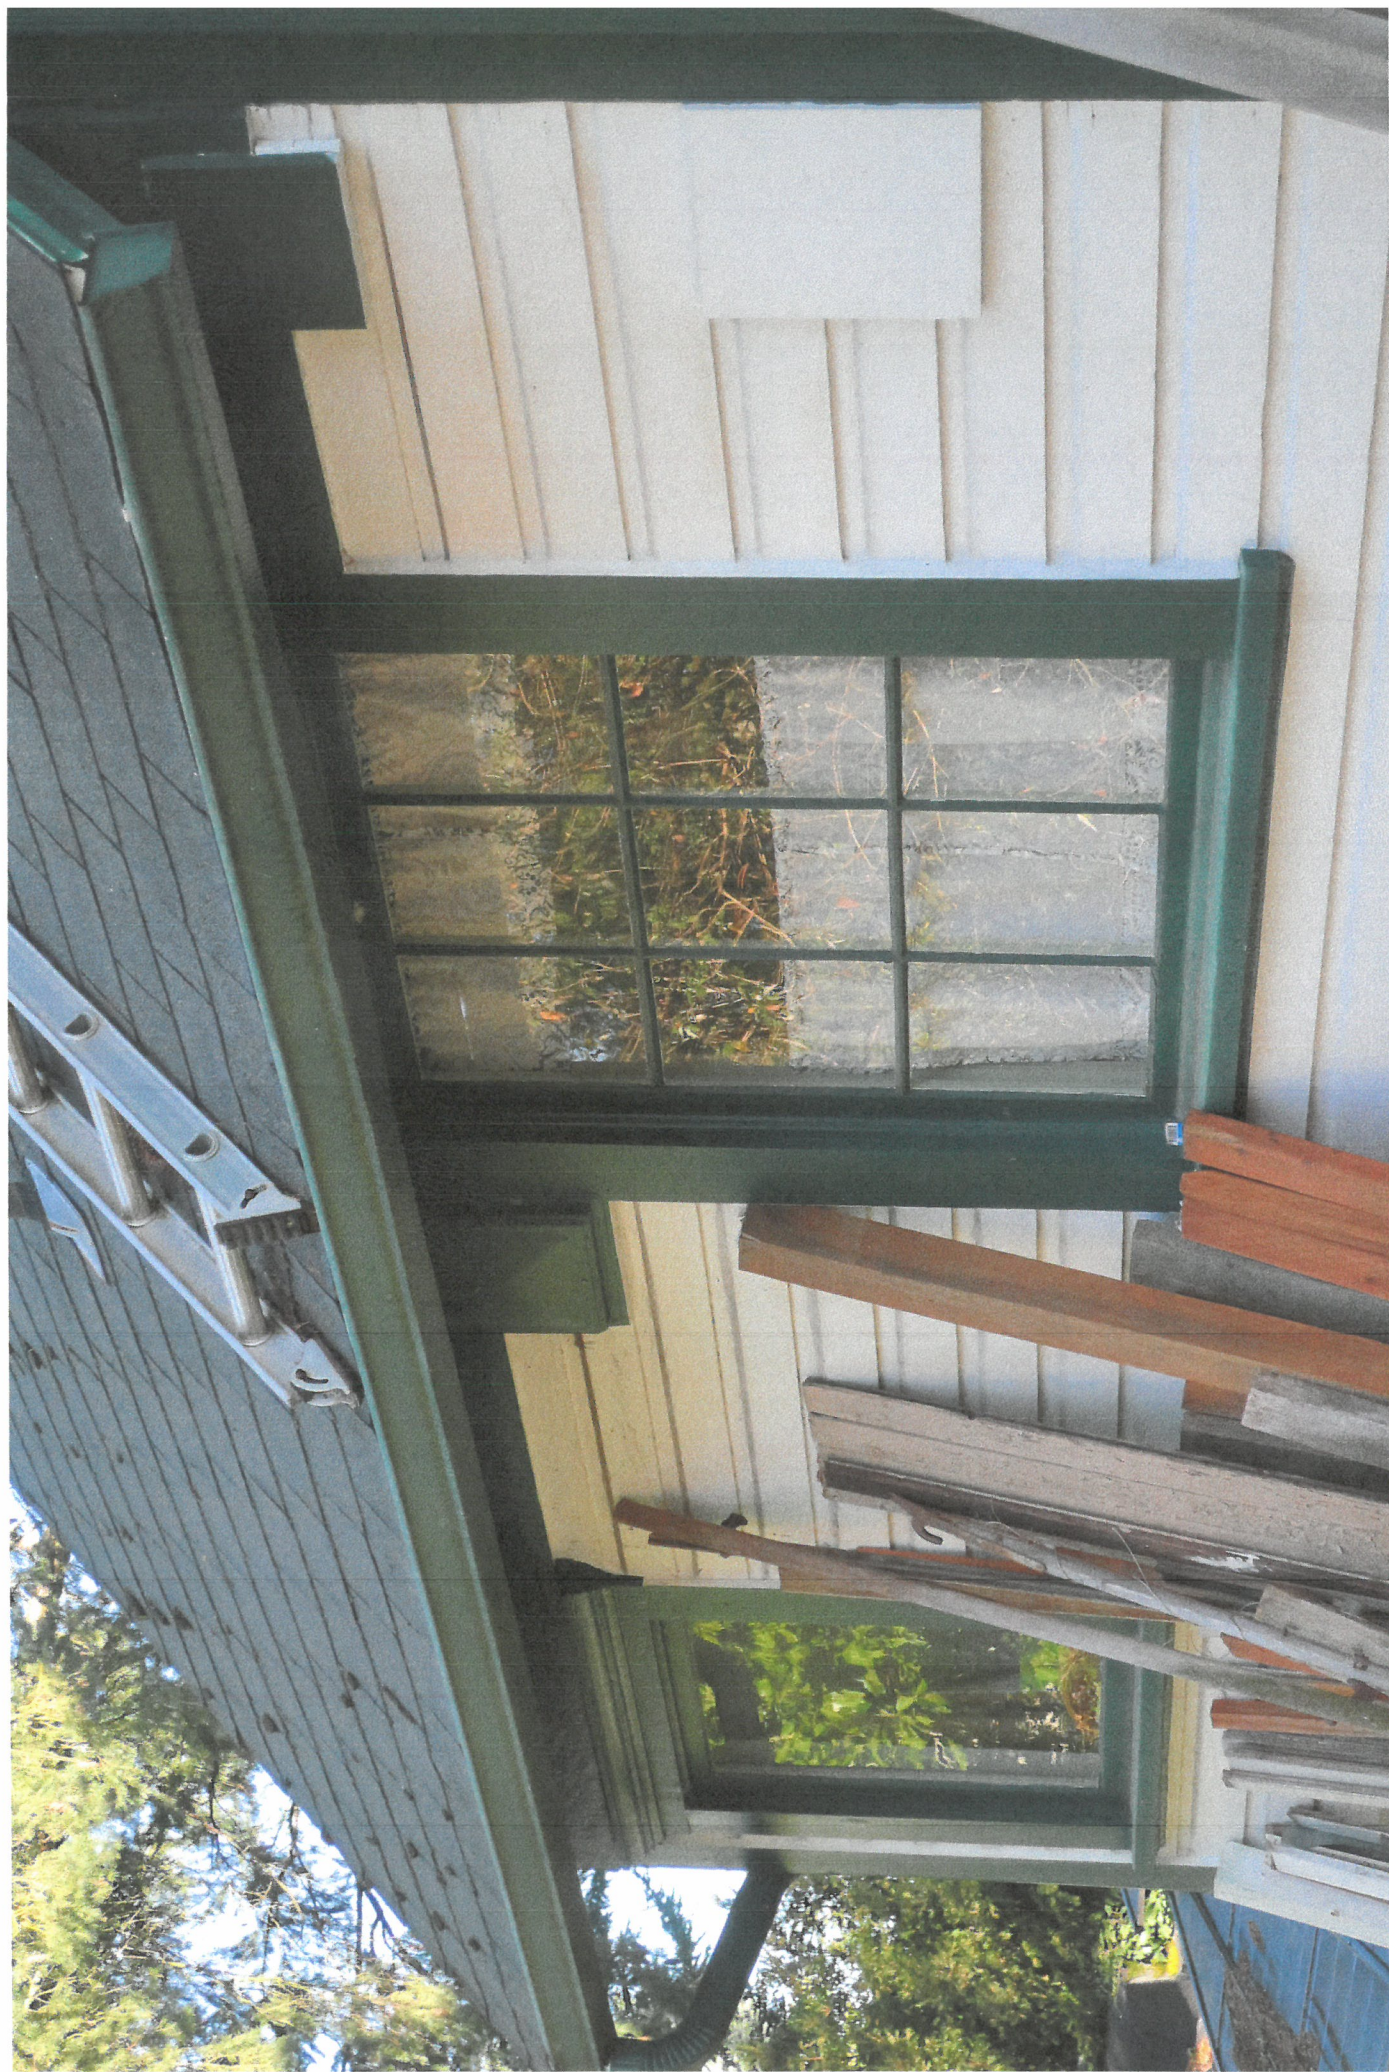
14. south elevation - left side

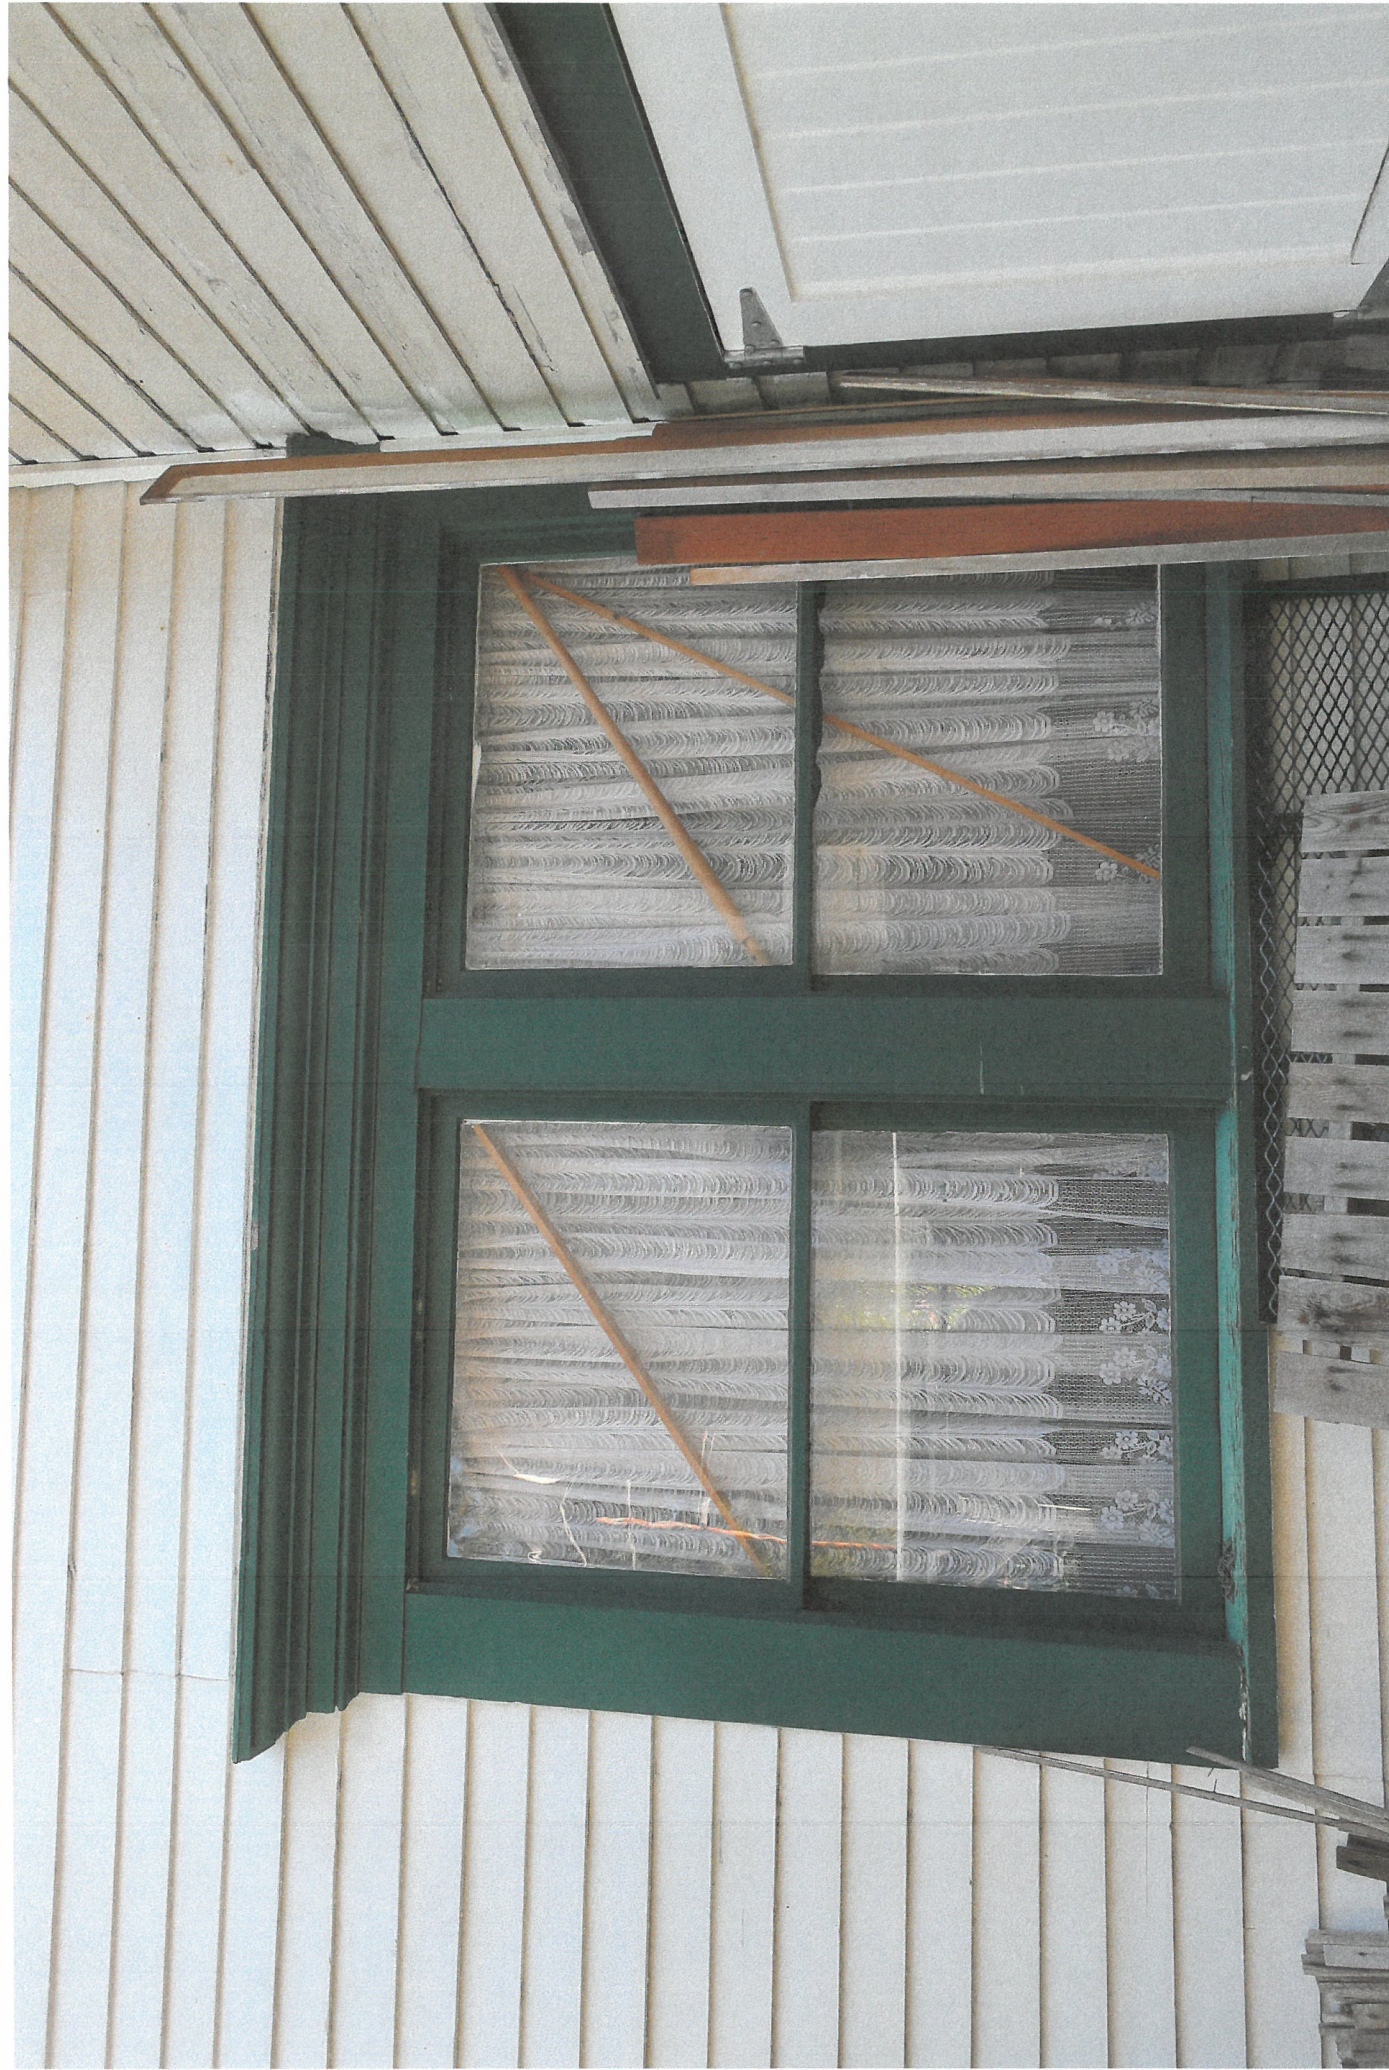
southelevation - lower level - left side

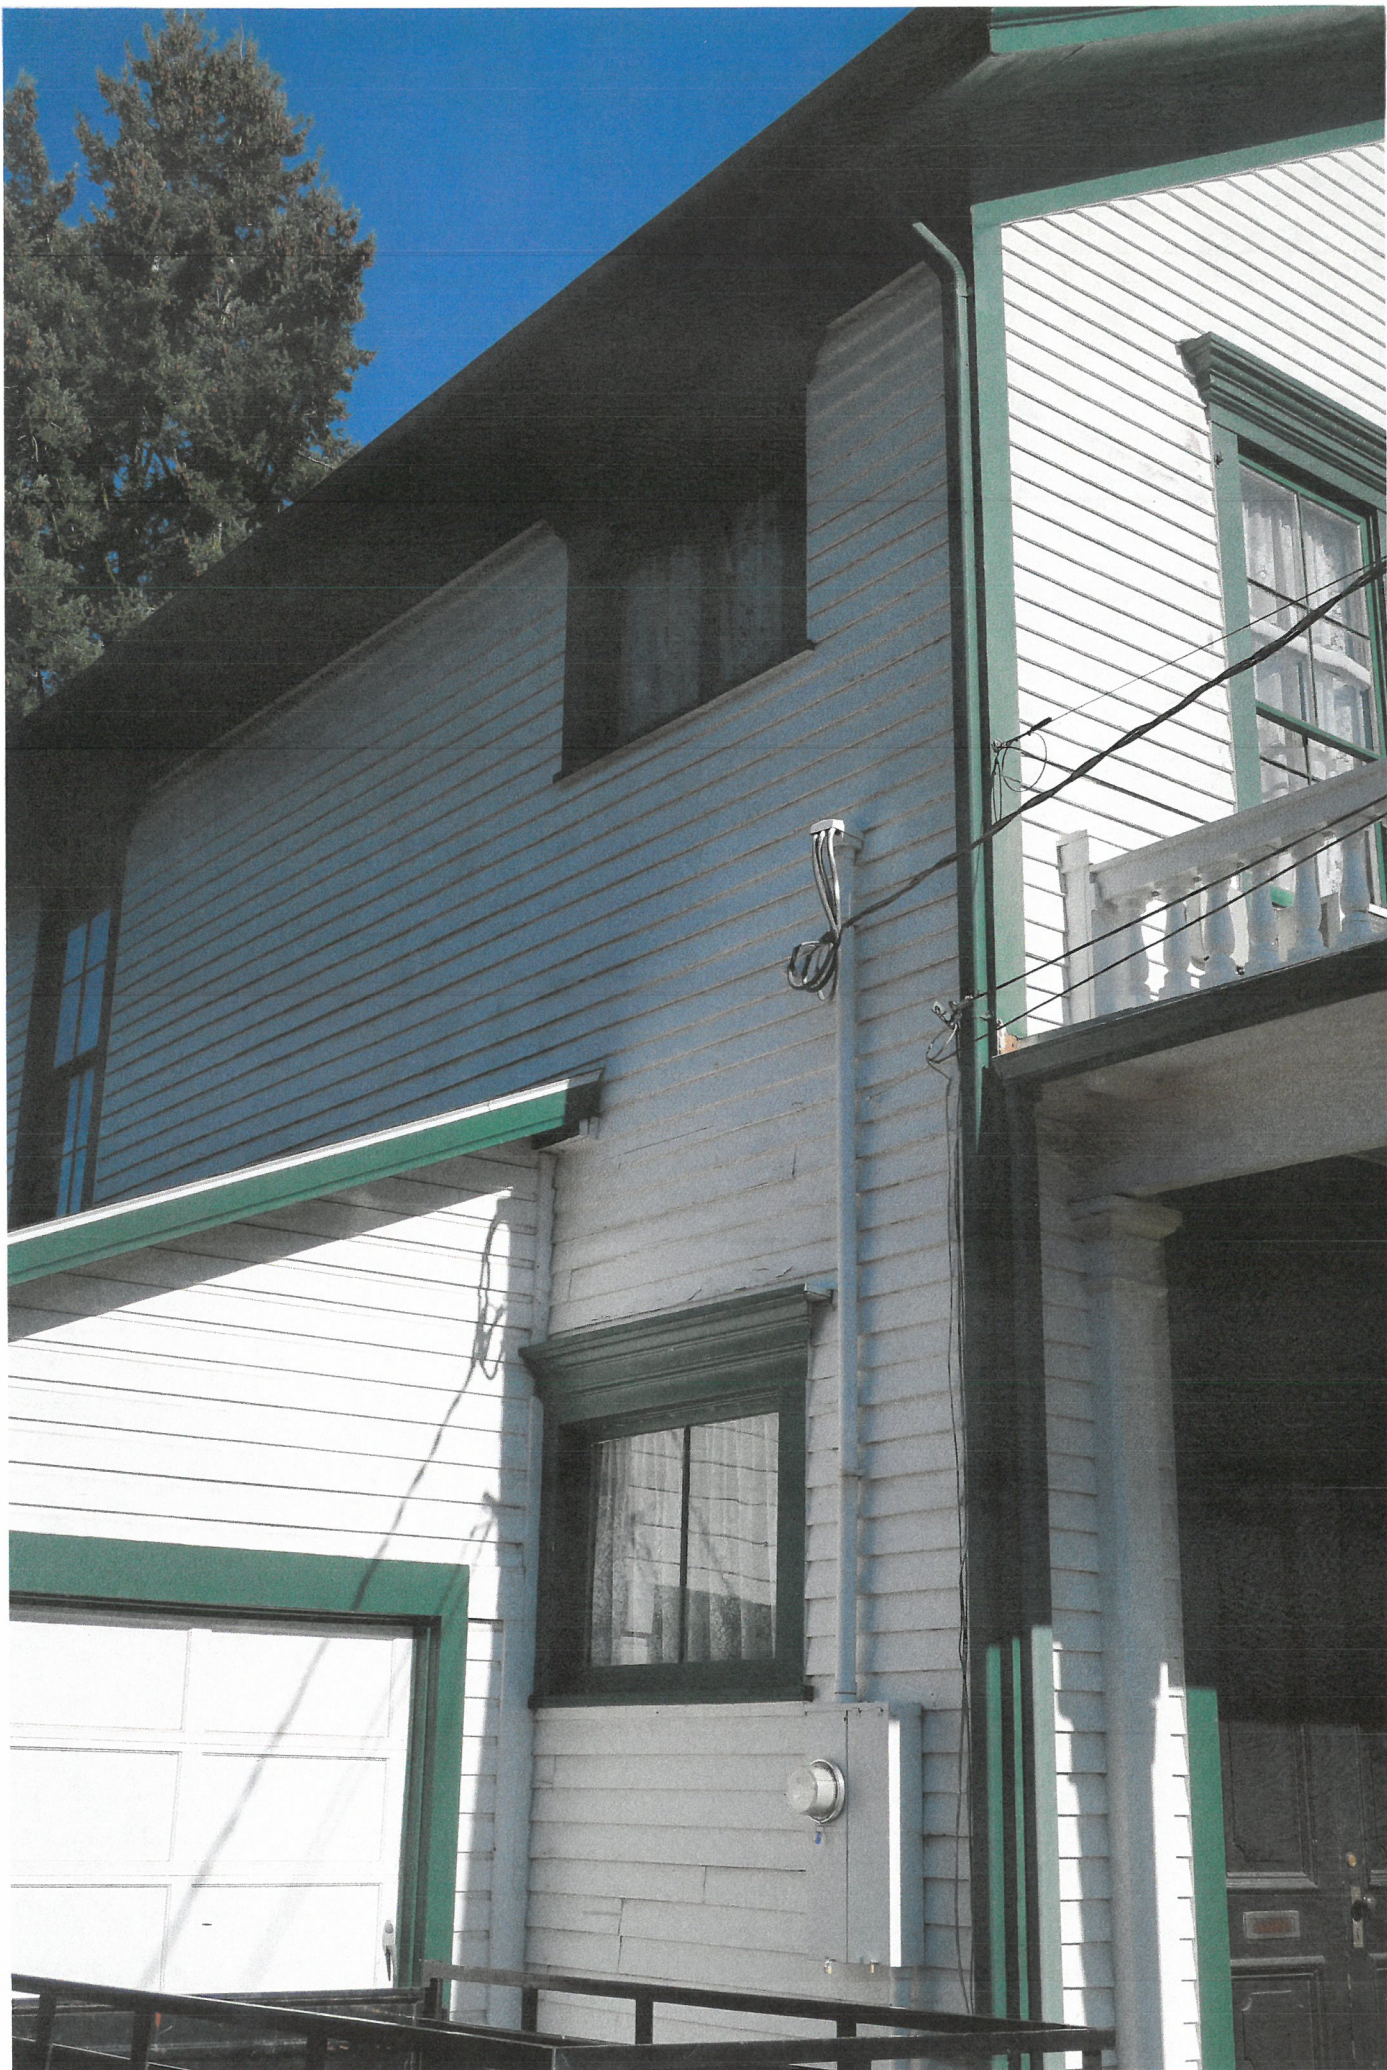
South elevation - left side
