## Molalla Ave./Pearl St. Safety Study

## Key Findings and Recommendations

DKS Associates, Oregon City, Clackamas County

Nov. 19, 2019

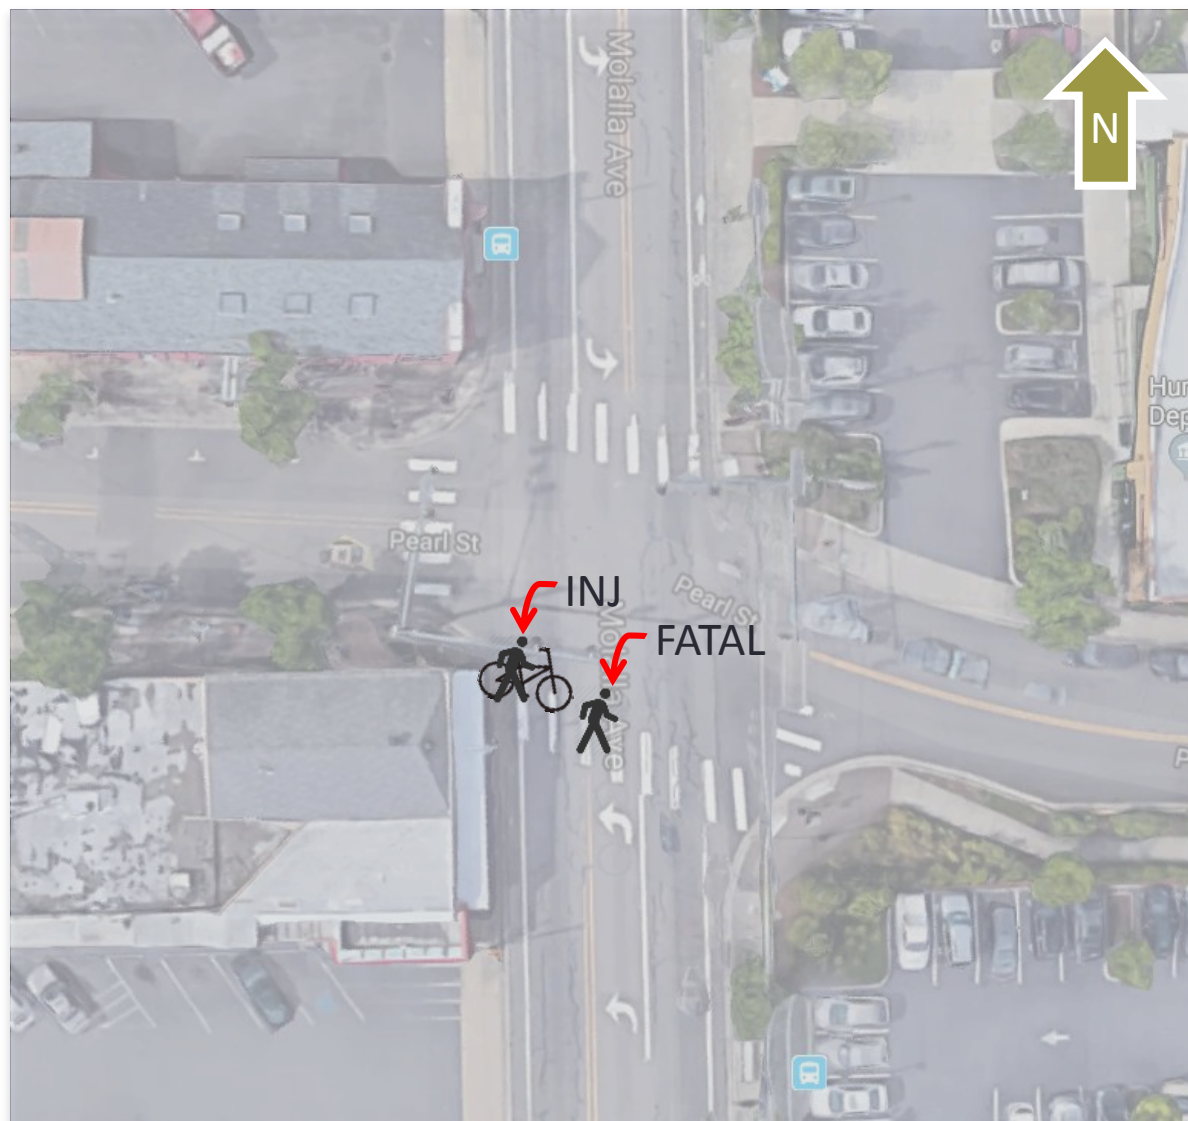
- 2 Ped/Bike Crashes
  - South crosswalk
  - Westbound left turns
  - 1 Fatal
  - 1 Injury

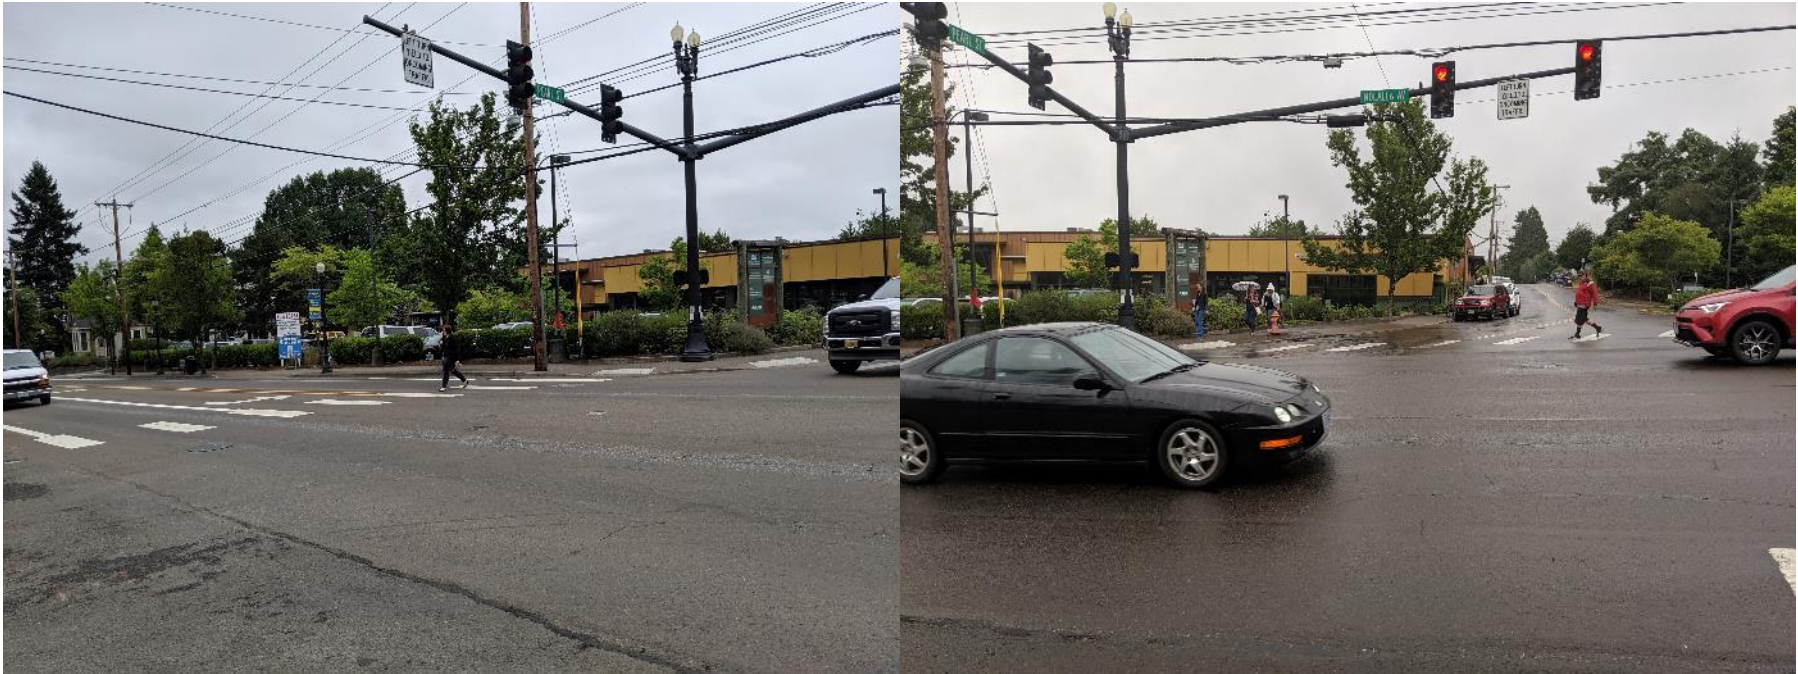
- Office complex and off-site parking supply generate significant pedestrian activity at the intersection
- Several near-miss events observed (including DKS team)
- Skewed geometry and adjacent buildings restrict pedestrian visibility

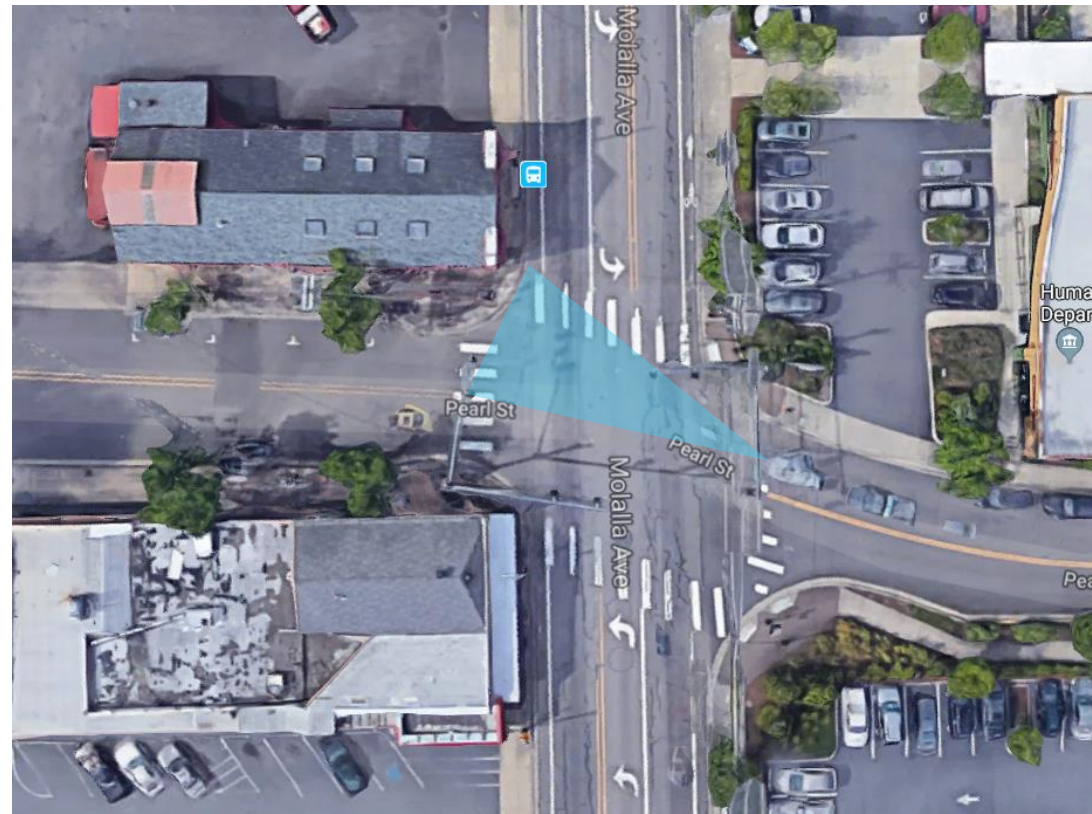
- Current alignment of the eastern leg of the intersection orients vehicles to face north-west instead of due west. Restricts visibility of pedestrians in south crosswalk.
- WB thru vehicles make awkward movements to get around EB left-turning vehicles that are yielding within the intersection

- Short Term Improvements
  - Proposed restriping orients westbound vehicles to face west
  - Remove 2 parking spaces (prevents false signal calls that currently exist)

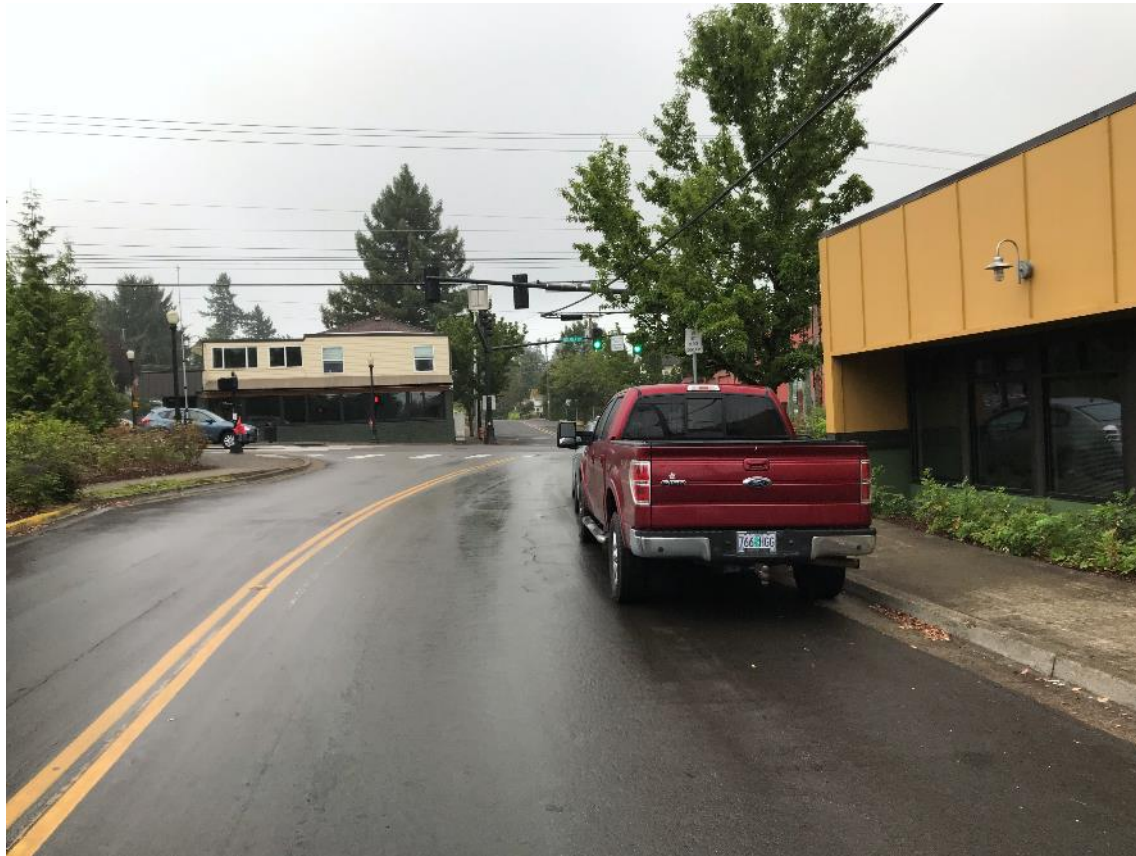
- On-street parking on east leg limits visibility of intersection and crosswalks as drivers approach from the east (looking west)

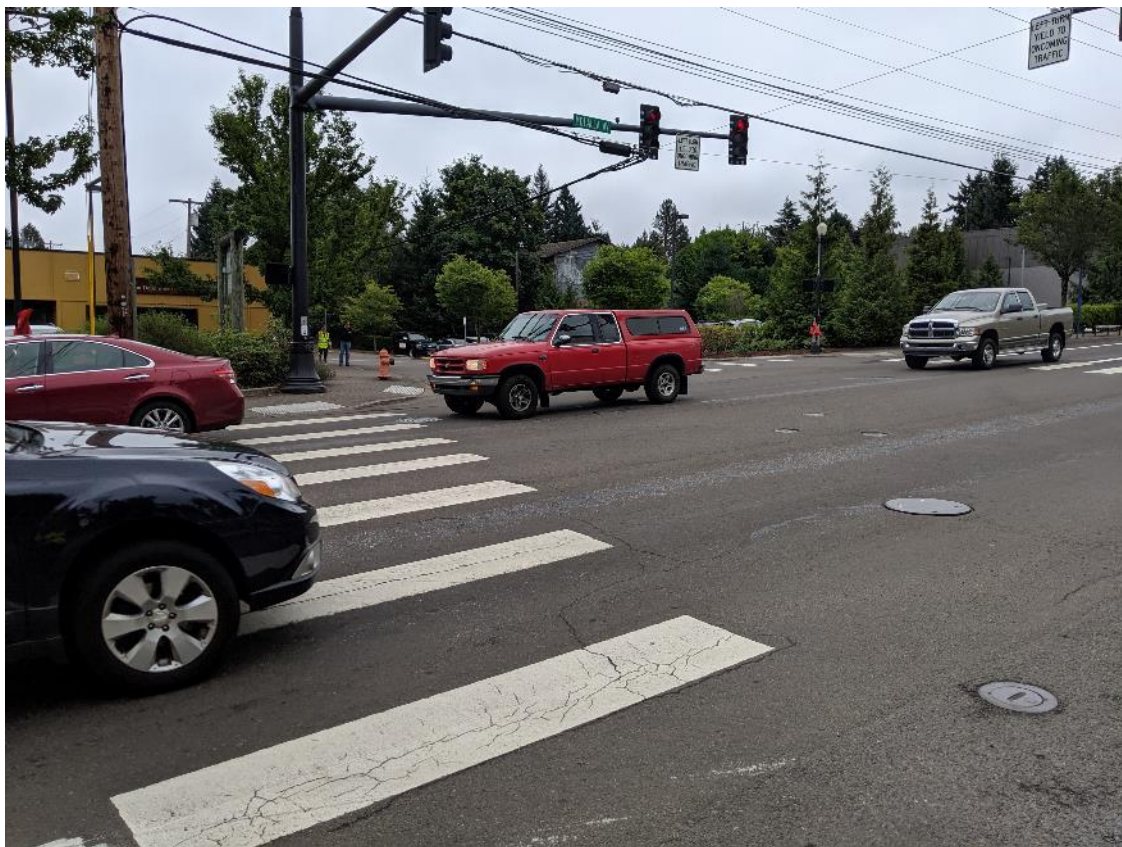
- Observed high speeds and red light running on northbound approach (downgrade)
- Posted speed 30 mph
- Northbound 85<sup>th</sup> Percentile Speed 34 mph
- 40 mph speeds were registered

- Recommend adding backplates with retroreflective borders to vehicle signal heads to improve visibility
  - Sun-glare in westbound direction
  - High frequency of rear-end crashes in northbound direction
- Recommend installing supplemental signal head for westbound approach

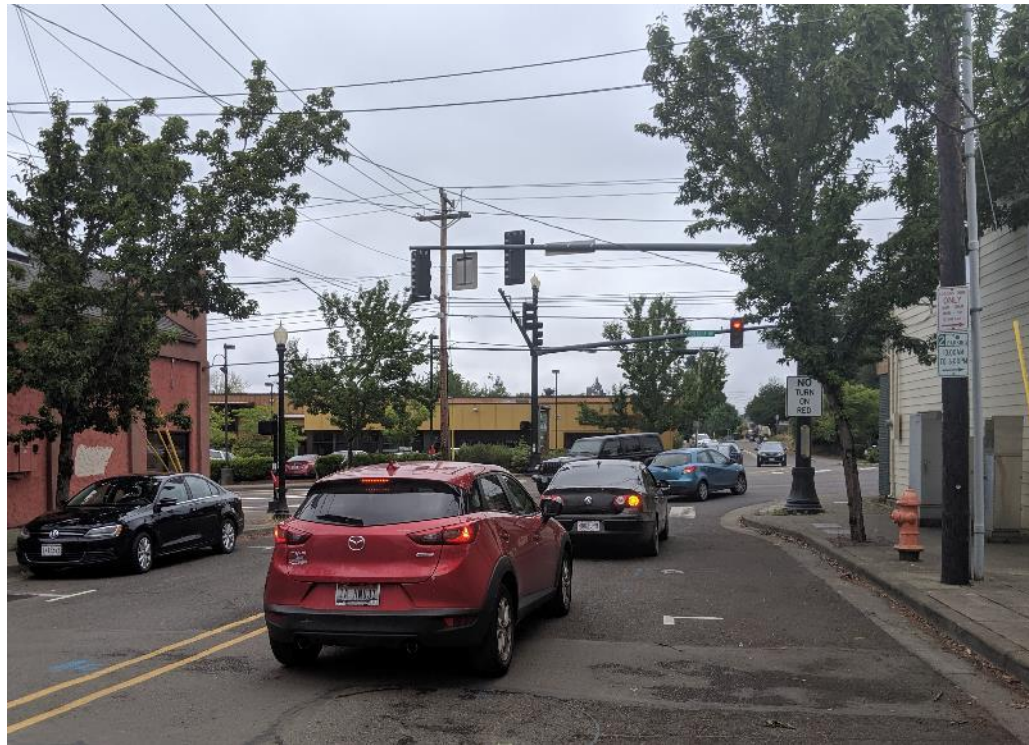
- The right turn on red restriction is needed due to limited sight distance, however drivers disregard this restriction.

Driver making right turn on red despite “No Turn on Red” sign

- Sign is in place for eastbound approach due to limited sight distance caused by building in northwest corner
- Often ignored (placed behind eastbound stop bar)
- Recommend relocating onto mast arm servicing eastbound traffic

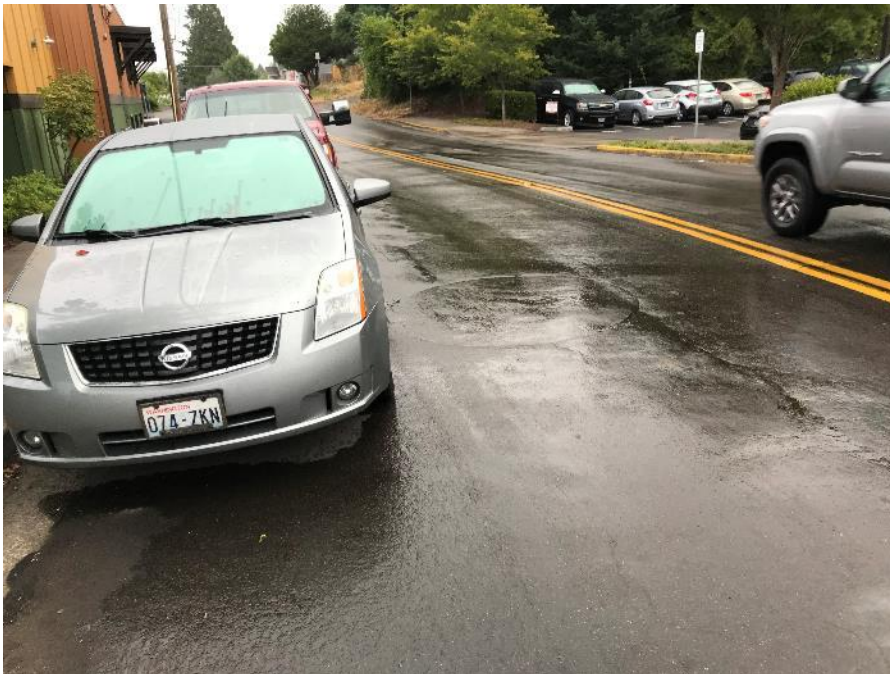
- Continuous (false) signal calls due to parking adjacent to traffic signal inductive loop

Parked vehicle next to loop on EB approach

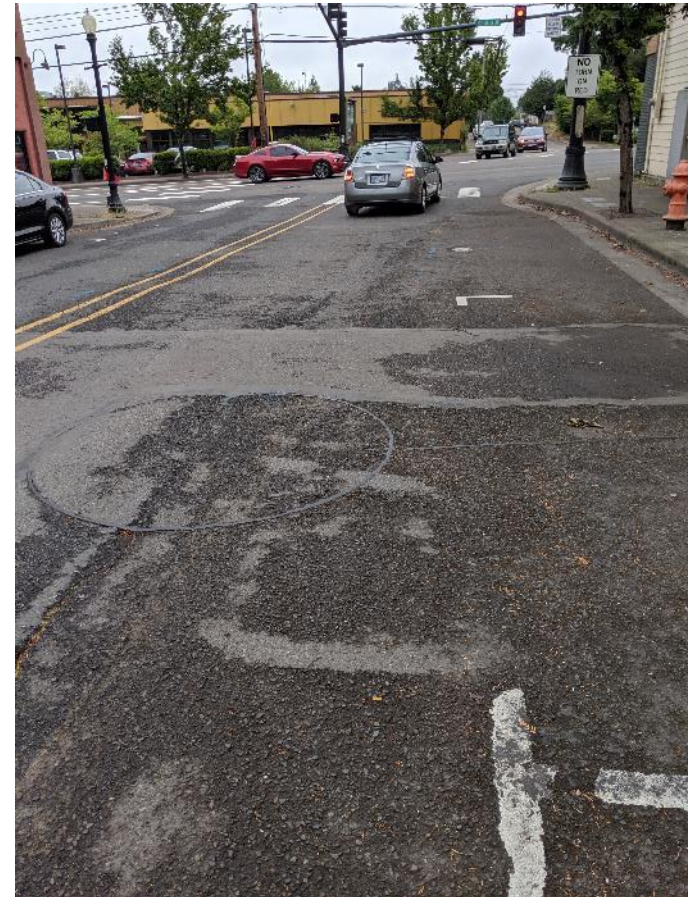
Loop in close proximity to parking spot (WB approach)

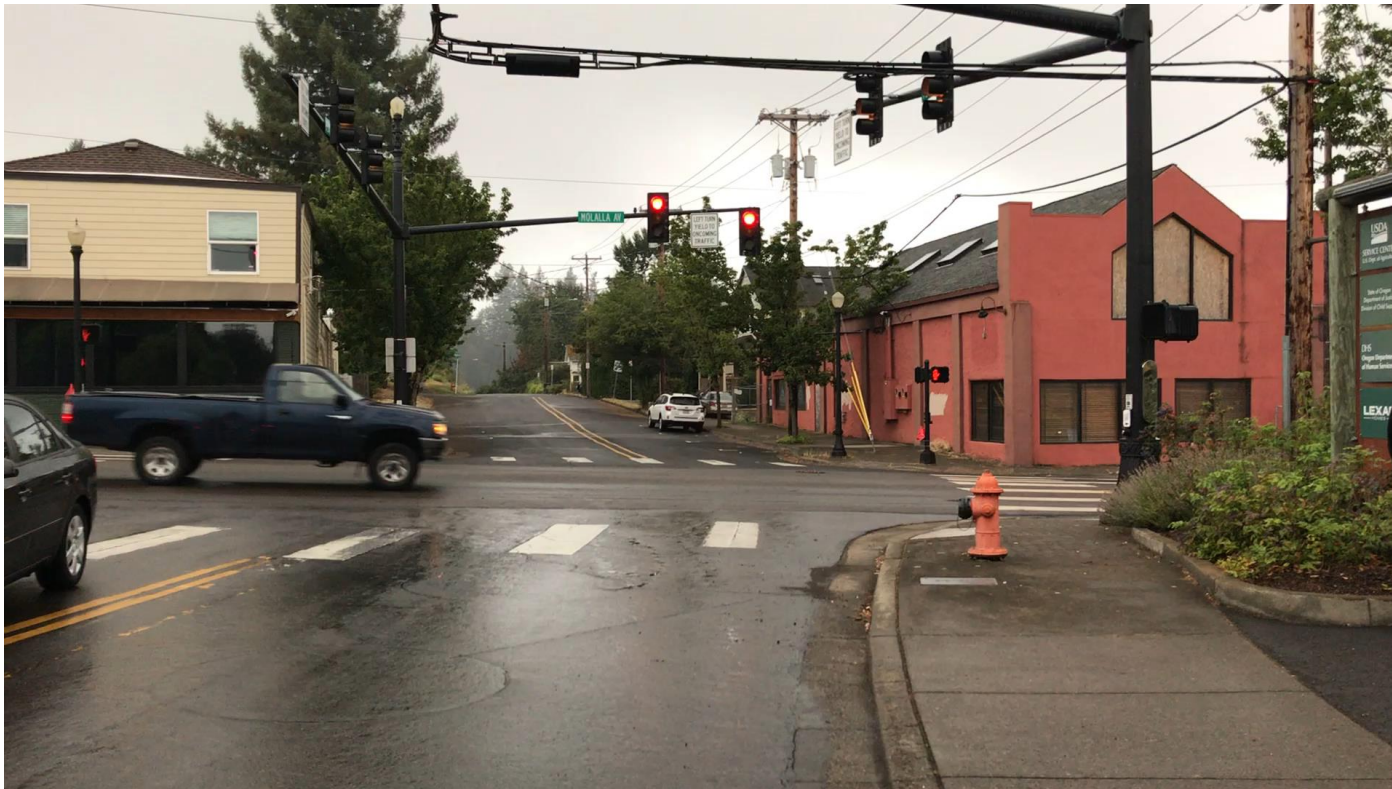
- False signal calls due to parking adjacent to detection loop lead to maximum green times on minor street increasing the delays to the major street

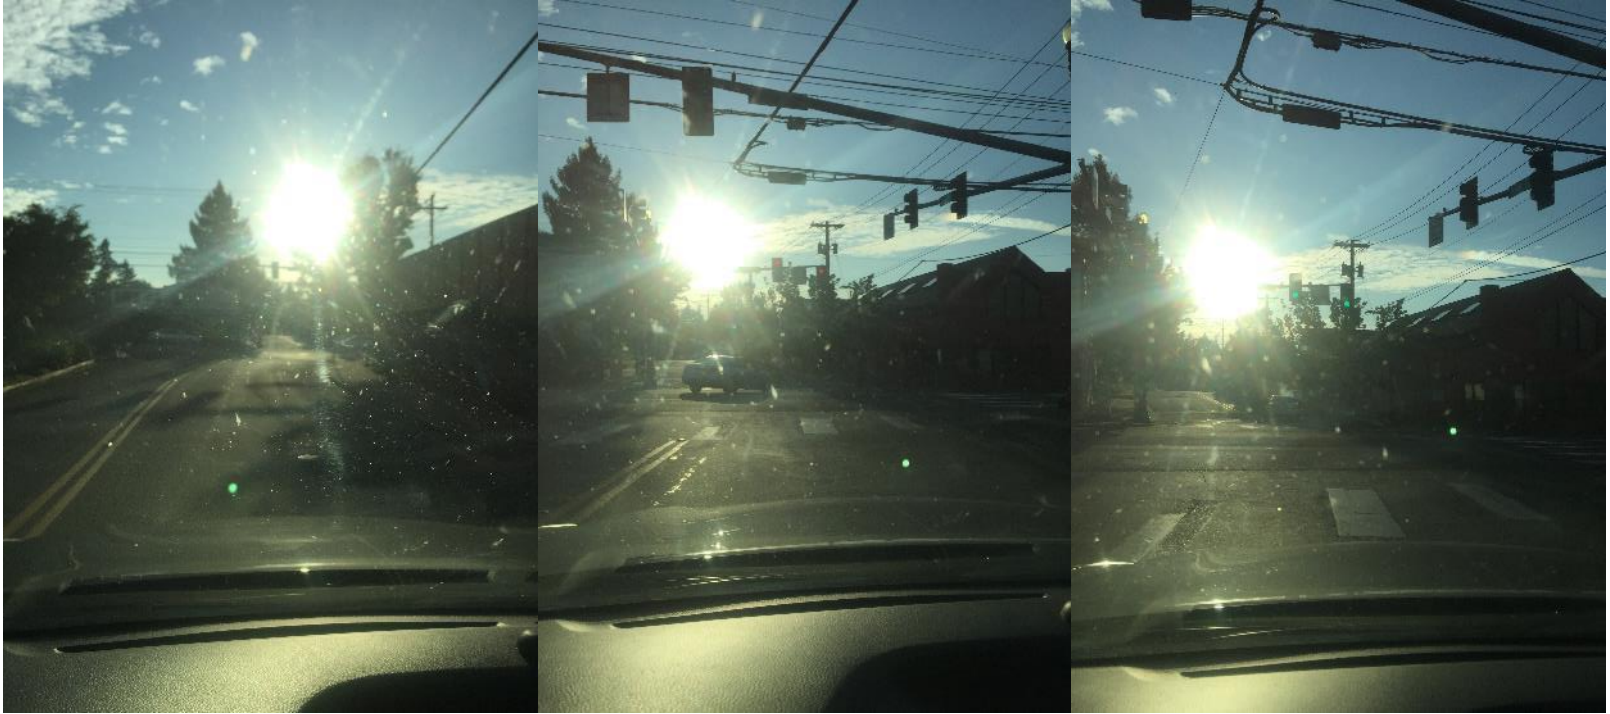
Observed sun glare approaching the intersection from the east.

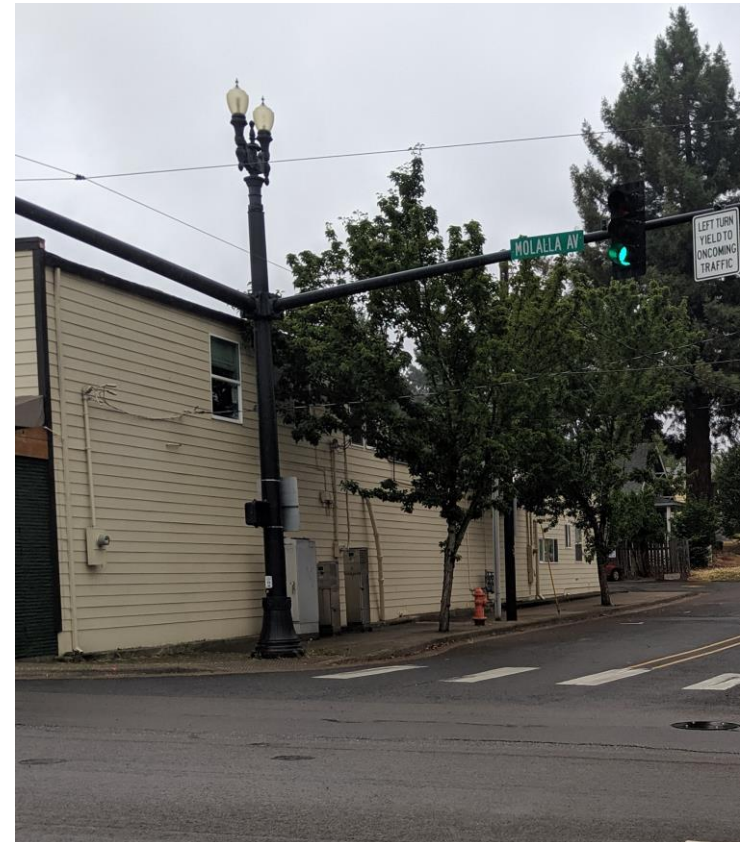
- Evening observations (7:00 p.m. – 9:00 p.m.)
- Lighting appeared sufficient in immediate vicinity
- Extents of intersection were dim

Decorative acorn lights provide less light than traditional cobrahead luminaires would.

- Replace acorn lights with clamp-on luminaire lights to improve visibility and safety
- Could be completed by modifying poles instead of replacing

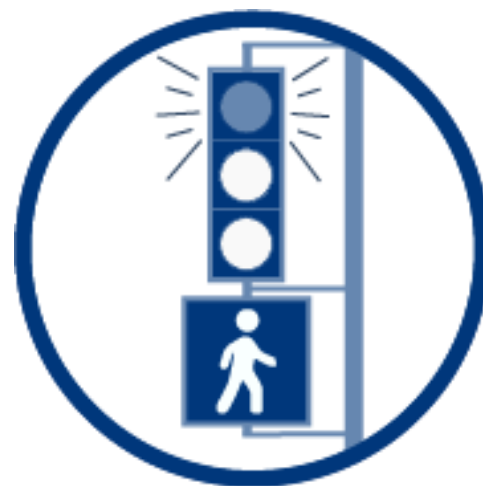
- Pedestrians can enter the crosswalk before vehicles are given the green light
- Enhances visibility of pedestrians in the intersection and reinforces right-of-way over turning vehicles
- Recommend 4-second leading pedestrian interval for south crosswalk (eastbound phase)
- **CRF = 37% (bike and ped crashes)**

Pedestrians receive “Walk” signal before vehicles receive green light (FHWA)

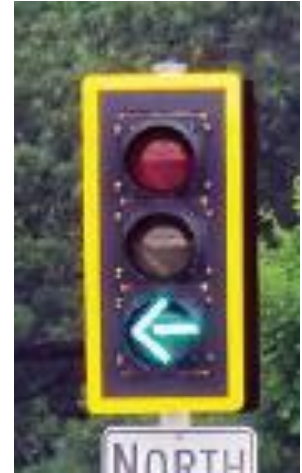
Retroreflective border example

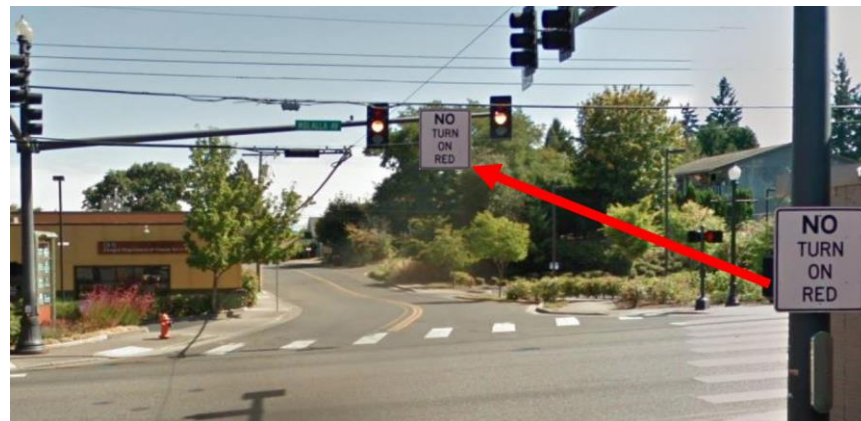
Proposed “No Turn on Red” sign relocation

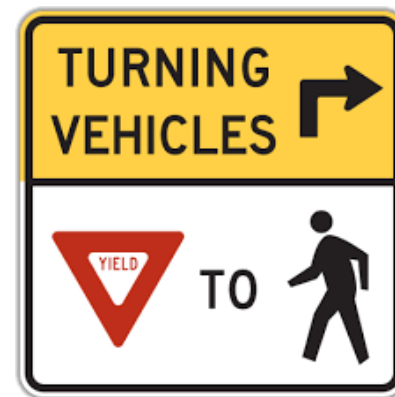
- “Turning Vehicles Yield to Pedestrians” sign (MUTCD-R10-15)
- Recommend placing adjacent to signal heads for the through-right shared lanes
- Especially helpful for eastbound approach (limited visibility of south crosswalk)
