# **Natural Resource Overlay District Report for the Oregon City Tyrone S. Woods Park Project in Oregon City, Oregon**

(Township 3 South, Range 2 East, Section 9D, Tax Lot 1401 and 1500)

**Pacific Habitat Services, Inc.**

**September 27, 2019**

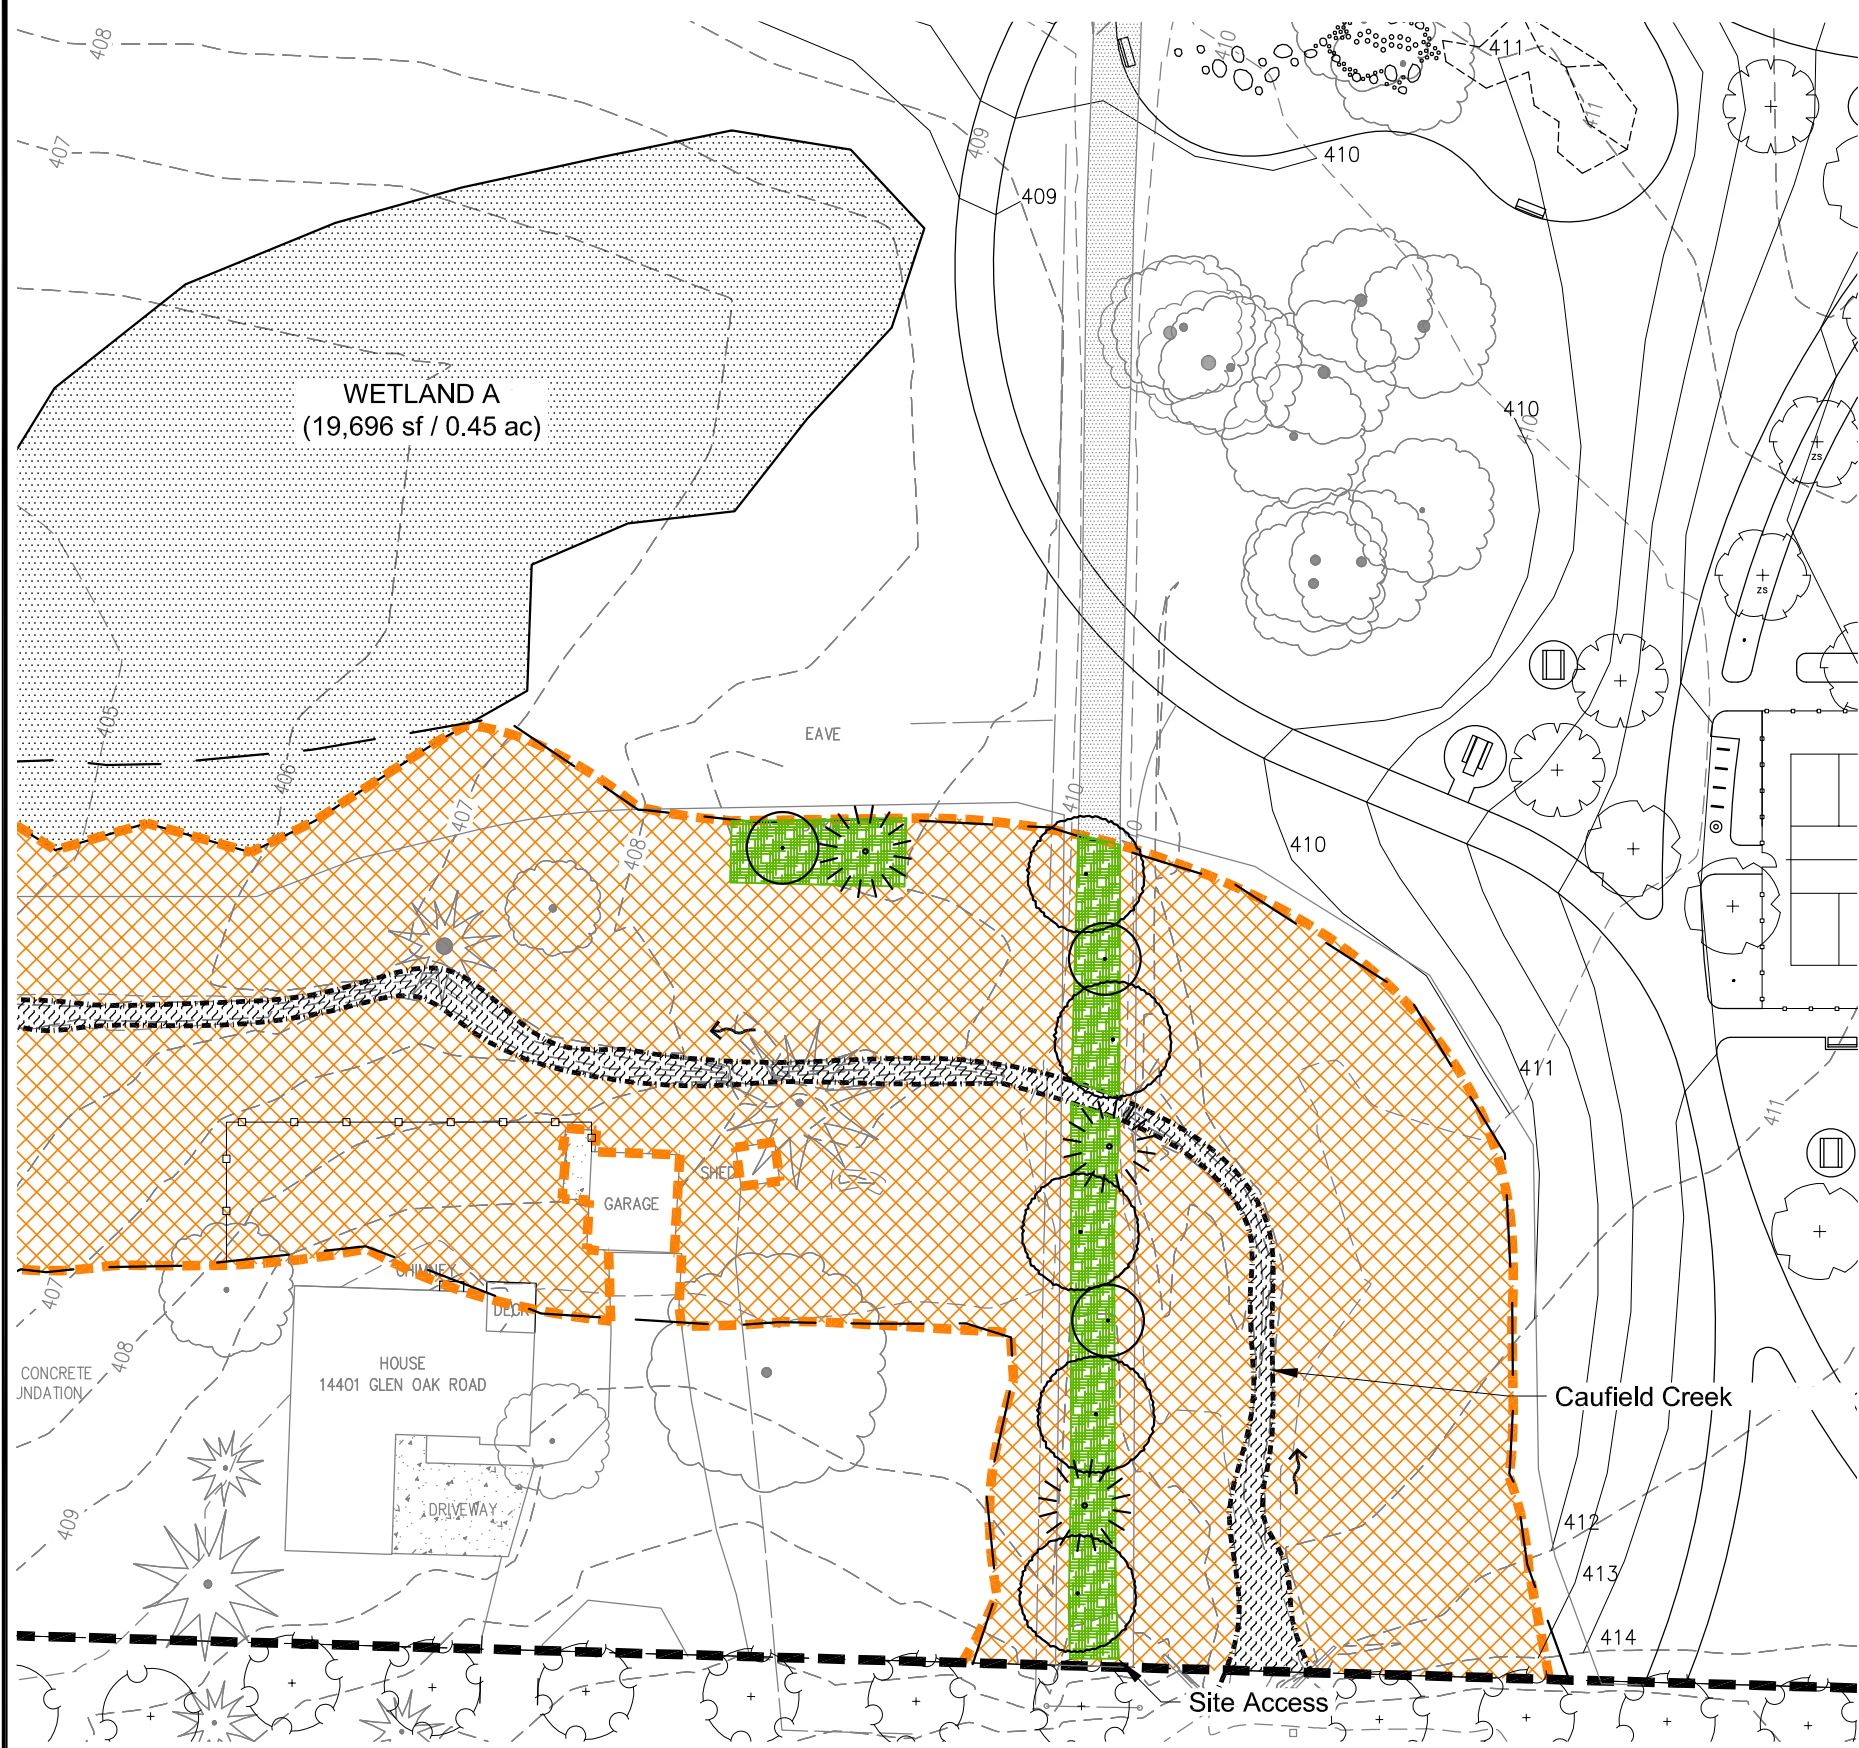
FIGURE  
**5A**

- LEGEND
- Study Area Boundary
  - Wetland
  - Waters of the State / US
  - Ordinary High Water
  - New Vegetated Corridor (40,035 sf / 0.92 ac)
  - Proposed Revegetation Area (2,049 sf / 0.05 ac)

Option 2 will be utilized for the revegetation plan. The revegetation is proposed to occur in areas of temporary disturbance along the removed road. The existing vegetated corridor is in degraded condition. It is anticipated that the revegetation will improve the functional value of the vegetated corridor by removing invasive species and increasing native plant diversity and coverage, and increase the size of the VC by restoring the road prism and removed barn area. As the project is exempt, no mitigation plan report is proposed (Section 17.49.230). Mitigation Standards described in Section 17.49.180 do not apply.

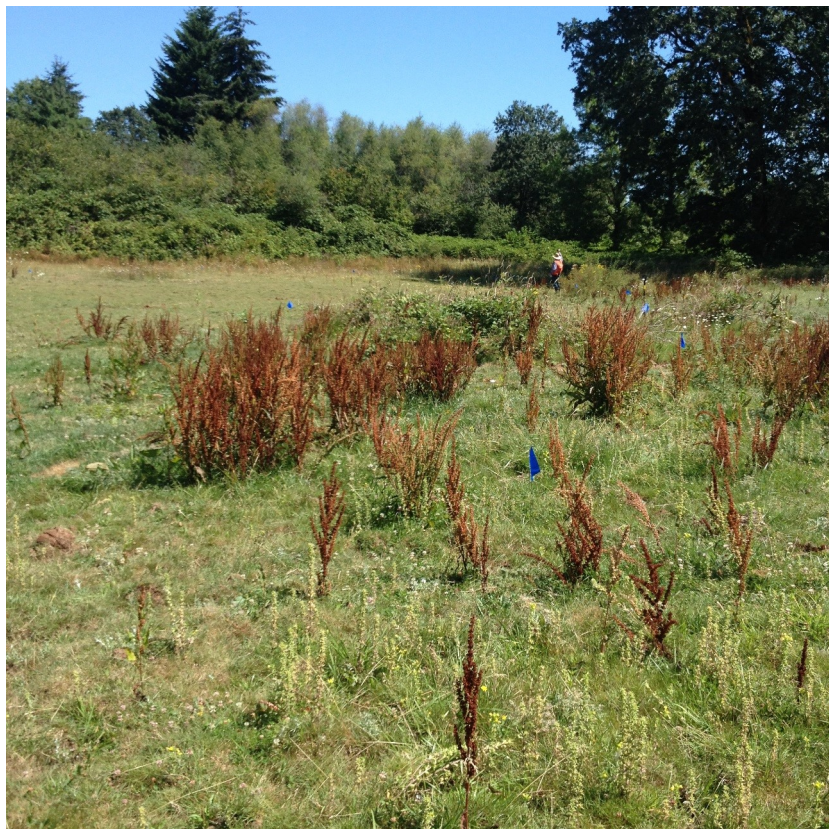
**Photo A:**

Looking north at the Wetland A boundary.

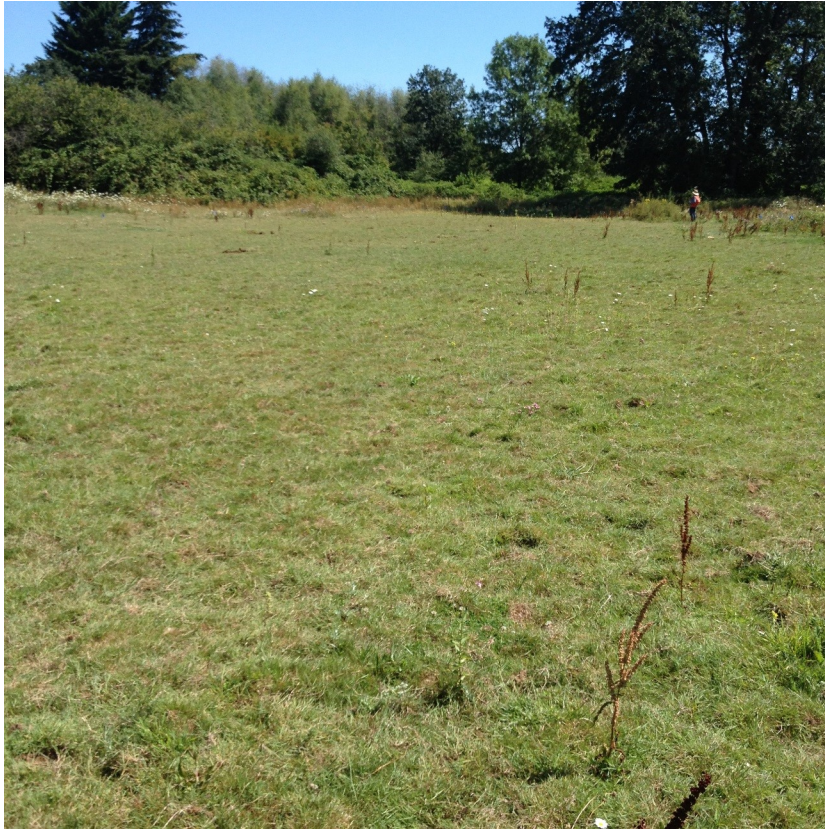
**Photo C:**

Looking northeast at Wetland A.

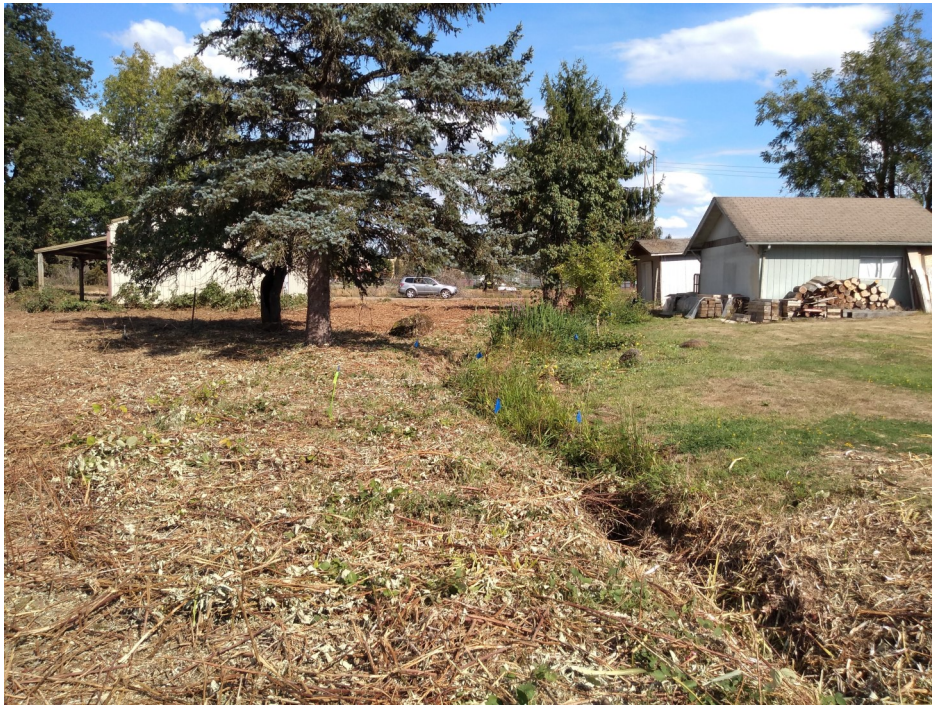
**Photo E:**

Looking east at Caufield Creek  
and sample point 6.

The creek is somewhat incised, and the banks, though steep, appear to be stable. Sample point 6 characterizes the riparian area along the upland banks of Caufield Creek, and includes Himalayan blackberry, colonial bentgrass (*Agrostis capillaris*, FAC), velvet grass, and one large ornamental blue spruce (*Picea pungens*, FAC). No hydrology or hydric soils were present.

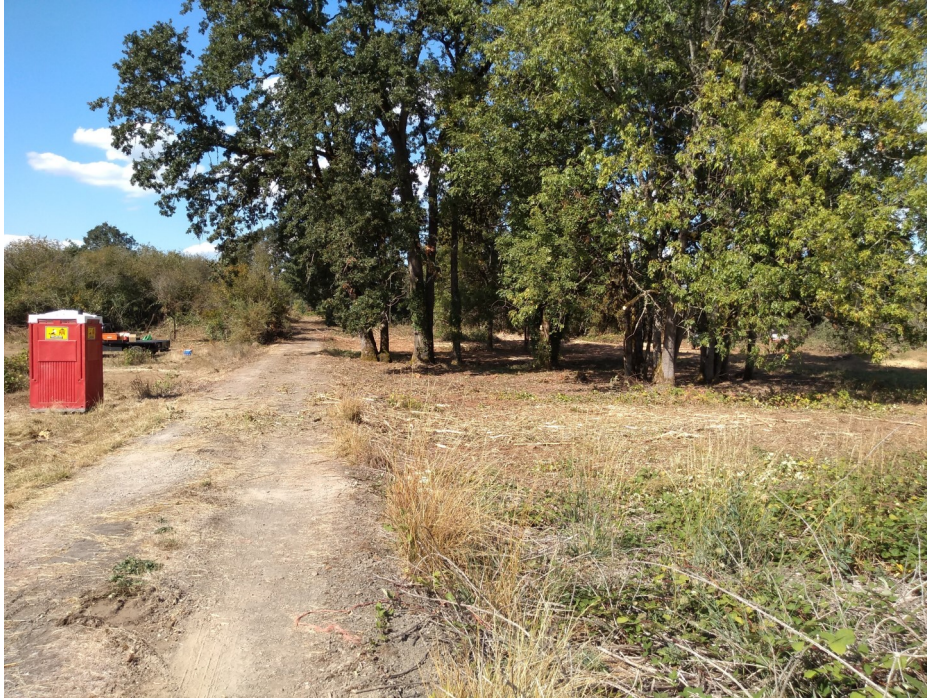
**Photo G:**

Looking north at an existing road and trees in an upland area.
