National Register of Historic Places Registration Form

historic name Buena Vista Social Clubhouse

street & number 1601 Jackson Street

city or town Oregon City

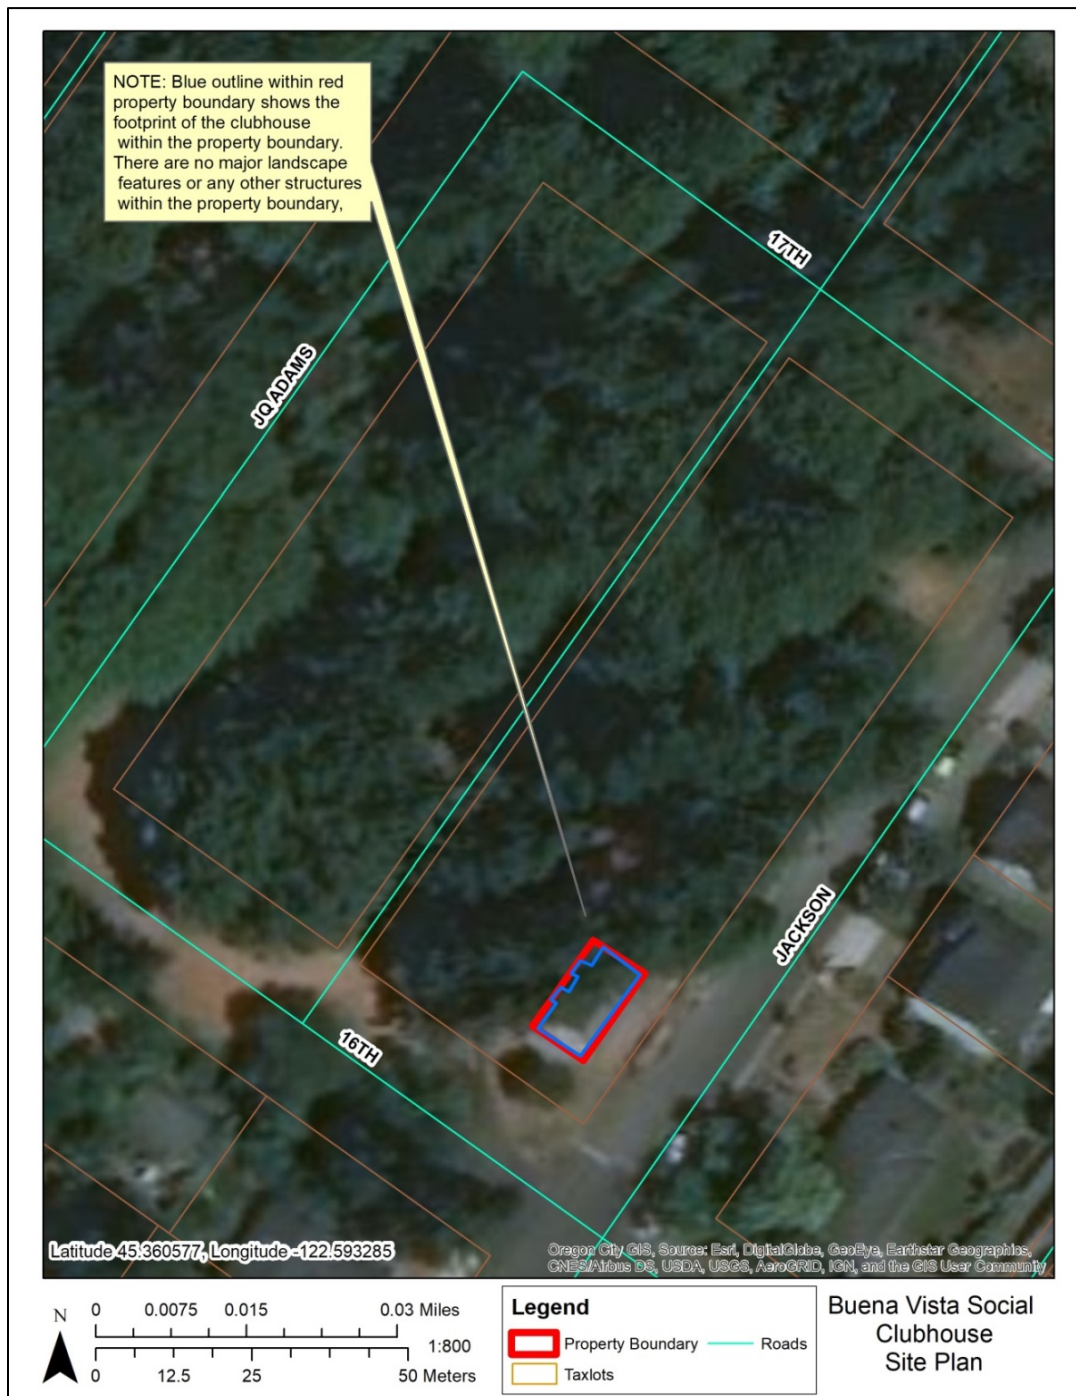
Figure 4: Site Plan. Property located in southern portion of tax lot 2-2E-29CD-03000.

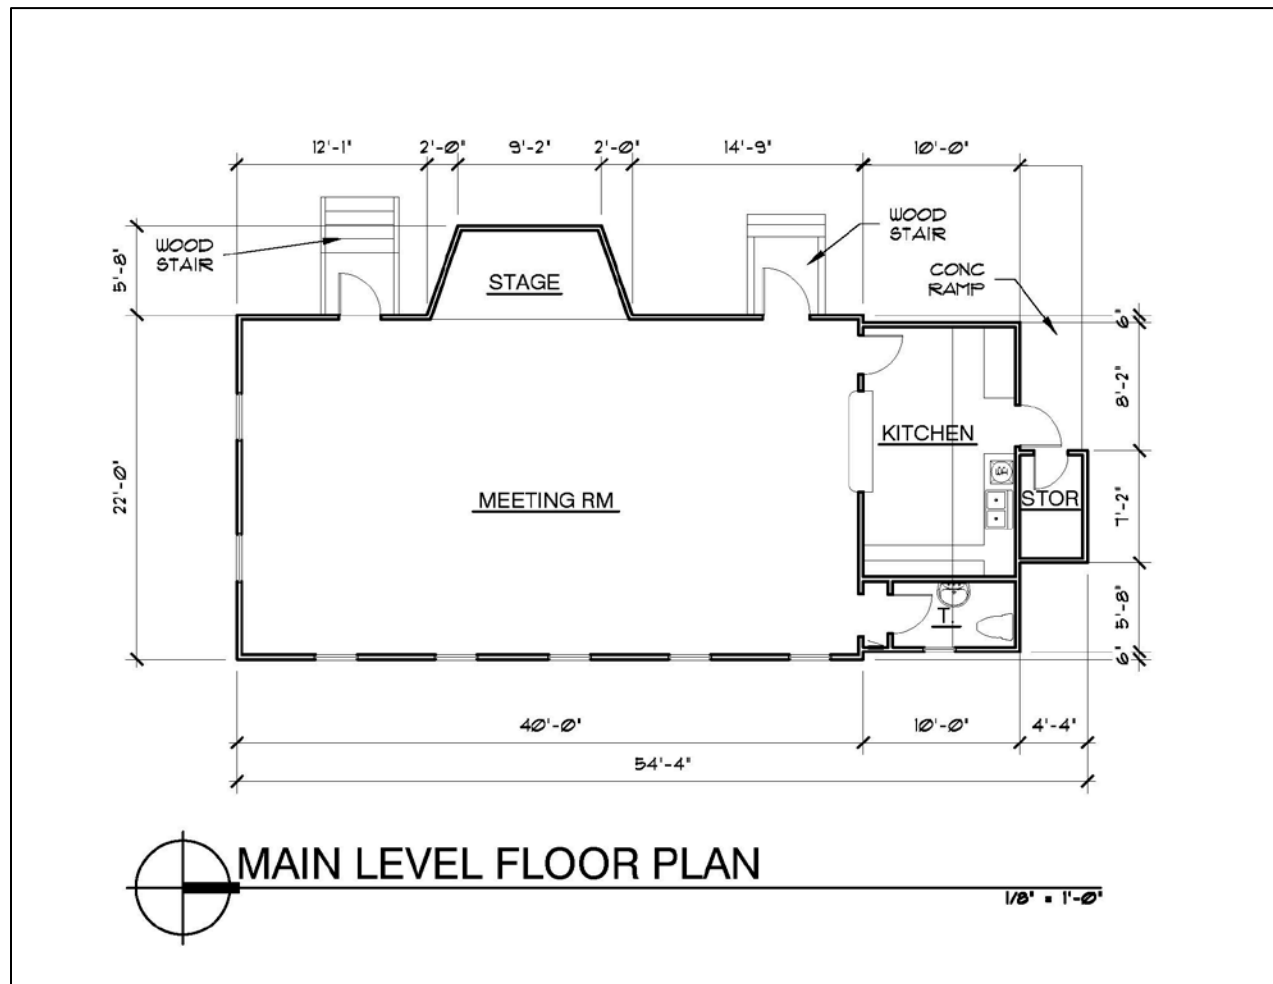
Figure 5: Floor Plan, Created by Todd Iselin

The interior consists of a large, open meeting space, a stage, a kitchen, and a small bathroom. The open meeting space exhibits interior plaster, oak flooring, and simple wood base molding. A 1930 article states that after the building was moved a partition was removed from the interior, which is evidenced by a shadow line across the floor adjacent to where the building was divided. In addition, the article states that the kitchen would "remain as is", indicating the configuration of the kitchen is likely the same as it was before the building was moved (*Banner Courier* Mar. 17, 1930).

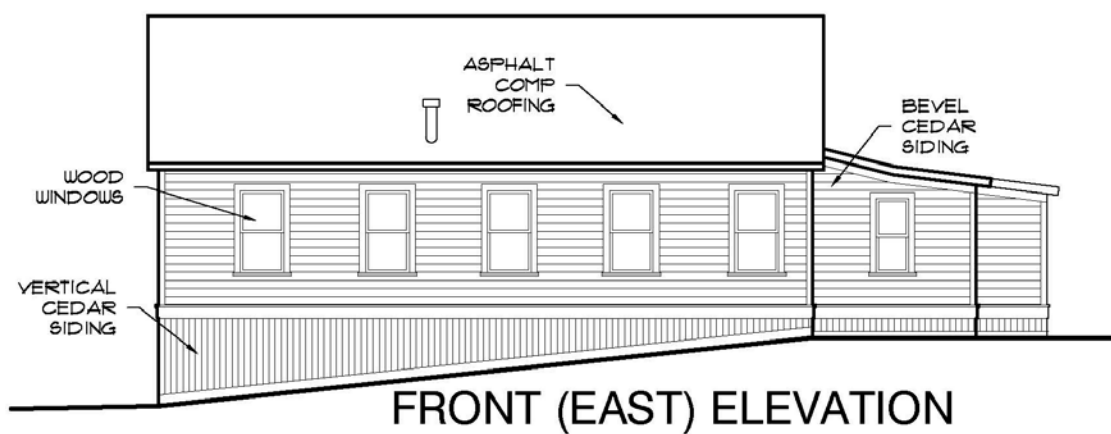
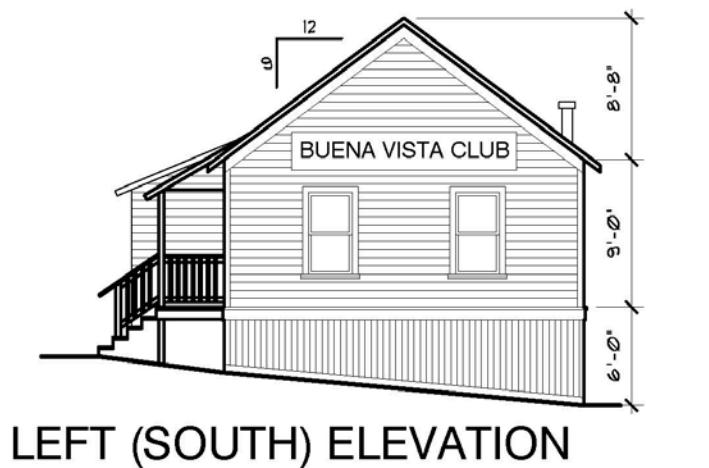
Figure 7: Elevation Drawings, Created by Todd Iselin

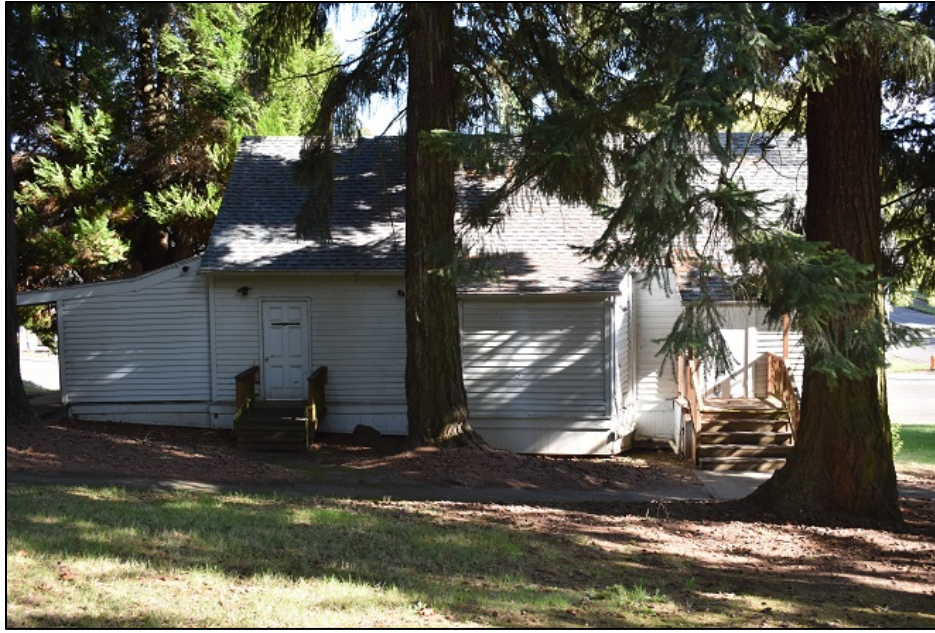
Photo 5 of 15: OR_ClackamasCounty_BuenaVistaSocialClubhouse_0005
Exterior view facing southeast towards northwest elevation.

The façade faces northwest with three bays. The façade contains (from south to north) the primary entry door, which is a replacement single-leaf steel door (ca. 1960), the projecting shed roof that covers the exterior-projecting stage, and a secondary entrance door that appears original from ca. 1930 and has six wood panels. Both entry doors are accessed via ca. 2000 wood stairs and the primary entrance has a shed roof extension with replacement vertical wood posts (ca. 2000). The replacement of the primary door and replacement of the original entry stairs are the only known alterations on the façade.
