National Register of Historic Places Registration Form

historic name Buena Vista Social Clubhouse

street & number 1601 Jackson Street

city or town Oregon City

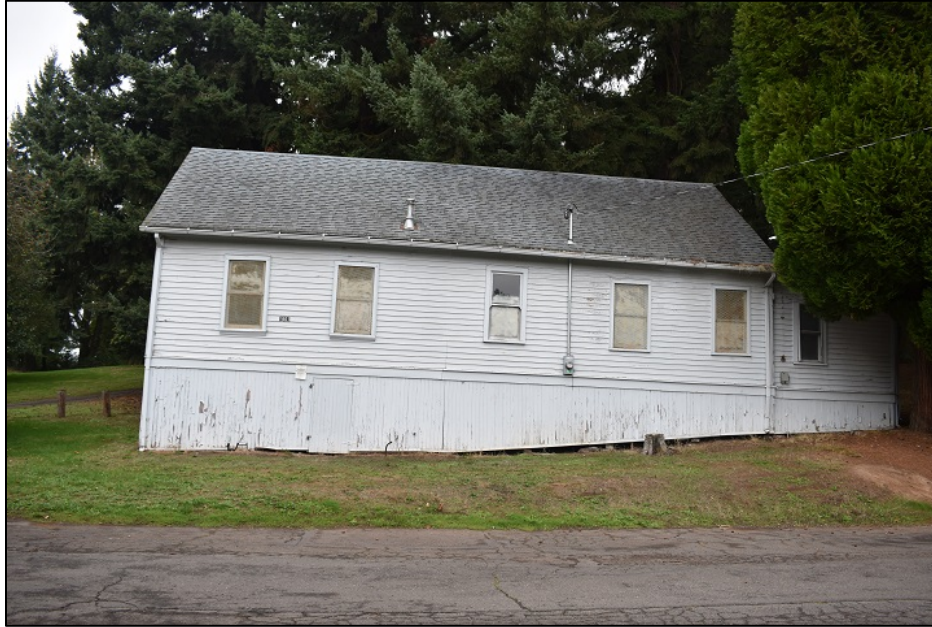
Photo 1 of 15: OR_ClackamasCounty_BuenaVistaSocialClubhouse_0001
Exterior view facing northwest towards southeast elevation.

The southeast elevation contains six bays and six one-over-one sash windows. One window is original to ca. 1896 (center window) and retains lambs tongue molding, see additional documentation for a picture of this window, as well as the entire exterior and interior. The two windows to the left and right of the center window were replaced ca. 1930 based on material, design, and joinery, and are one-over-one wood sash. These windows are located within the original ca. 1896 window frames and the original pulley mechanism and weight pocket are visible. The last window on the southeast elevation is located at the building's east corner and is a vinyl sash window that was replaced ca. 2000. This is the only window on the building that has been replaced since ca. 1930 and has frosted privacy glass. This elevation also features a metal vent pipe associated with the HVAC system as well as the vertical board skirting along the foundation. A gas meter is attached to the building below the vent pipe.

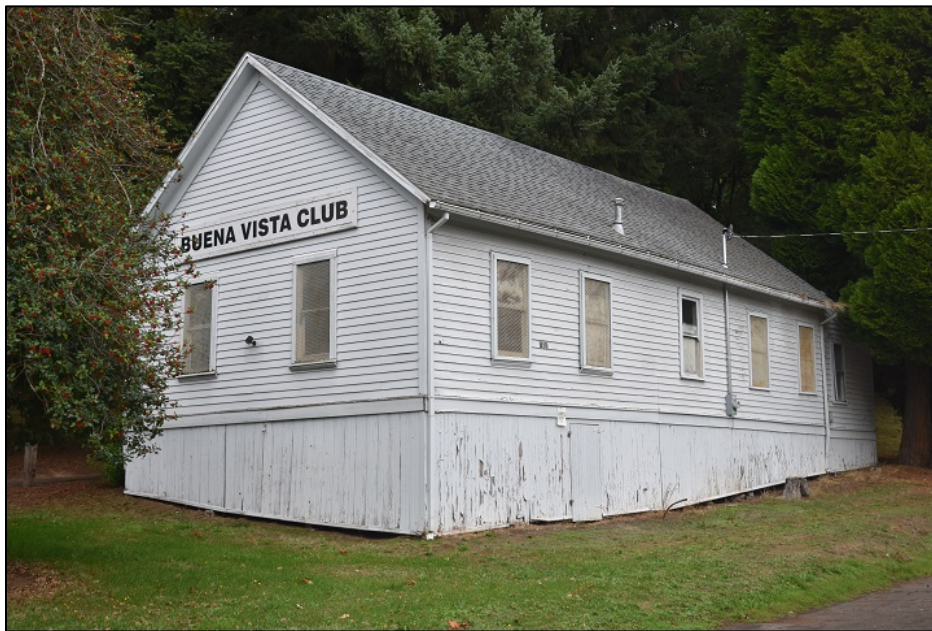
Photo 2 of 15: OR_ClackamasCounty_BuenaVistaSocialClubhouse_0002
Exterior view facing north towards southwest (left) and southeast (right) elevations.

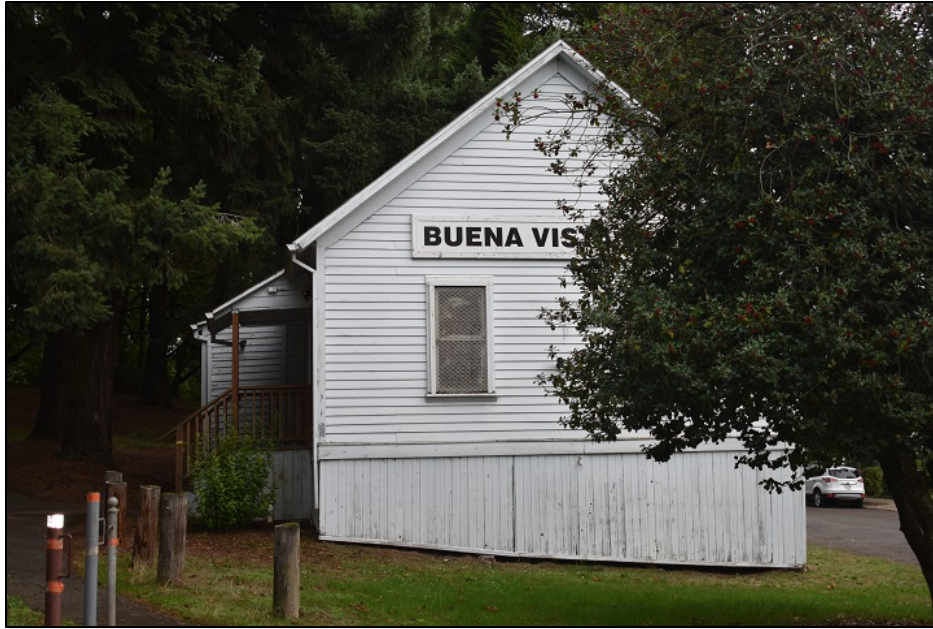
Photo 3 of 15: OR_ClackamasCounty_BuenaVistaSocialClubhouse_0003
Exterior view facing northeast towards southwest elevation.

The southwest elevation contains two bays and two one-over-one, wood-sash windows. Both windows date to ca. 1930 and are located within the original ca. 1896 wood frames. The wood skirting is prominent on this elevation as well. A wood sign that reads "Buena Vista Club" is also located on this elevation and is painted white with black letters. This is not the original sign for the building, and it could be removed.

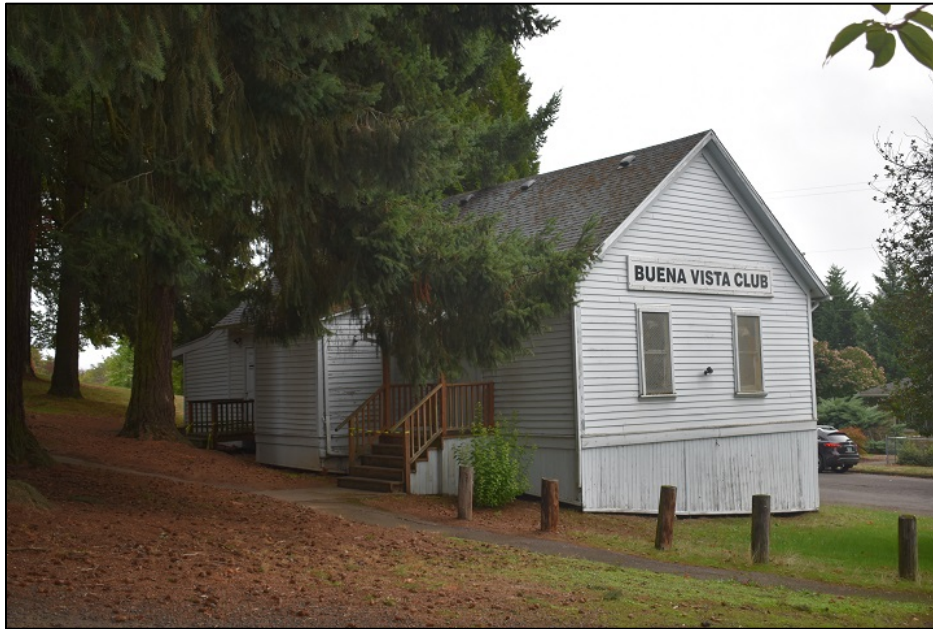
Photo 4 of 15: OR_ClackamasCounty_BuenaVistaSocialClubhouse_0004
Exterior view facing east-northeast towards northwest (left) and southwest (right) elevations.

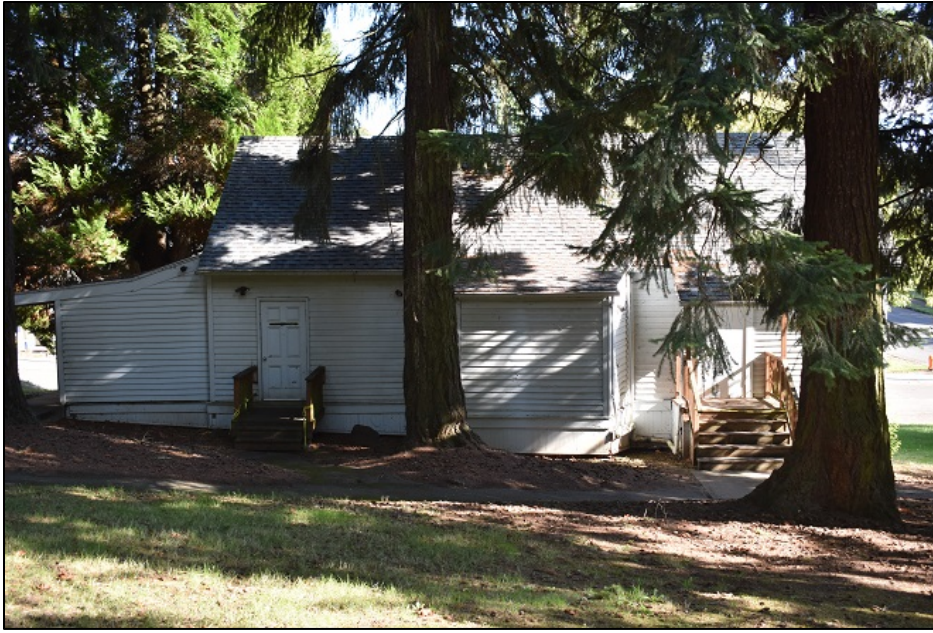
Photo 5 of 15: OR_ClackamasCounty_BuenaVistaSocialClubhouse_0005
Exterior view facing southeast towards northwest elevation.

The façade faces northwest with three bays. The façade contains (from south to north) the primary entry door, which is a replacement single-leaf steel door (ca. 1960), the projecting shed roof that covers the exterior-projecting stage, and a secondary entrance door that appears original from ca. 1930 and has six wood panels. Both entry doors are accessed via ca. 2000 wood stairs and the primary entrance has a shed roof extension with replacement vertical wood posts (ca. 2000). The replacement of the primary door and replacement of the original entry stairs are the only known alterations on the façade.

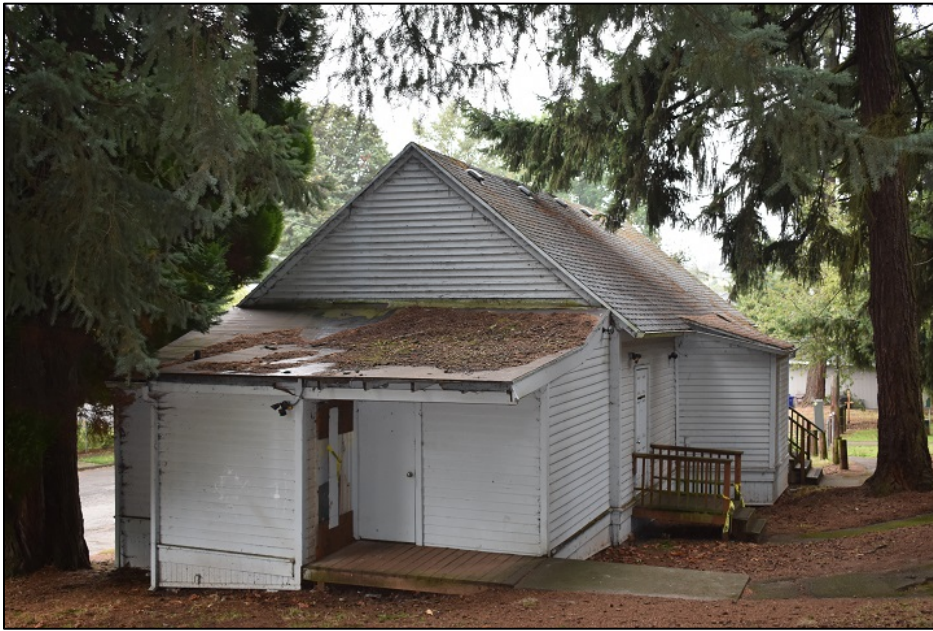
Photo 6 of 15: OR_ClackamasCounty_BuenaVistaSocialClubhouse_0006
Exterior view facing south towards northeast (left) and northwest (right) elevations.

The northeast elevation has two bays and contains the rear kitchen, restroom, and Americans with Disabilities Act (ADA) entry ramp. The concrete that leads up to the ramp likely dates to ca. 1950-1960, and the low ramp dates to the replacement of the entry stoop (ca. 2000). There are two doors located on this elevation. One door, which dates to ca. 1960, leads from the entry stoop to the kitchen. The second door leads to a storage closet accessible from the building exterior. Due to vandalism, the storage door is boarded and it is believed that the door beneath likely dates to ca. 1930-1960. As mentioned above, this elevation was likely the original façade until ca. 1920. Most of the material on this elevation dates to ca. 1930 and earlier except for the one ca. 1960 replacement door and ca. 2000 wood entry stoop. The roof covering the shed roof projection is clad in tar paper and some wood rafters are exposed.

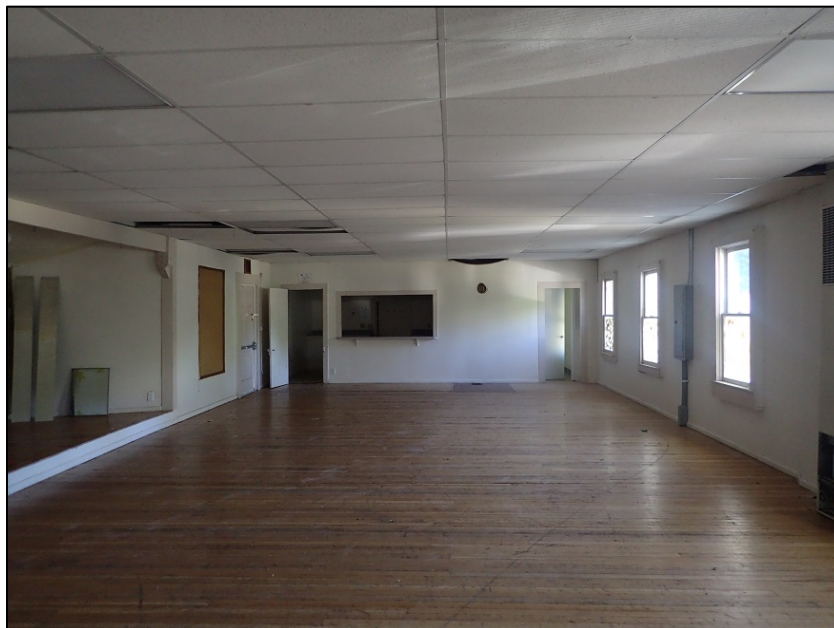
Photo 8 of 15: OR_ClackamasCounty_BuenaVistaSocialClubhouse_0008
Interior of meeting room, view facing northeast towards northeast elevation.

The interior consists of a large, open meeting space, a stage, a kitchen, and a small bathroom. The open meeting space exhibits interior plaster, oak flooring, and simple wood base molding. A 1930 article states that after the building was moved a partition was removed from the interior, which is evidenced by a shadow line across the floor adjacent to where the building was divided. In addition, the article states that the kitchen would "remain as is", indicating the configuration of the kitchen is likely the same as it was before the building was moved (*Banner Courier* Mar. 17, 1930).

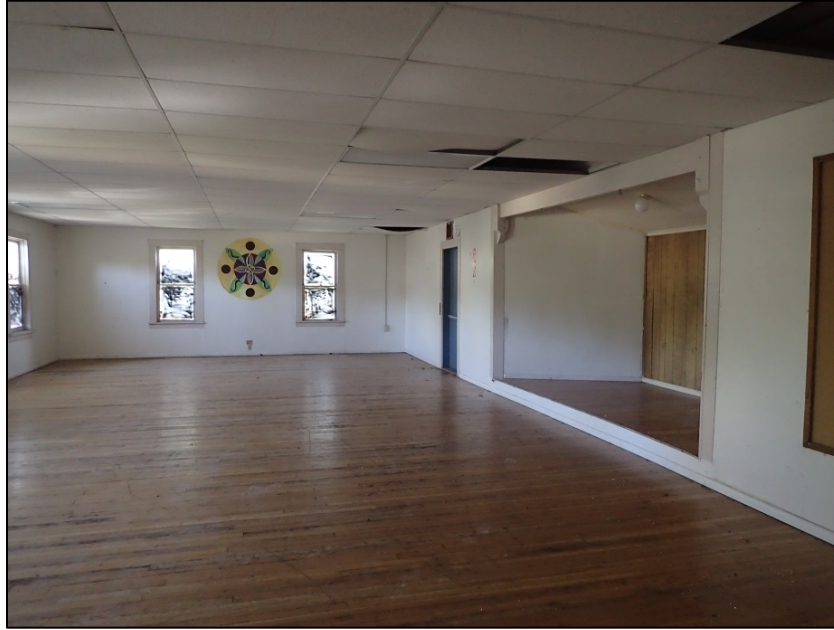
Photo 9 of 15: OR_ClackamasCounty_BuenaVistaSocialClubhouse_0009
Interior of meeting room, view facing west towards southwest elevation.

stage ca. 1950-60. The birch wood paneling has a glossy finish. A small mural, depicting geographic and natural forms, is was painted on the interior of the southwest wall at an unknown time. A cork board is located along the northwest wall between the stage and the entrance to the kitchen.

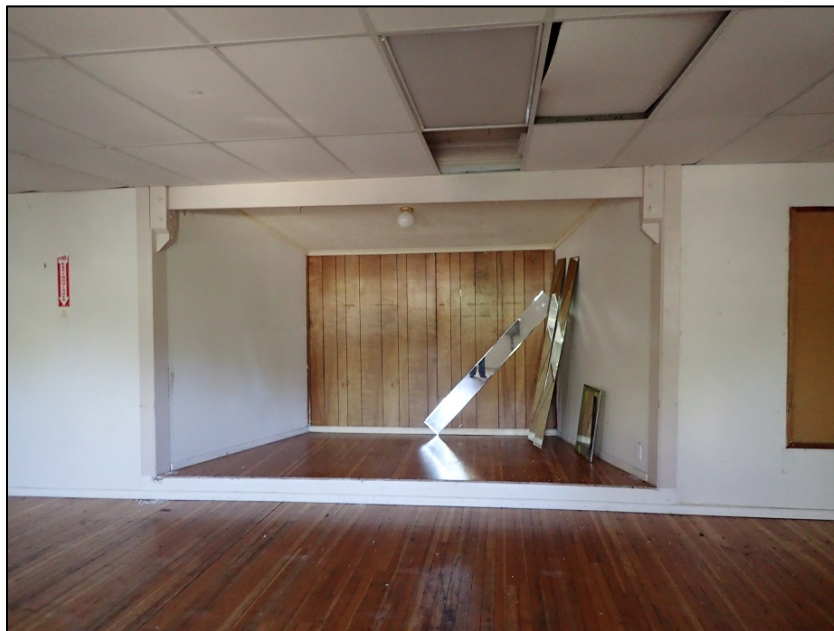
Photo 10 of 15: OR_ClackamasCounty_BuenaVistaSocialClubhouse_0010
Interior of meeting room, view facing northwest towards northwest elevation.

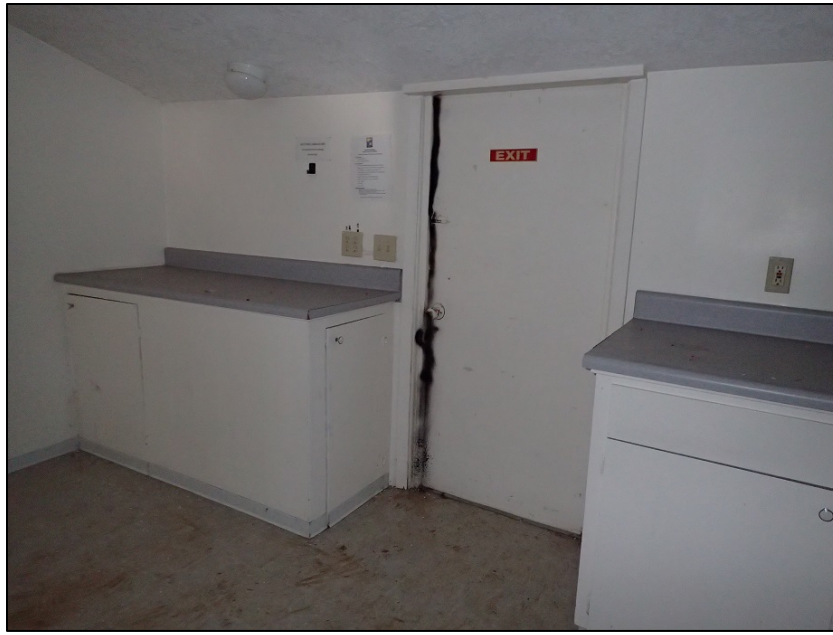
Photo 11 of 15: OR_ClackamasCounty_BuenaVistaSocialClubhouse_0011
Interior of kitchen, view facing north towards northeast elevation.

The door leading from the meeting space to the kitchen may date to ca. 1896 as it is the oldest apparent door and likely was the original main door before the porch was modified to add the kitchen. The wood door has four panels and is void of hardware. The kitchen includes a pass-through window connecting the meeting space with the kitchen that was added ca. 1930. The pass-through features a small counter supported by wood brackets. The kitchen floor linoleum likely dates to ca. 1980 based on the design and the cabinets date to ca. 1920. The wood cabinets have simple ceramic knobs and beveled crown molding. The counters and sink were replaced ca. 1960 and the sink hardware likely dates to ca. 1980-90. Lighting in the kitchen also dates to ca. 1980. The ceiling in the kitchen is sloped towards the northeast elevation. All appliances have been removed; however, a shadow of where the stove and refrigerator once sat is visible on the floor and an original three-prong outlet remains.

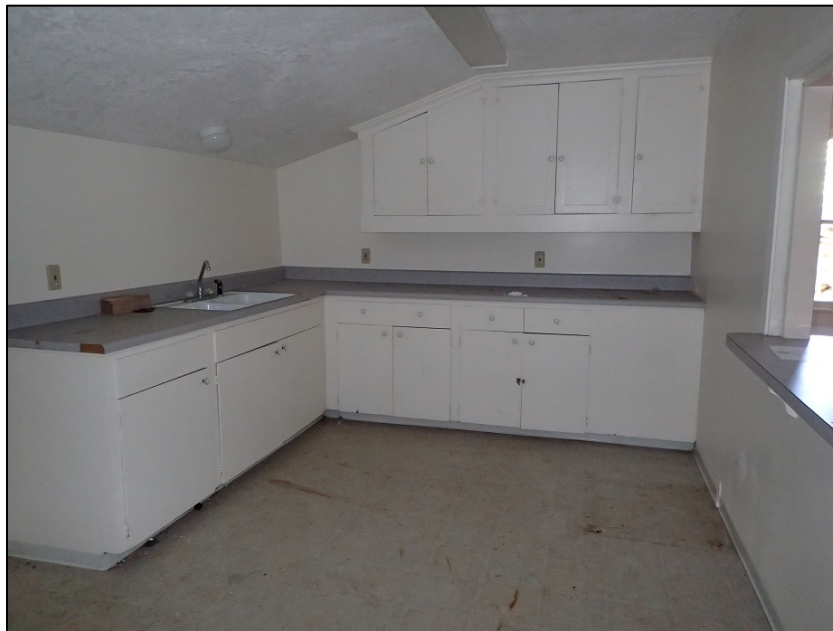
Photo 12 of 15: OR_ClackamasCounty_BuenaVistaSocialClubhouse_0012
Interior of kitchen, view facing east towards southeast elevation.

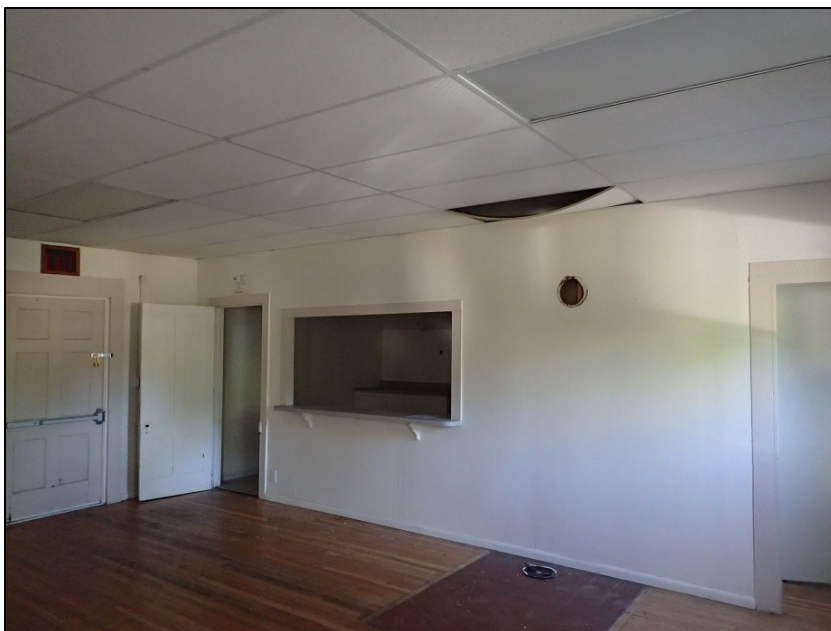
Photo 13 of 15: OR_ClackamasCounty_BuenaVistaSocialClubhouse_0013
Interior of meeting room, view facing north towards northeast elevation.

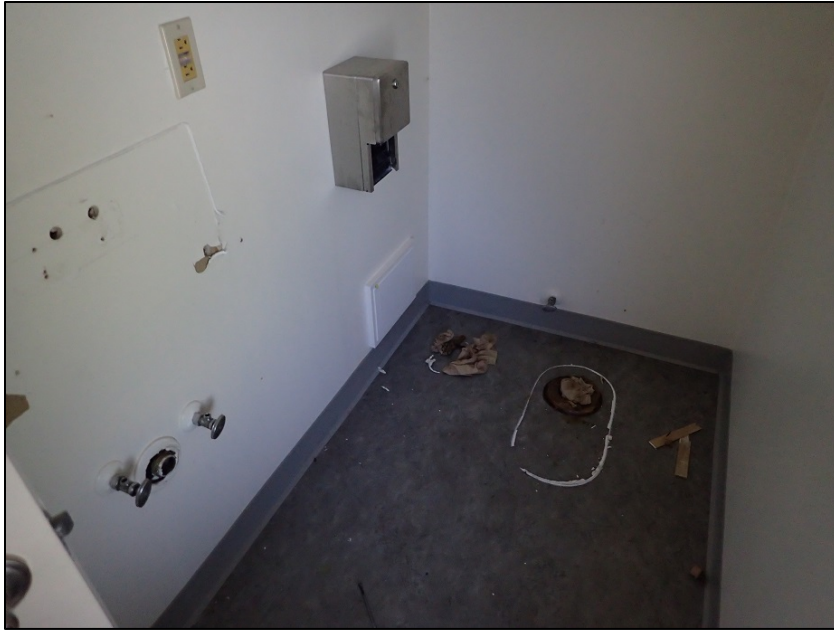
Photo 15 of 15: OR_ClackamasCounty_BuenaVistaSocialClubhouse_0015
Interior of restroom, view facing northwest towards northeast elevation.

A short hallway connects the meeting space with the one restroom in the building. The plaster in the bathroom likely dates to ca. 1930, but the floor was replaced ca. 2000 when the vinyl window was added to the bathroom. There isn't any historic material in the bathroom other than the interior plaster.
