Preliminary Geotechnical Engineering Report

The Cove Garden Apartments
Oregon City, Oregon

GeoPacific Engineering, Inc. Job No. 15-3719
May 12, 2015

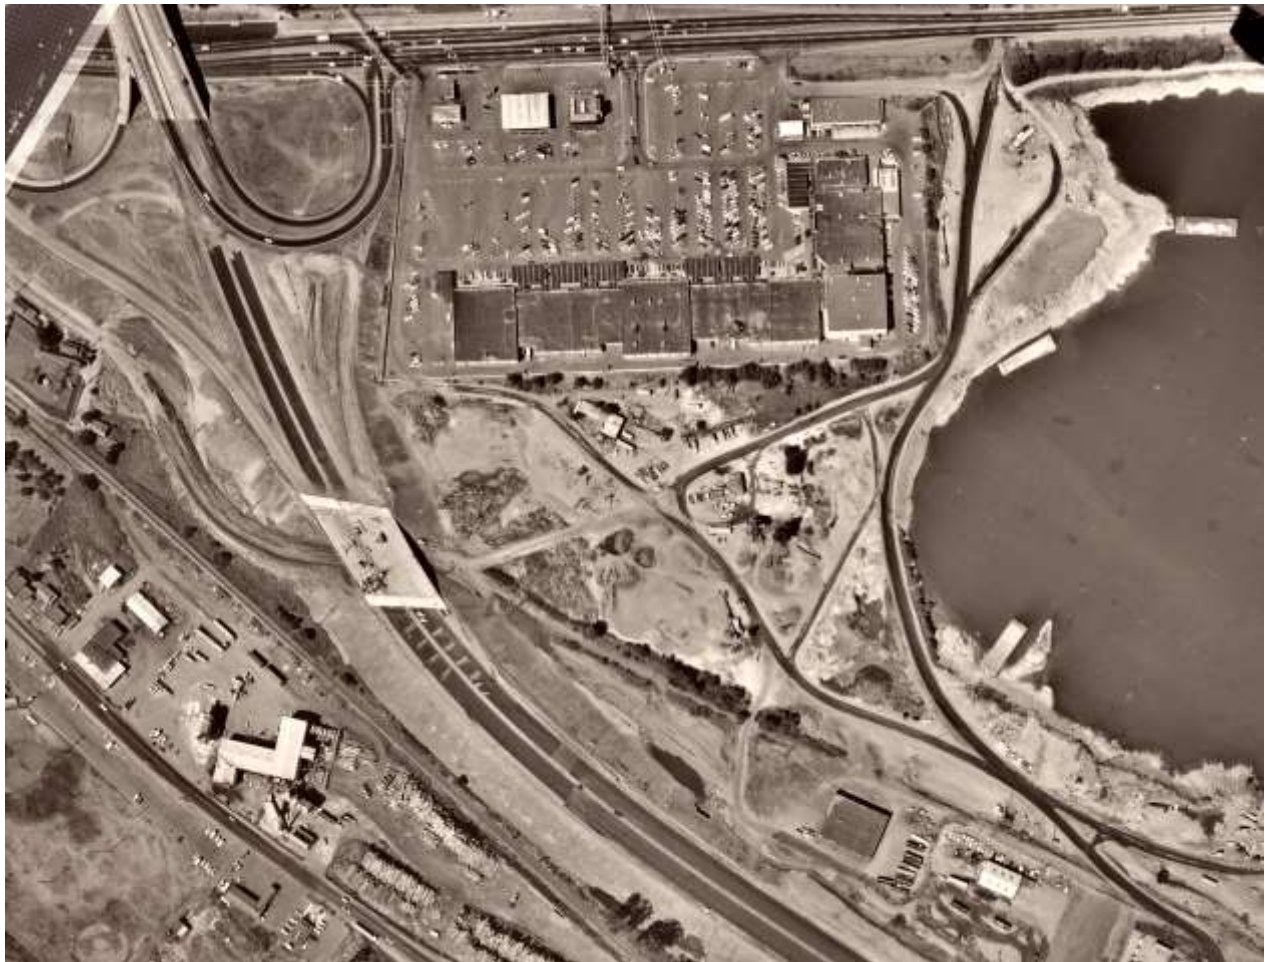
1972, North at Right

The concrete batch plant is in operation at the site and the stockpiles in the southern portion of the site have increased in size, more closely resembling the topography existing today. Several concrete trucks are visible. Main Street has been constructed to its present day location. Construction of I-205 is complete. The northeastern portion of the site appears to contain a conveyor belt and is in the location where extensive layering of random concrete pours was observed during our site investigation. It is likely that the area was used as a disposal location for test batches and reject batches of concrete.

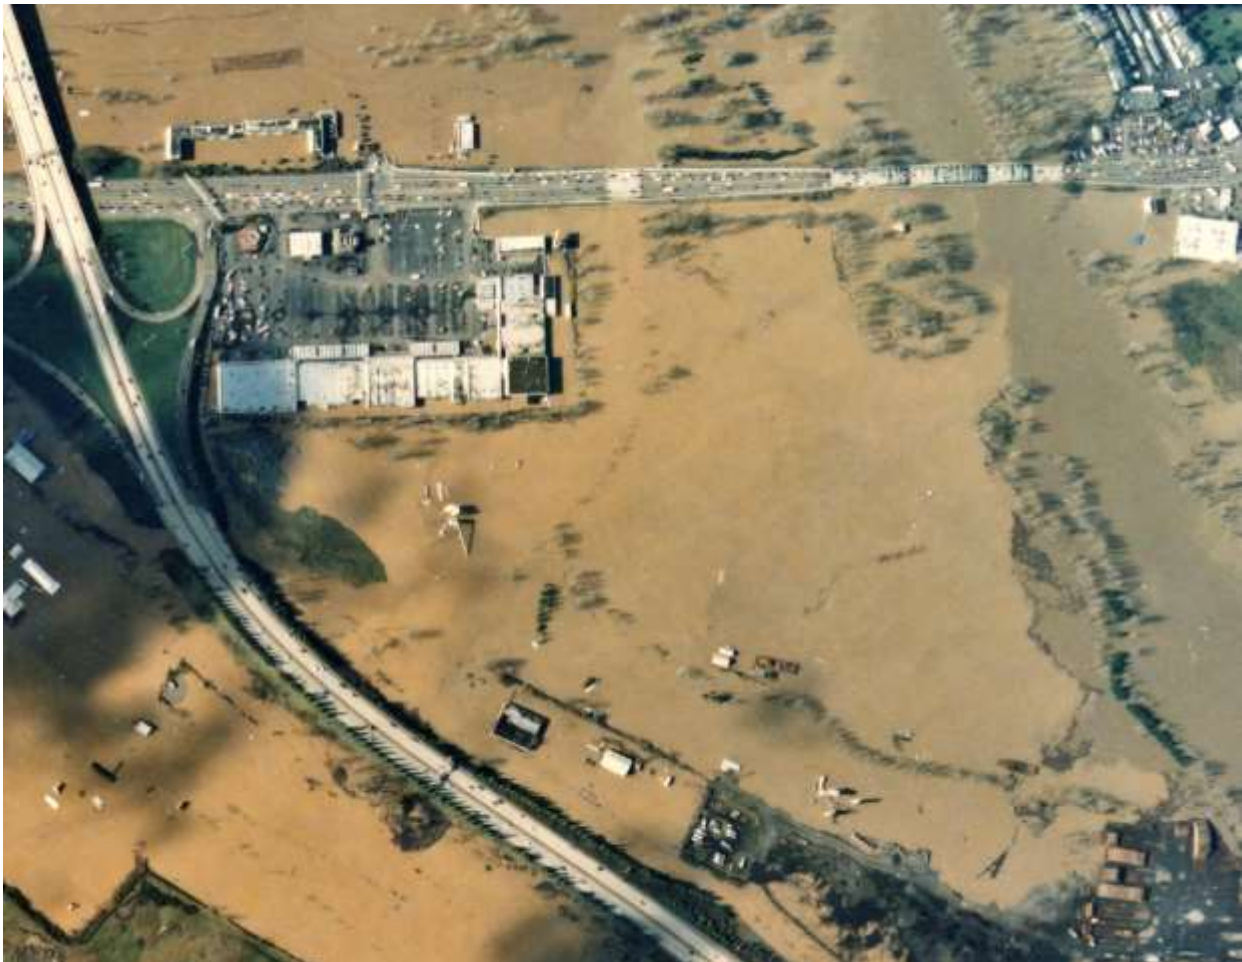
1996, North at Right, During 100-Year Flood Event

The concrete batch plant is still in operation. The southern portion of the site where fine-grained fill soils and remnant crushed aggregate stockpiles were encountered was being used as a parking area. The drive entrances into the batch plant are in the locations we observed during our site investigation. The pond in the northern portion of the site is present.

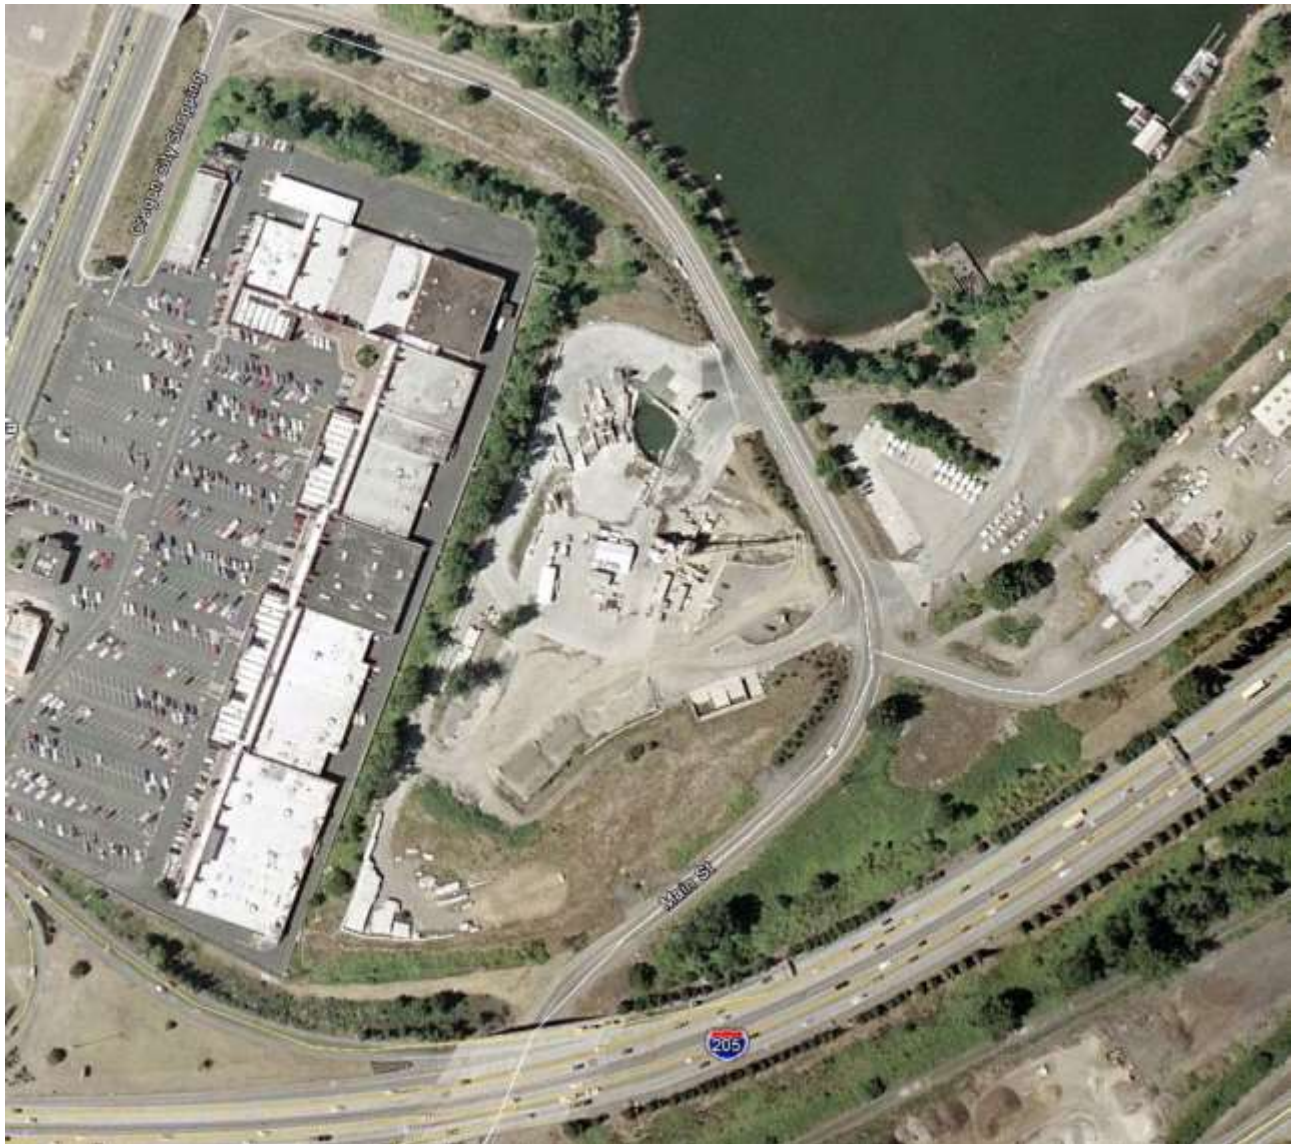
2001, North at Top

The concrete batch plant is gone from the site. The site appears to resemble its current condition.
