## MEMORANDUM

SUBJECT: Molalla Avenue & Pearl Street Intersection Review

We visited the site on April 25, 2019 @ 9am to review and observe the intersection. Additionally, we drove through the intersection and observed the visibility of pedestrians within the intersection.

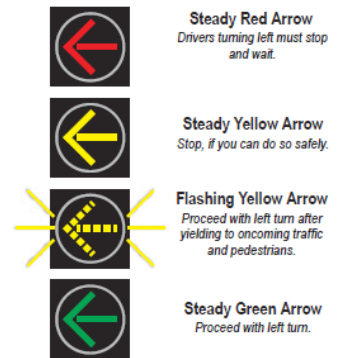
- This would resolve the visibility issue with northbound left turns & the conflict with visibility of pedestrians on the west side of Molalla Avenue crossing in a south to north direction, if the left turn is not allowed when the crossing has a pedestrian call.

- The signal would rest in permissive (flashing yellow arrow) which is similar to the current operation of the lane. When a pedestrian activates the crossing of Pearl, the left turn signal on Molalla would switch to Steady Red Arrow, removing the left turn conflict point between pedestrians & vehicles.
