Arborist Report

July 18, 2019

City of Oregon City
Oregon City Swimming Pool
1211 Jackson St.

Ruth Williams
ISA WE-7317-BM
ISA Qualified Tree Risk Assessor

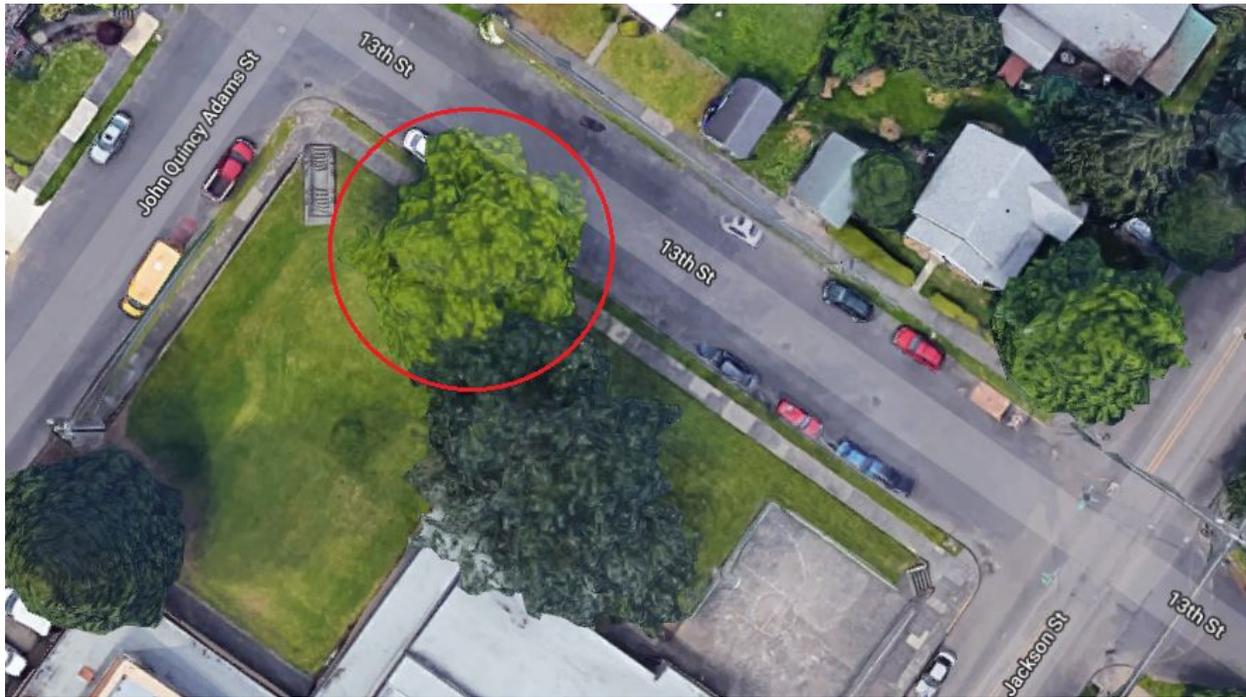
The tree is located the pool facility at 1211 Jackson St., near the intersection of John Quincy Adams St. and 13th St., in Oregon City, Oregon. The tree is on a slope down toward 13th St. The area is not irrigated but has maintained turf. The adjacent public sidewalk, parking lane and road are within the dripline of the tree. The sidewalk has multiple 1" disruptions likely caused by tree roots. The tree trunk is within 4' of the adjacent sidewalk.

Aerial overview illustration of the site and the tree (circled red)
