Type I Site Plan and Design Review

Site Address or Clackamas County Map and Tax Lot: 1211 JACKSON ST. / 2-2E-32BB-06100

Project Description: oak & WALNUT TREE REMOVALS - HAZARD

Arborist Report

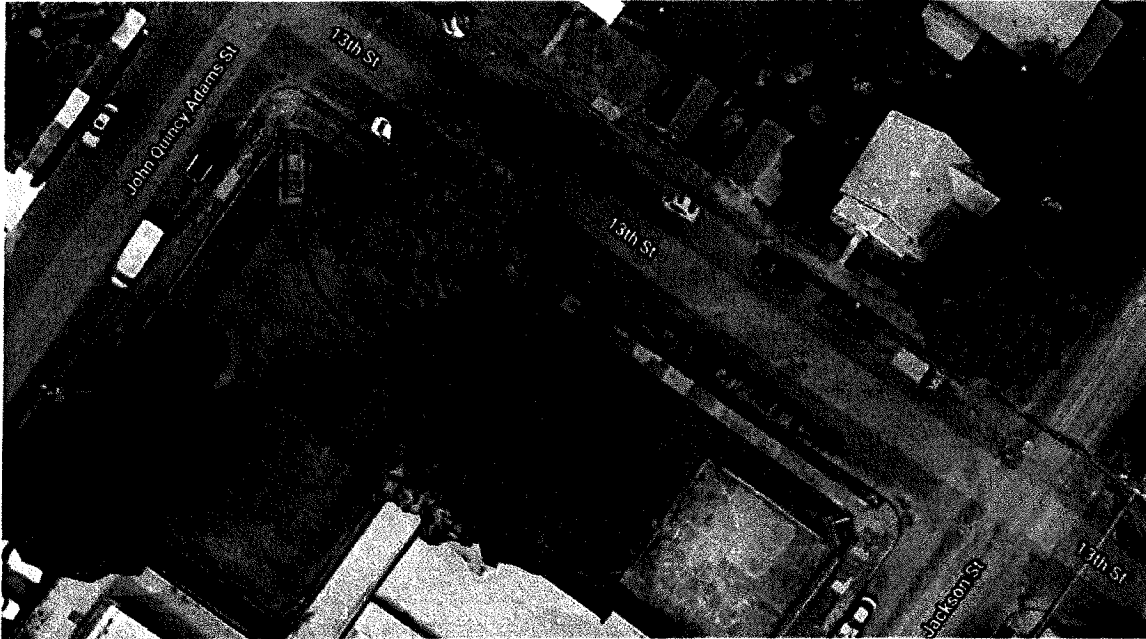
The tree is located the pool facility at 1211 Jackson St., near the intersection of John Quincy Adams St. and 13th St., in Oregon City, Oregon. The tree is on a slope down toward 13th St. The area is not irrigated but has maintained turf. The adjacent public sidewalk, parking lane and road are within the dripline of the tree. The sidewalk has multiple 1" disruptions likely caused by tree roots. The tree trunk is within 4' of the adjacent sidewalk.

Aerial overview illustration of the site and the tree (circled red)

1. Throughout construction, protect trunk with straw waddle to root flare and trunk up to 6' above sidewalk grade.
2. Install tree protection fencing one foot back from the sidewalk and do not allow construction equipment on the soil area to avoid soil compaction. For this case, orange plastic mesh attached at 10' intervals to t-stakes is acceptable.
3. Carefully remove 15' of pavement with pri-bars and hand tools, rather than jackhammers. Heavy equipment is not recommended as it can crack, compact, and break roots, and resulting injury can be sites of infection and promote decay.
4. Root pruning (if necessary) should be conducted by an arborist or with arborist supervision with a sharp saw and at an angle that minimizes wound size.

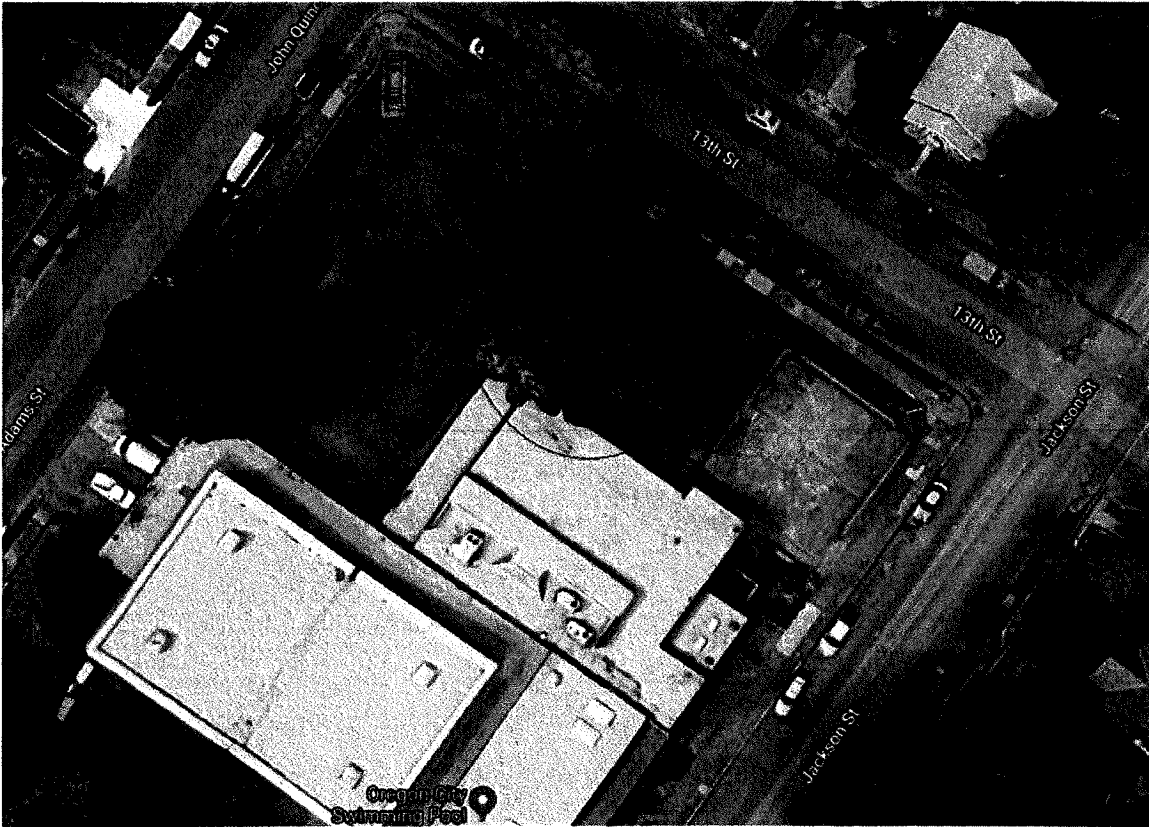
The tree is located in front of 1211 Jackson St., near the intersection of 13th Ave., in Oregon City, Oregon. The tree is on level ground near a slope down toward 13th St. The area is not irrigated but has maintained turf. The adjacent building, access sidewalk, and public sidewalk are within the dripline of the tree. An adjacent classroom hosts a children's play area, and the kids are sometimes out on the lawn area for activities. The target areas are occupied occasionally (lawn) to frequently (building).

Aerial overview illustration of the site and the tree (circled red)
