Type I Site Plan and Design Review
Office/Mixed Use/Commercial/Multi-Family/Industrial Uses

File Number: SP 19-00065 Reviewed By: [Signature] Date: 8.30.19

Project Description: OAK & WALNUT TREE REMOVALS - HAZARD
replacing sidewalks - DAMAGED

Arborist Report

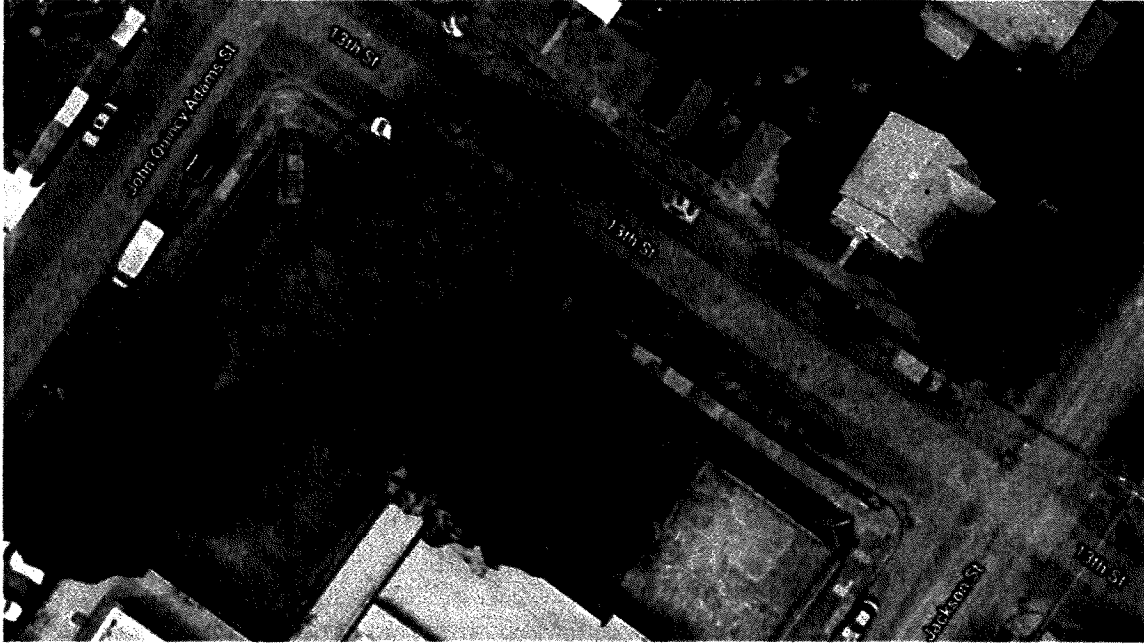
The tree is located the pool facility at 1211 Jackson St., near the intersection of John Quincy Adams St. and 13th St., in Oregon City, Oregon. The tree is on a slope down toward 13th St. The area is not irrigated but has maintained turf. The adjacent public sidewalk, parking lane and road are within the dripline of the tree. The sidewalk has multiple 1" disruptions likely caused by tree roots. The tree trunk is within 4' of the adjacent sidewalk.

Aerial overview illustration of the site and the tree (circled red)

1. Throughout construction, protect trunk with straw waddle to root flare and trunk up to 6' above sidewalk grade.
2. Install tree protection fencing one foot back from the sidewalk and do not allow construction equipment on the soil area to avoid soil compaction. For this case, orange plastic mesh attached at 10' intervals to t-stakes is acceptable.
3. Carefully remove 15' of pavement with pri-bars and hand tools, rather than jackhammers. Heavy equipment is not recommended as it can crack, compact, and break roots, and resulting injury can be sites of infection and promote decay.
4. Root pruning (if necessary) should be conducted by an arborist or with arborist supervision with a sharp saw and at an angle that minimizes wound size.

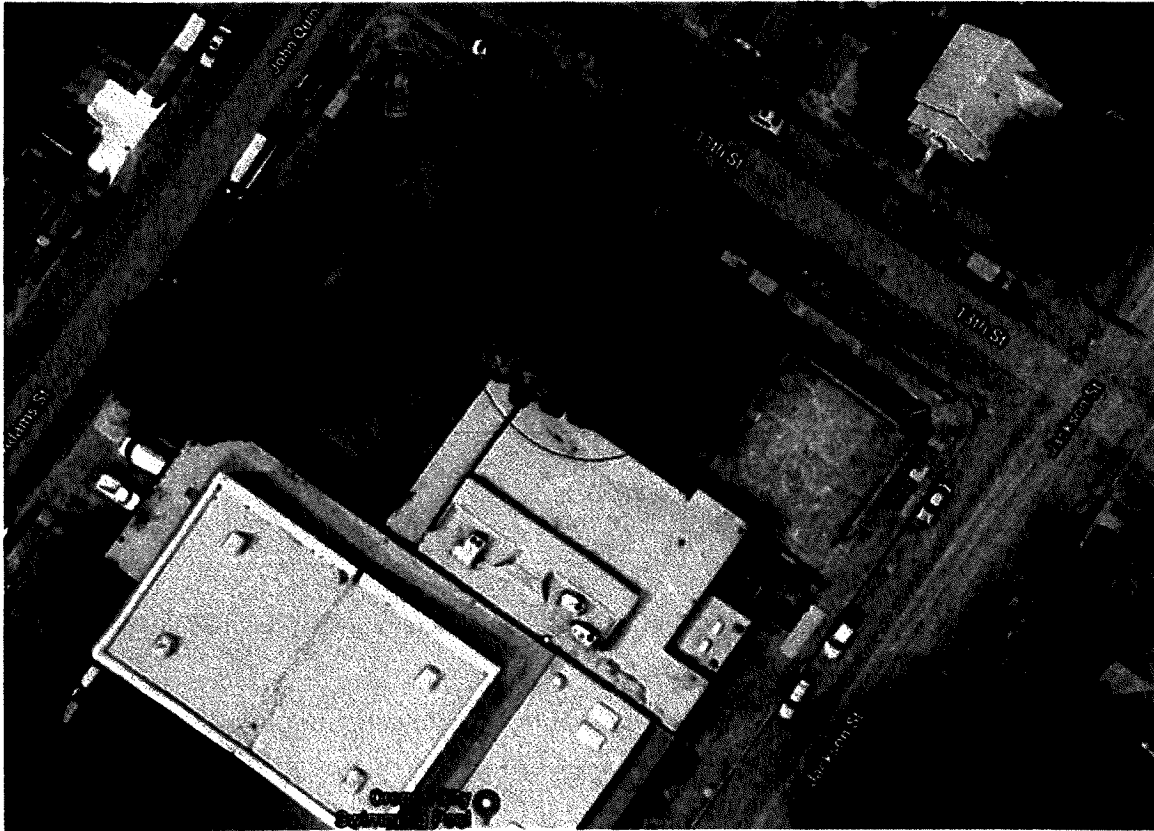
The tree is located in front of 1211 Jackson St., near the intersection of 13th Ave., in Oregon City, Oregon. The tree is on level ground near a slope down toward 13th St. The area is not irrigated but has maintained turf. The adjacent building, access sidewalk, and public sidewalk are within the dripline of the tree. An adjacent classroom hosts a children's play area, and the kids are sometimes out on the lawn area for activities. The target areas are occupied occasionally (lawn) to frequently (building).

Aerial overview illustration of the site and the tree (circled red)
