March 12, 2019

RJL Holdings, LLC  
14155 Beavercreek Road  
Oregon City, OR 97045

**Supplemental Report of Geotechnical Engineering Services**  
**Geologic Hazards Development Permit**  
Forest Edge Apartments  
Oregon City, Oregon  
GeoDesign Project: RJLHold-1-01

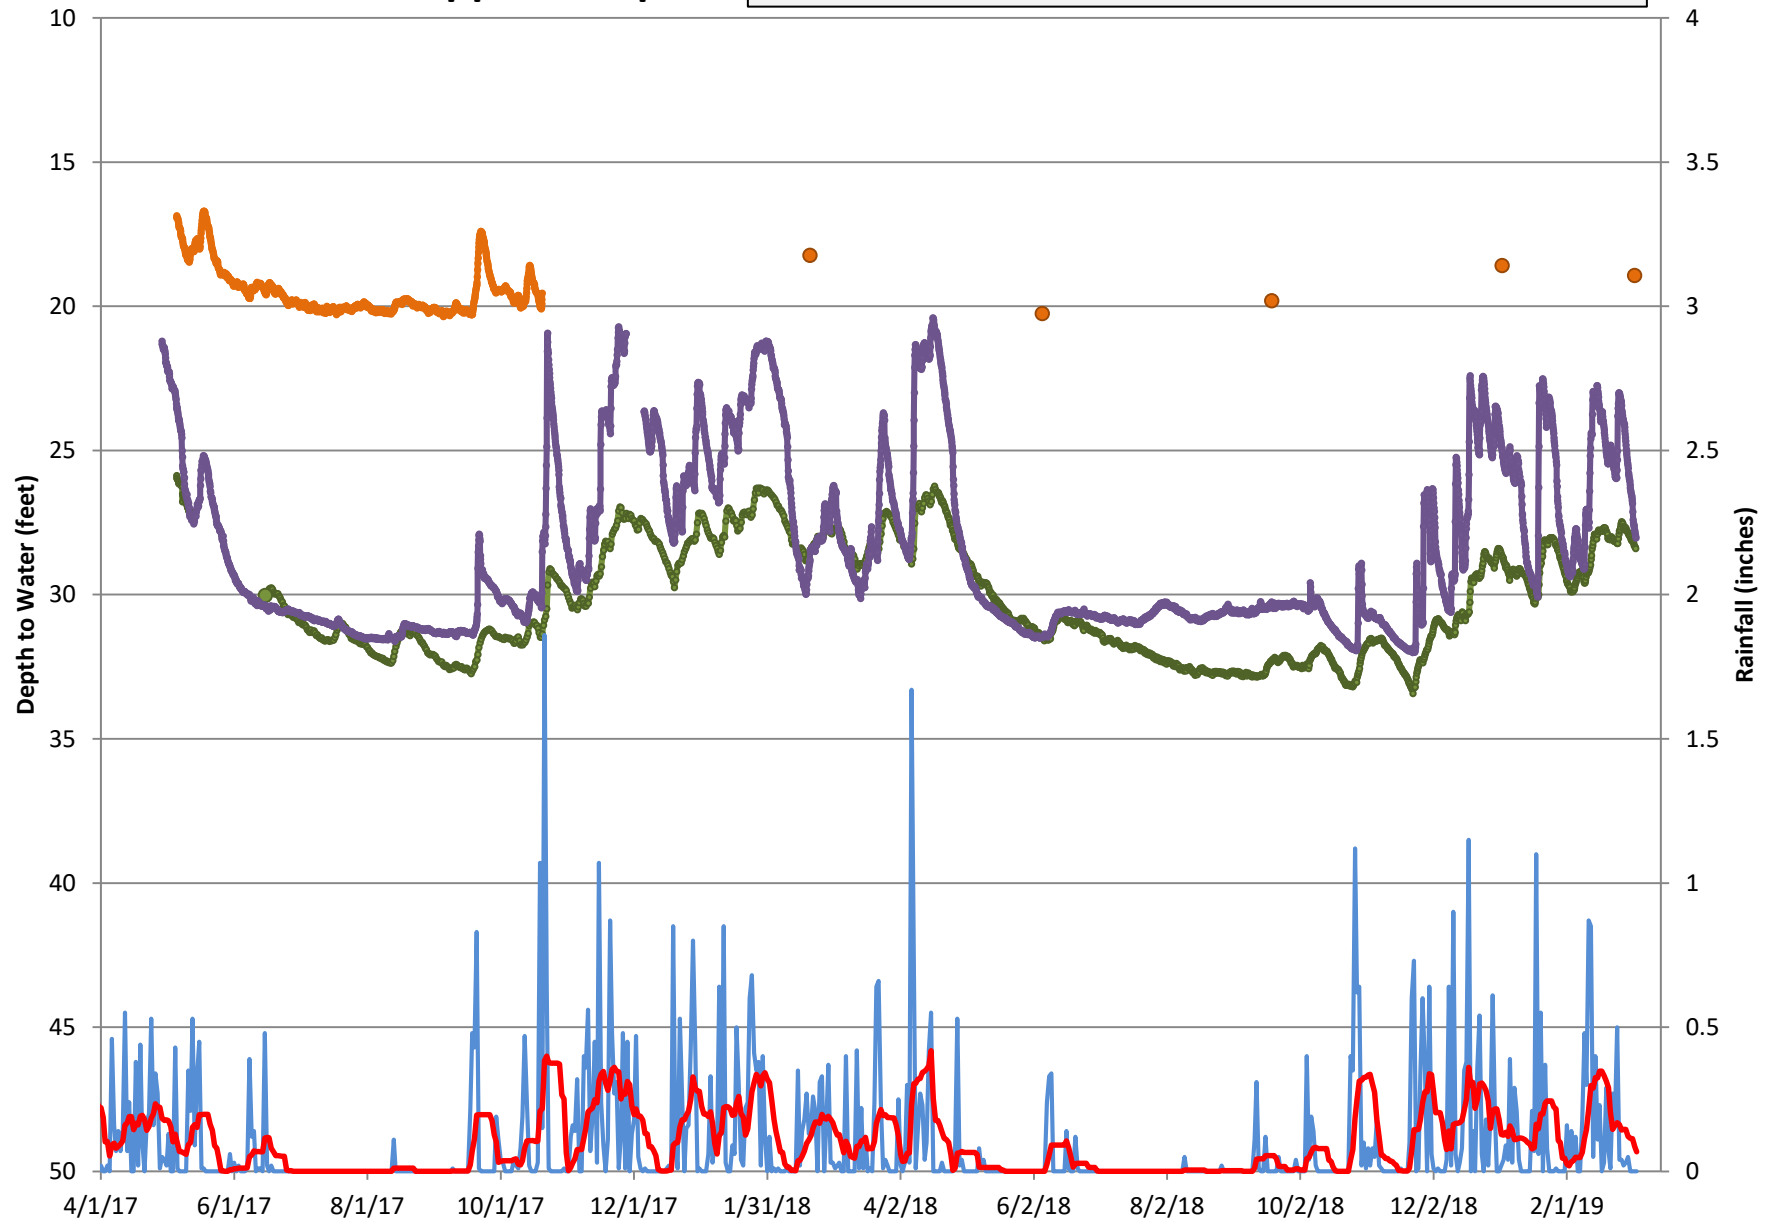
## Water Levels - Upper Campus

Since the spring of 2017 GeoDesign has monitored water levels in a variety of piezometers. The preliminary dewatering system was fully activated in March 2018, and water levels significantly dropped throughout the Lower Campus compared to levels recorded prior to installing the system. We provide updated piezometer data plots in the Attachment of this supplemental report, representing data collected from early April 2017 until our last monitoring event (March 4, 2019). The data show that during the 2018-2019 wet season, water levels have been mostly maintained below the lowest levels observed during the very dry 2017 summer. Water levels are currently 10 to 30 feet lower than observed during the 2017-2018 wet season prior to operation of the dewatering system. Rainfall has been comparable to the last wet season, indicating the dewatering system is the primary cause for lowered groundwater.
