Drainage Report
Marquis Oregon City Parking Lot Expansion
Oregon City, Oregon 97045
(TL 00301, Tax Map 3S-2E-05C)

Emerio Project Number: 086-020
City of Oregon City Permit Numbers: TBD
Date: 01/24/2018

Project Overview and Description:

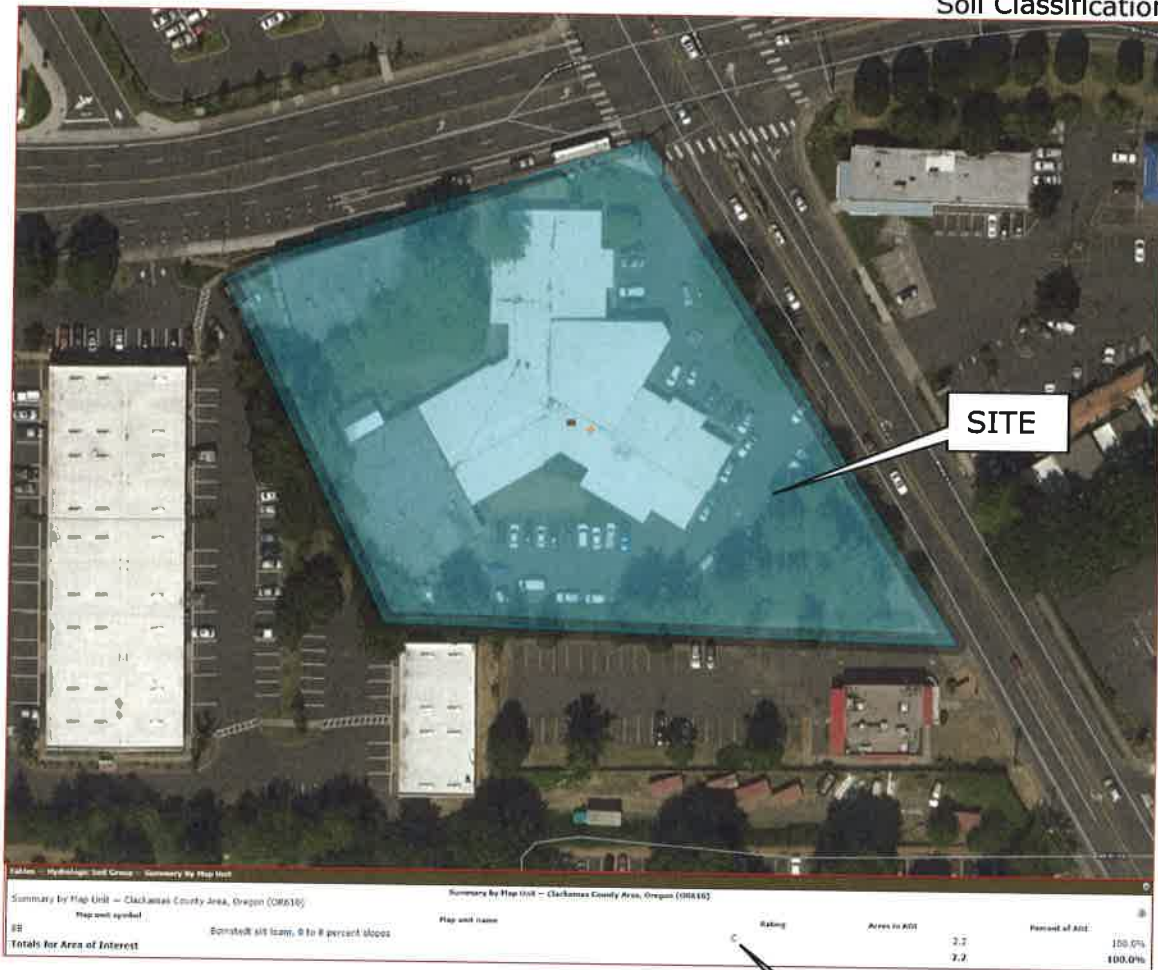
Appendix (B (1))
Soil Classification

The NRCS soil survey of Clackamas County, Oregon classifies the development site soil as Bornstedt silt loam with an associated hydrologic group of C, Appendix (B (1)). The associated curve number utilized in this design is 74 for pervious surfaces with class C subsoil and 98 for impervious developed surfaces.

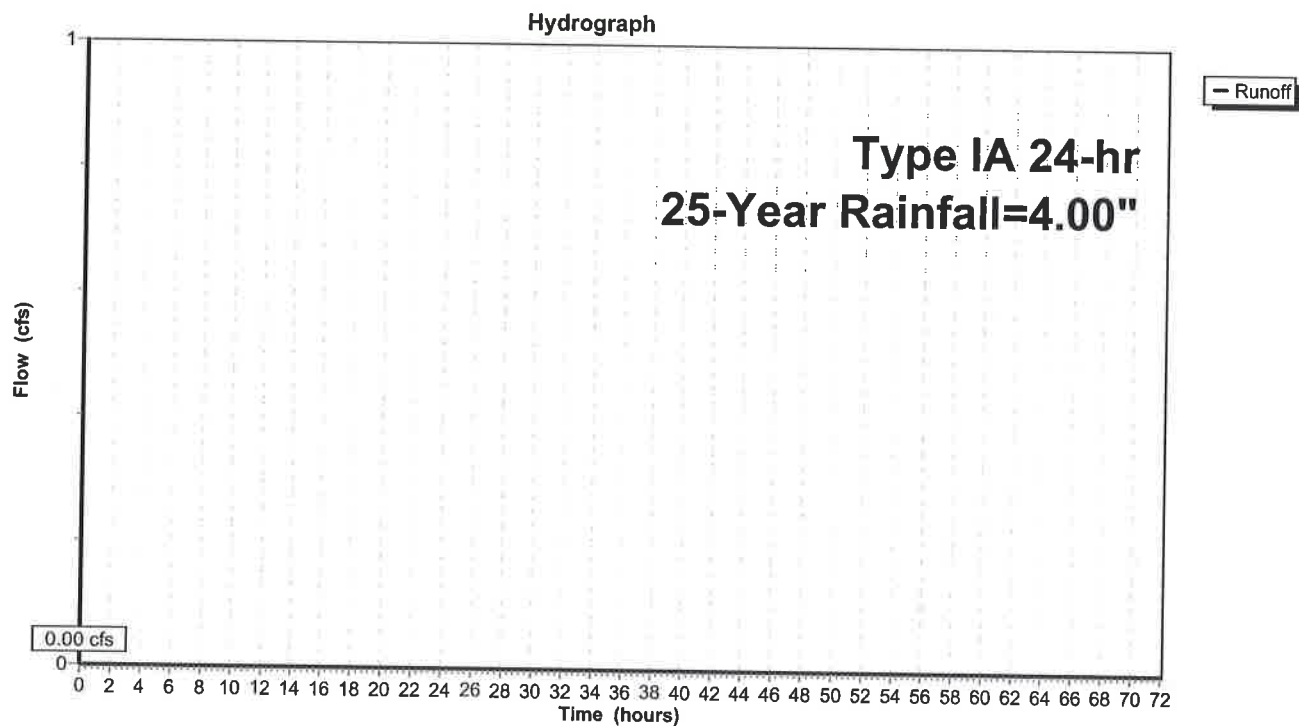
Summary for Subcatchment 201: Entire Site Impervious (Conservative)

Runoff = 0.00 cfs @ 0.00 hrs, Volume= 0.000 af, Depth= 0.00"

Type IA 24-hr 25-Year Rainfall=4.00"

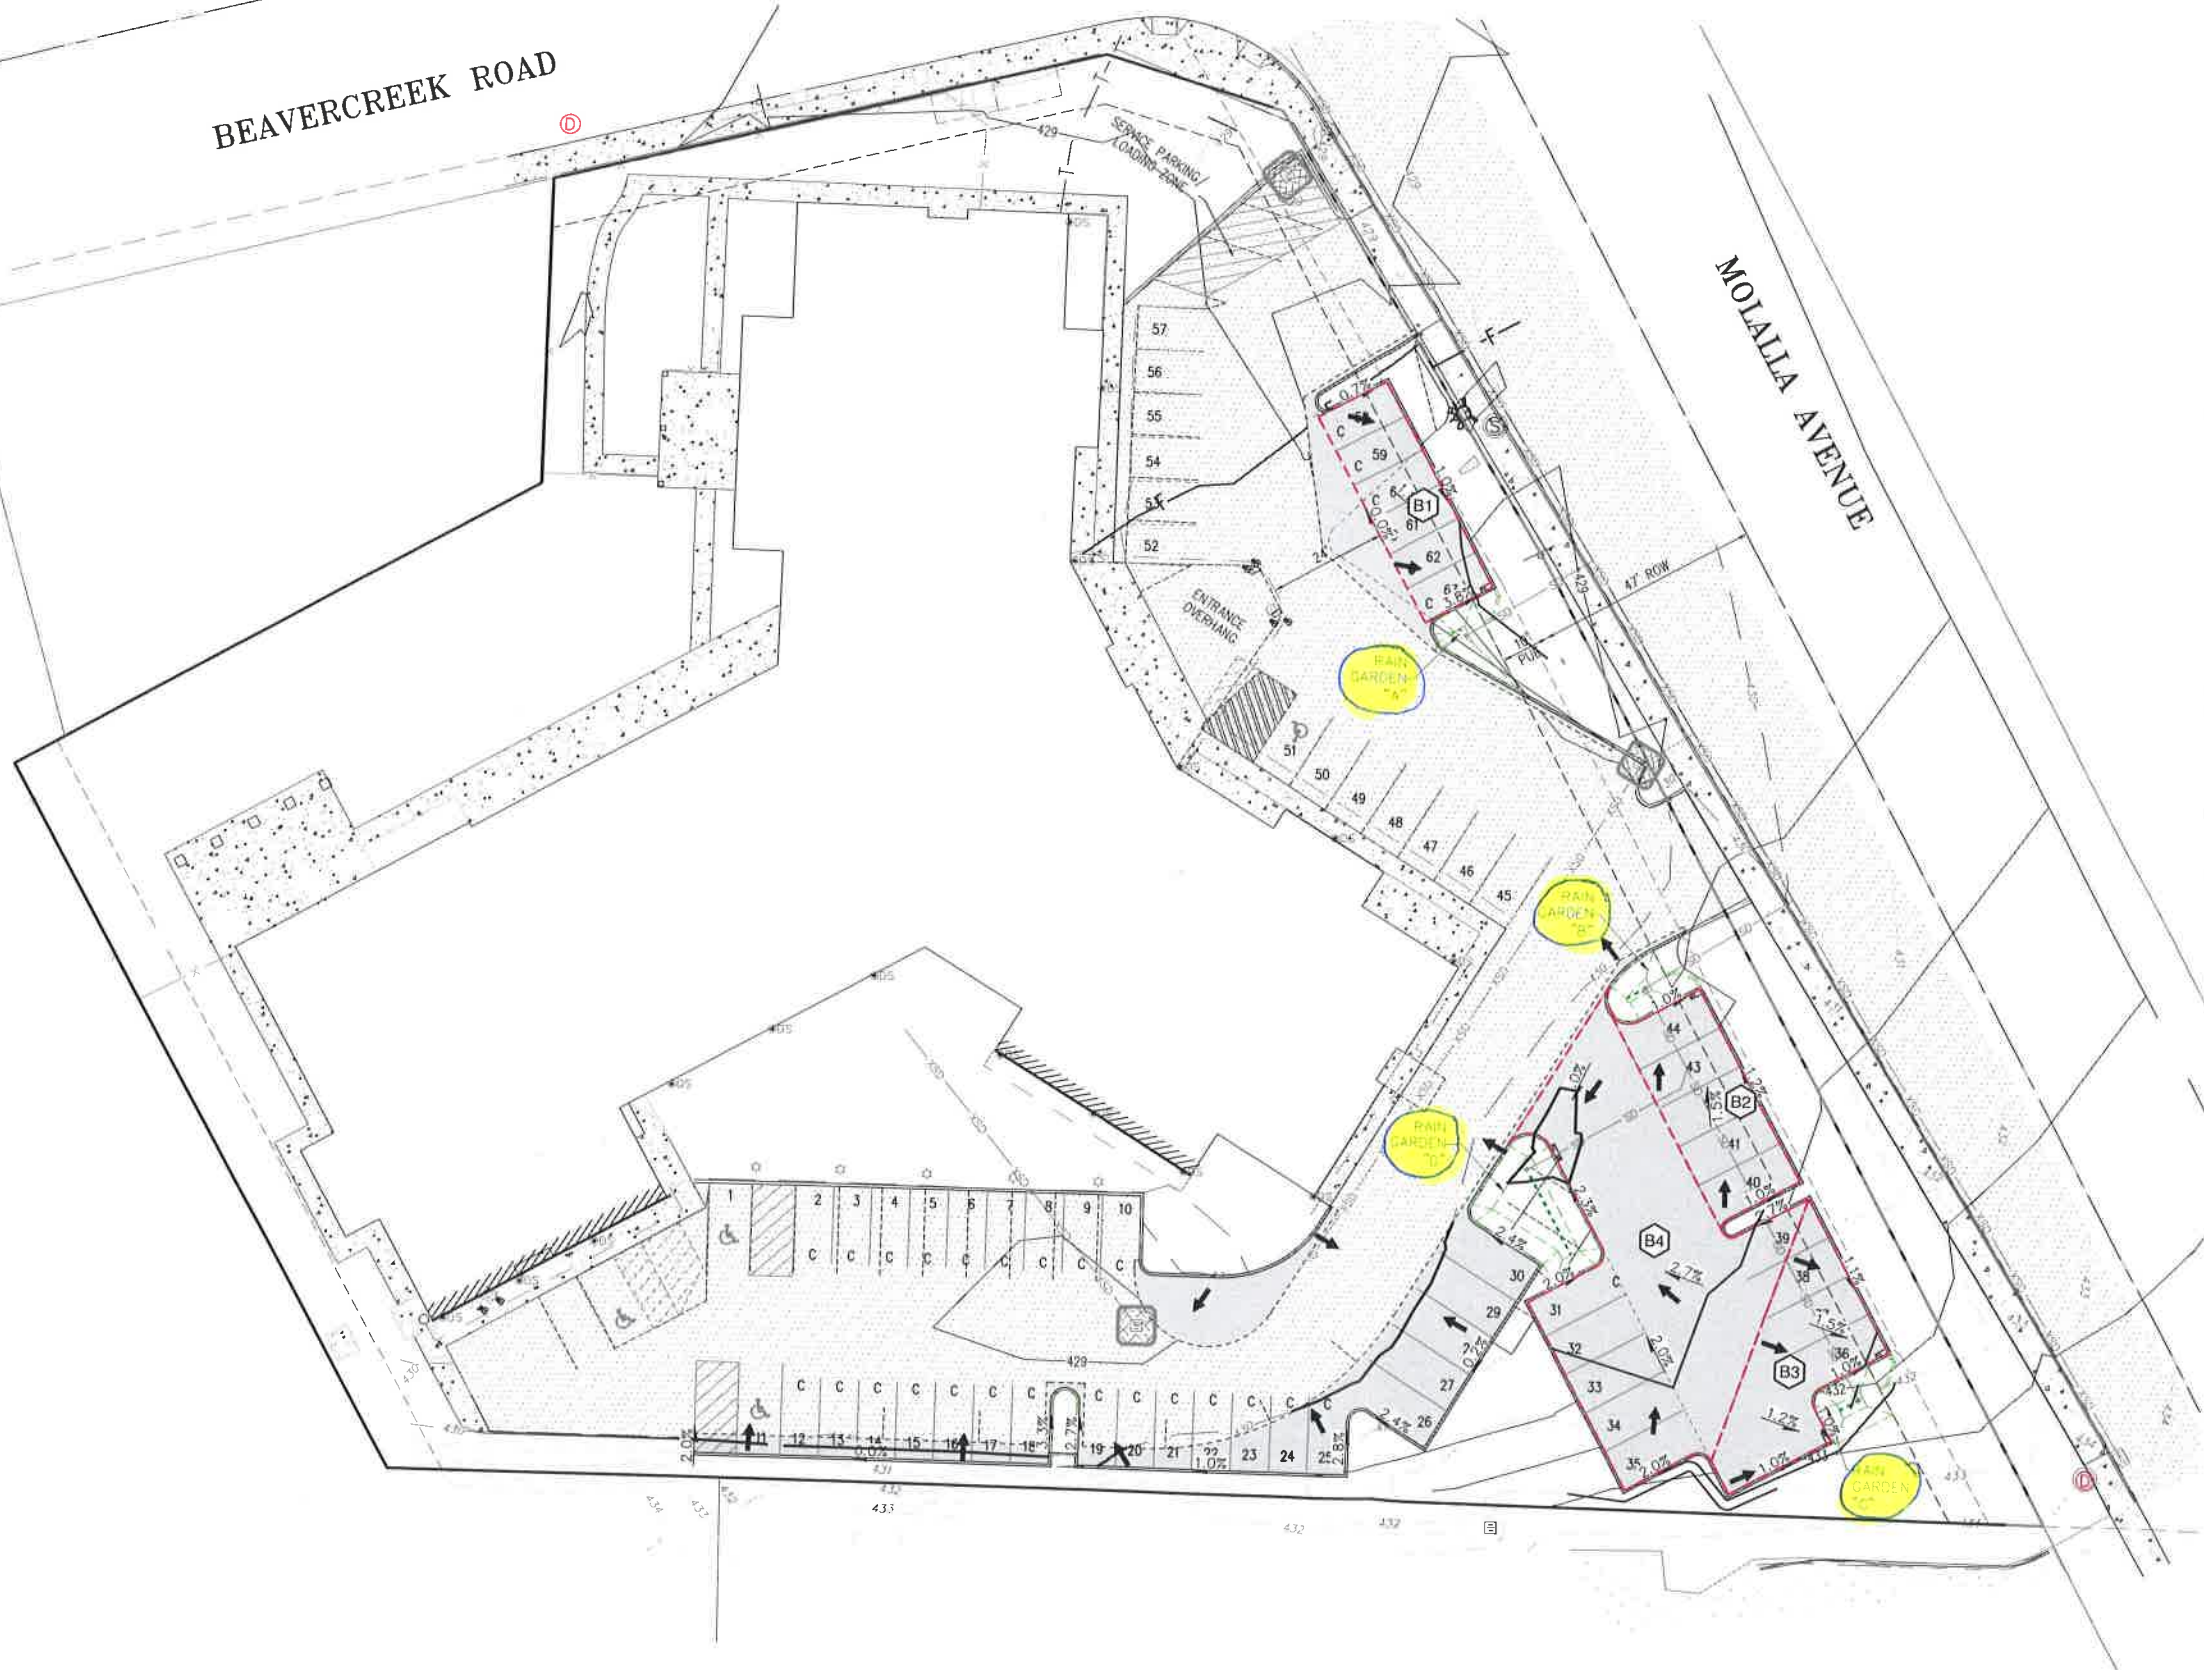
STORMWATER
MANAGEMENT
PLAN

- BOUNDARY LINE
- ADJACENT/ADJOINING LOT LINE
- CENTER LINE ROW
- EXISTING STORM DRAIN LINE
- DIRECTION OF SURFACE DRAINAGE
- DRAINAGE BASINS
