## Map 1 - Vicinity Map

## Map 2 - Site Map / Air Photo

# Map 3 - Site Map / Construction Area

## Project Major Improvements

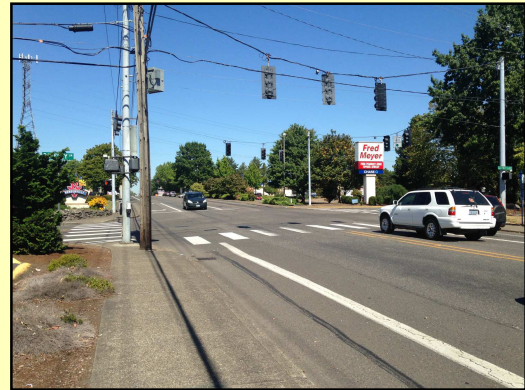
Replace outdated signal systems. Add medians, improve channelization / access management, and increase transit solutions to improve corridor safety

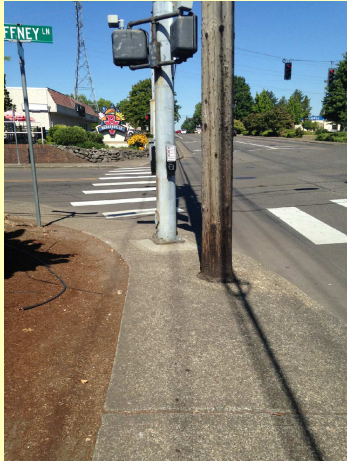
Replace existing non-conforming ADA ramps with compliant ramps and updated ADA facilities

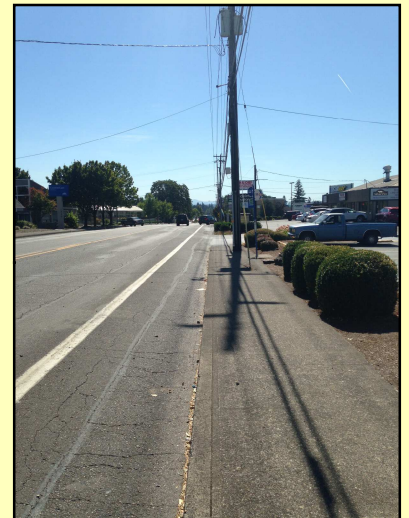
Replace narrow and obstructed sidewalks with new wider pedestrian friendly sidewalks including furnishings, trees and improved transit facilities

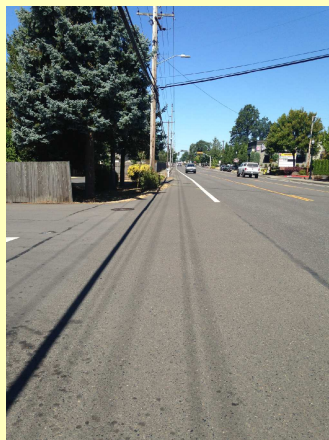
Add 1315 linear feet of sidewalks currently missing from the corridor and increase safe pedestrian crossing opportunities using mid-block pedestrian activated rapid flashing beacons

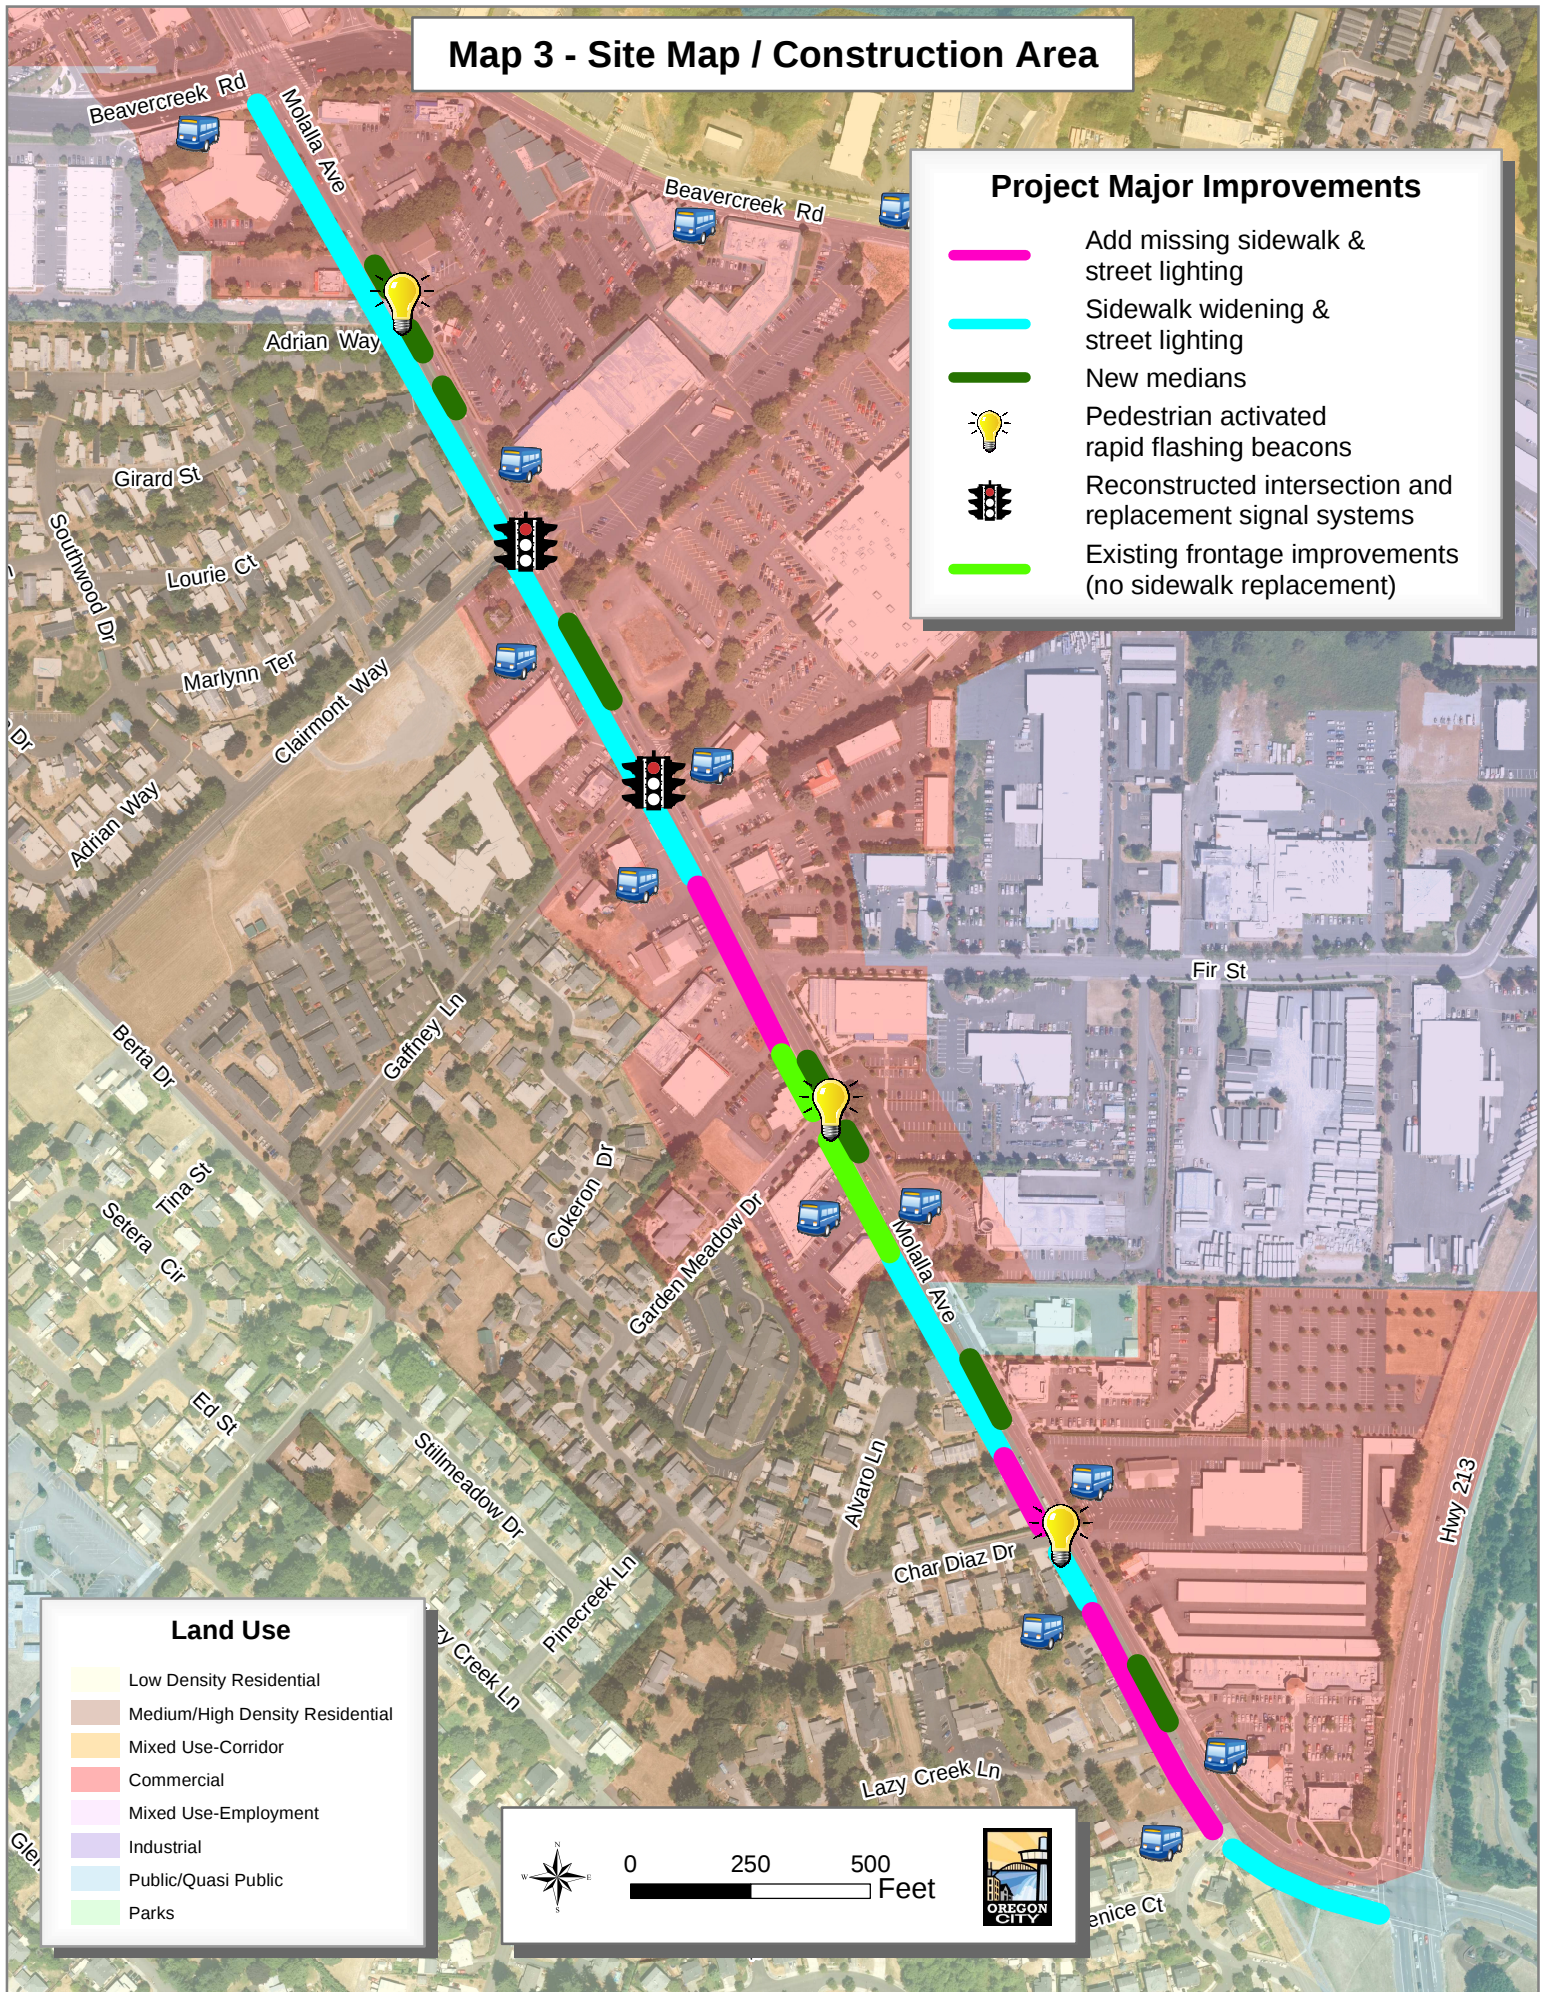
- Add missing sidewalk & street lighting
- Sidewalk widening & street lighting
- New medians
-

Pedestrian activated rapid flashing beacons
-

Reconstructed intersection and replacement signal systems
- Existing frontage improvements (no sidewalk replacement)
