Highway 213/Beavercreek Road Improvements Project

Stormwater Fact Sheet

PRIOR TO CONSTRUCTION
Holcomb Creek Culvert Replacement Project
2002—2003

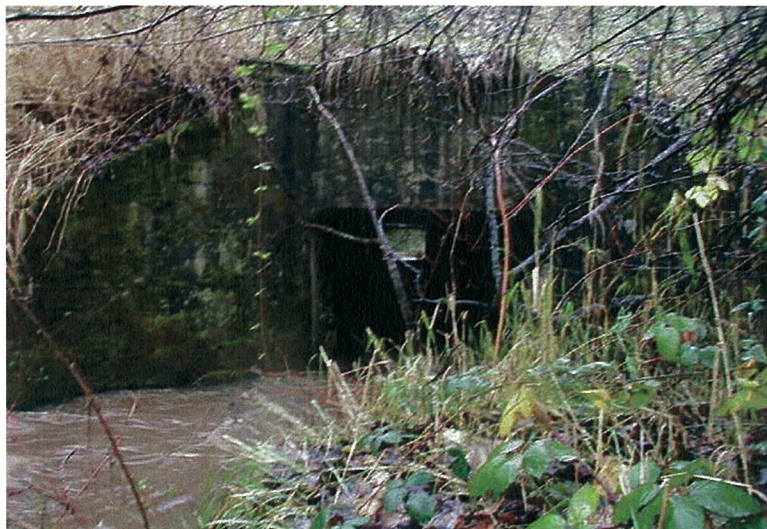
From culvert inlet opening,
looking downstream through
the 6'x 6' concrete box culvert

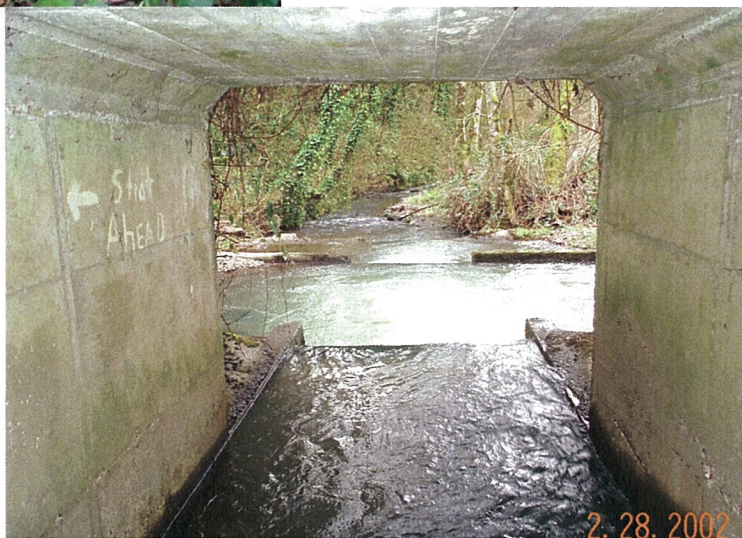
Looking downstream through
6'x 6' concrete box culvert
Outlet perched over 1.5',
creating fish passage barrier.
Downstream weirs in
background.

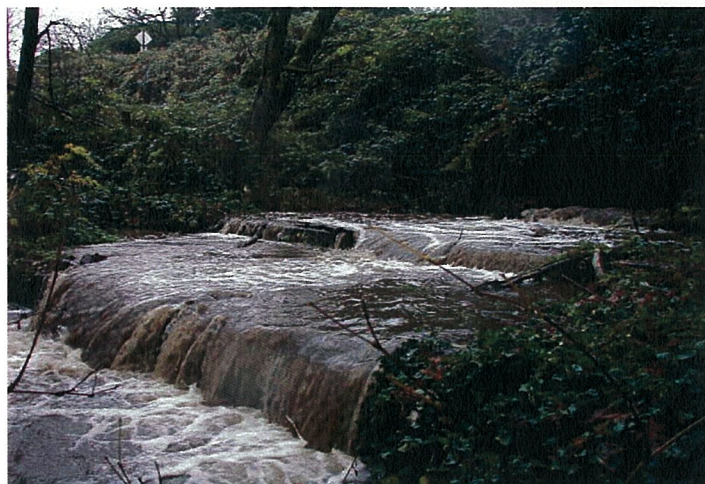
Looking upstream (culvert at right edge
of photo) series of downstream weirs

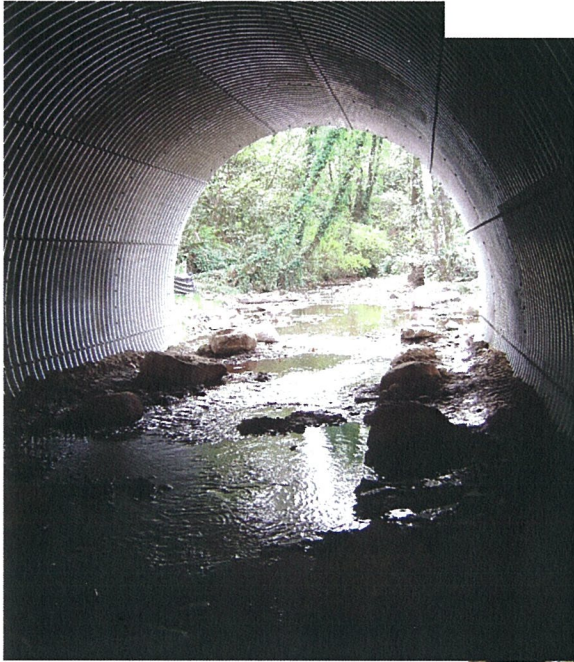
From culvert inlet opening, looking downstream through the multi-plate arched culvert. Culvert is embedded 2 feet below thalweg with native material and fish habitat rocks.

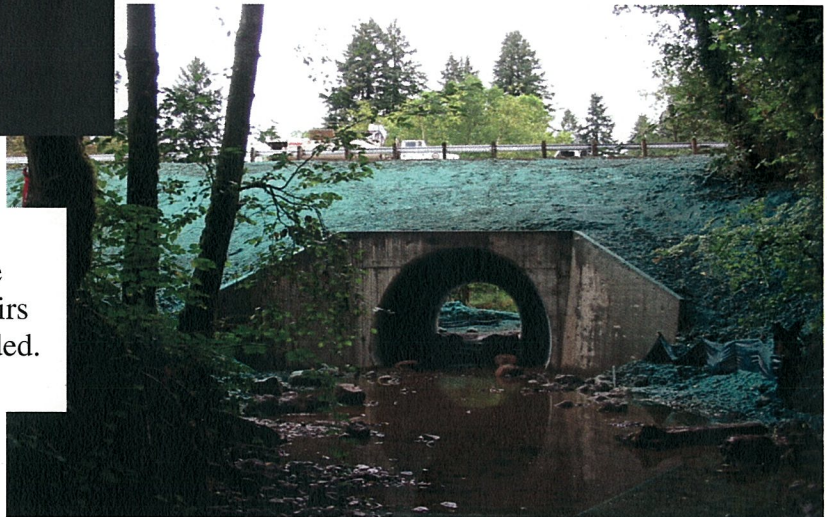
From culvert outlet, looking upstream through the multi-plate arched culvert. Downstream weirs are removed and channel re-graded.

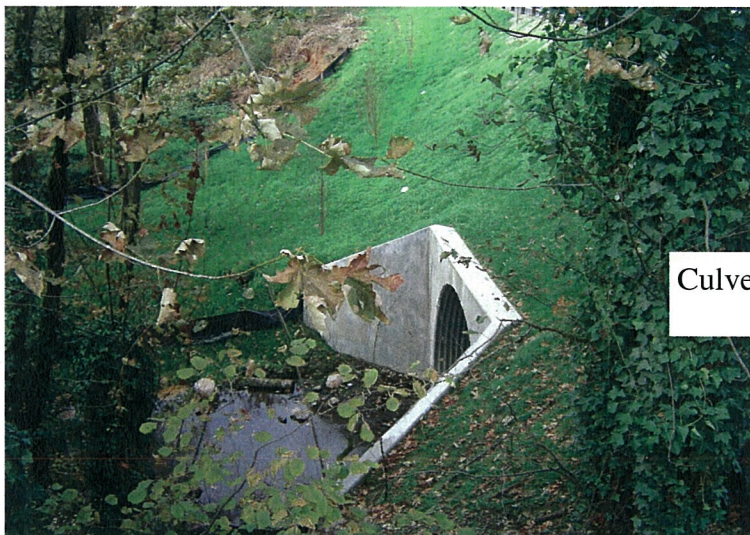
Culvert outlet view from road surface

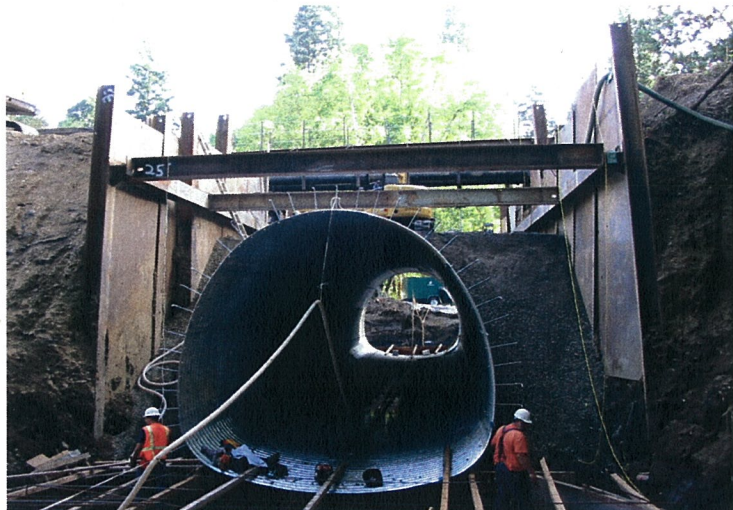
Assembling Multi-plate Arch culvert while stream is being diverted following fish salvaging operation.
