Technical Memorandum

Project title: I/I Abatement Program

Technical Memorandum 1

Subject: Smoke Testing

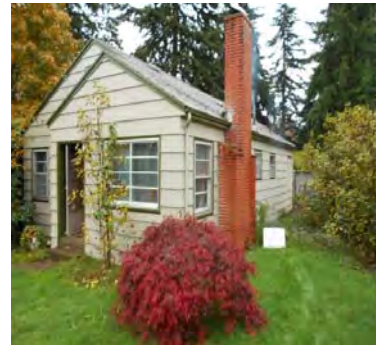
Basin 1 Run 2 Leak 1 B

Comments: Smoke coming from crawlspace vent

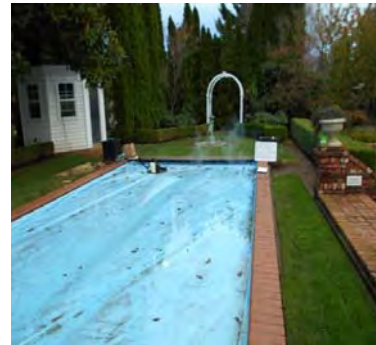
Basin 1 Run 10 Leak 1 B

Comments: Leak type is unknown, smoke coming from edge of pool. Apparently connected to Sanitary

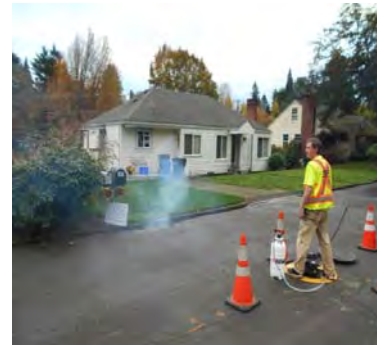
Basin 1 Run 10 Leak 2 B

Observations: Heavy smoke from Stormwater catch basin

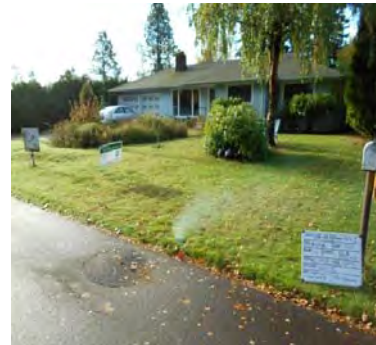
Basin 1 Run 14 Leak 1 B

Comments: Smoke coming from a rodent hole in the front yard.

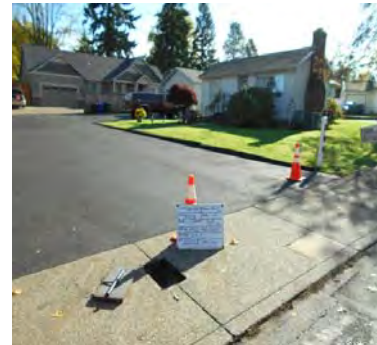
Basin 1 Run 17 Leak 1 B

Comments: Smoke coming from a water meter hatch.

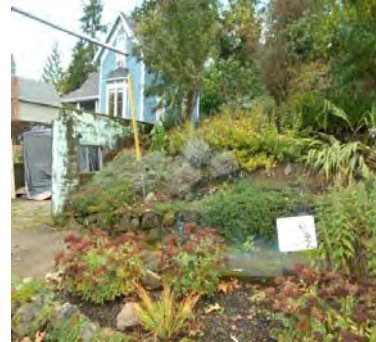
Basin 2 Run 1 Leak 1 B

Comments: Cracks in sidewalk, unknown source

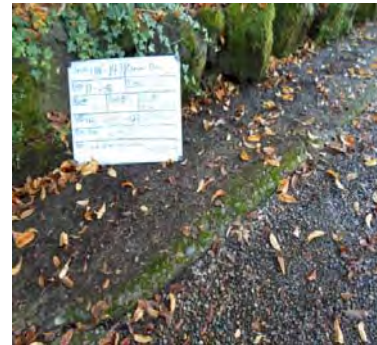
Basin 2 Run 2 Leak 1 A

Comments: Leak at end of driveway/sidewalk. Unknown Source

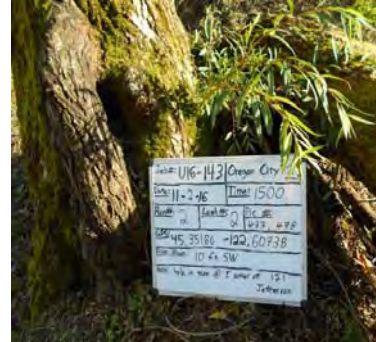
Basin 2 Run 2 Leak 2 A

Comments: Hole in tree at E corner of property. Unknown Source

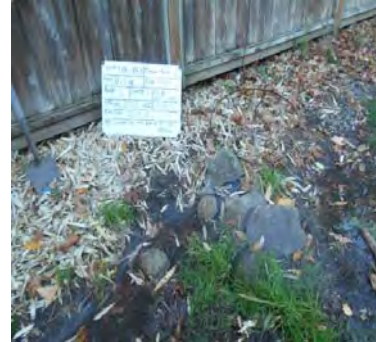
Basin 2 Run 2 Leak 3 A

Comments: Black drainage pipe along back side of property.

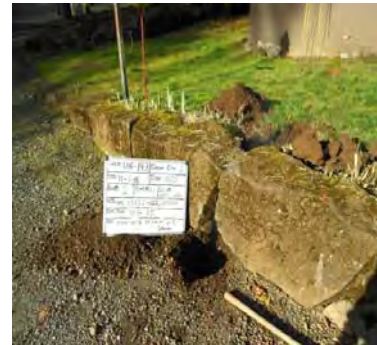
Basin 2 Run 2 Leak 4 A

Comments: Leak from stone wall at SW side of property.

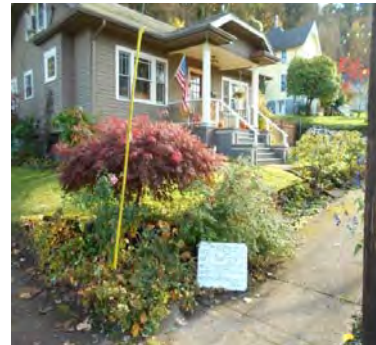
Basin 2 Run 2 Leak 5 B

Comments: Smoke from edge of sidewalk at N corner. Unknown Source

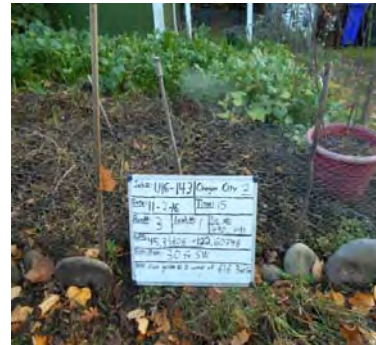
Basin 2 Run 3 Leak 1 A

Comments: Smoke coming from garden at N corner of property. Unknown Source

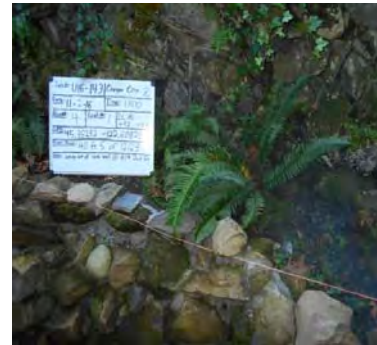
Basin 2 Run 4 Leak 1 A

Comments: Smoke coming from rock wall. Unknown Source

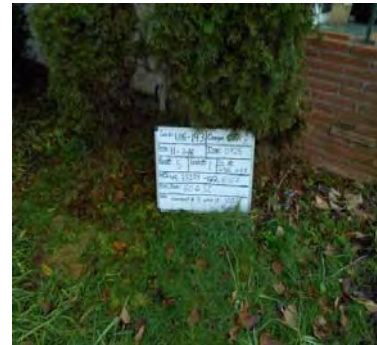
Basin 2 Run 5 Leak 1 A

Comments: Leak at N corner of 100 High St.

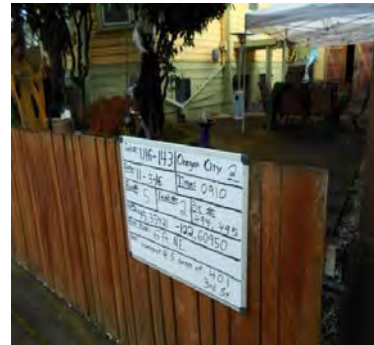
Basin 2 Run 5 Leak 2 A

Comments: Downspout at S corner of property.

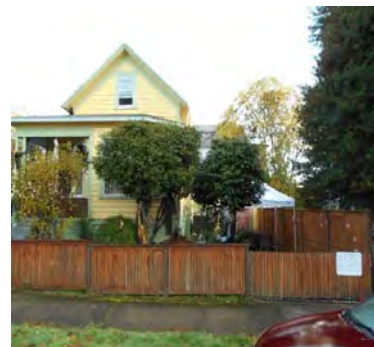
Basin 2 Run 5 Leak 2 B

Comments: Downspout at S corner of property.

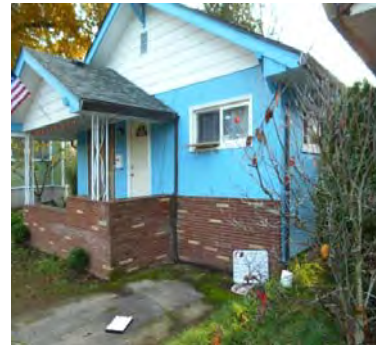
Basin 2 Run 5 Leak 3 B

Comments: Downspout at W corner of house.

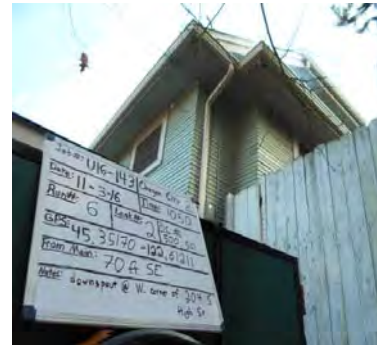
Basin 2 Run 6 Leak 2 A

Comments: Downspout at W corner of house.

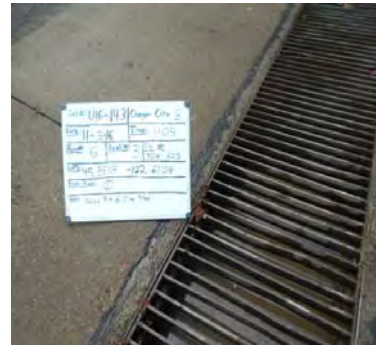
Basin 2 Run 6 Leak 3 A

Comments: Wash pit appears to be connected to Sani

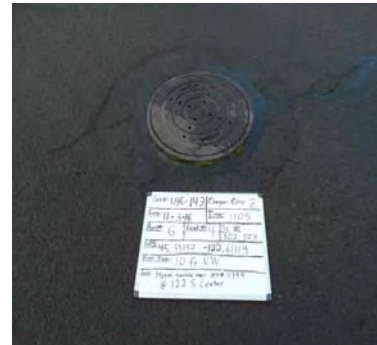
Basin 2 Run 6 Leak 4 A

Comments: Storm MH near MH #11599 smoking. Need to verify that this is Storm line. Possible manhole lid mis-label.

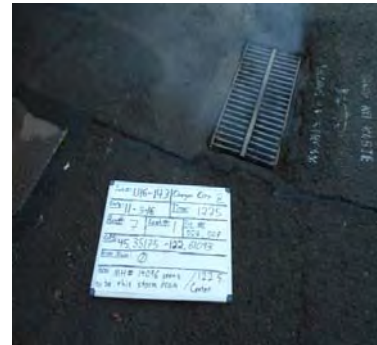
Basin 2 Run 7 Leak 1 A

Comments: Storm drian in parking lot appears to be connected to Sani

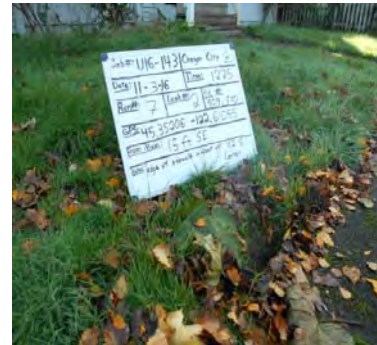
Basin 2 Run 7 Leak 2 A

Comments: Smoke coming from edge of sidewalk, Unknown Source.

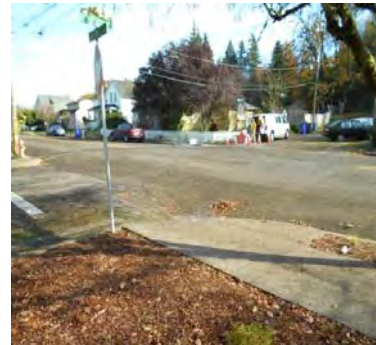
Basin 2 Run 7 Leak 3 B

Comments: All storm drains at 1st + Center have smoke coming out, 4 storm drains

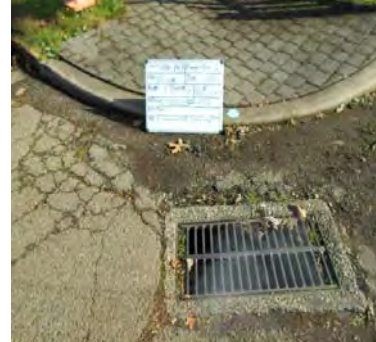
Basin 2 Run 7 Leak 4 A

Comments: All storm drains at 1st + Center have smoke coming out, 4 storm drains

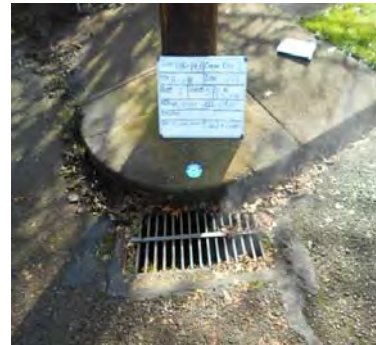
Basin 2 Run 7 Leak 5 A

Comments: All storm drains at 2nd + Center have smoke coming out, 4 storm drains

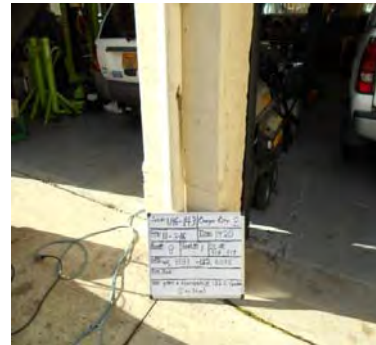
Basin 2 Run 8 Leak 1 A

Comments: Leaks from gutters and downspouts at city shop

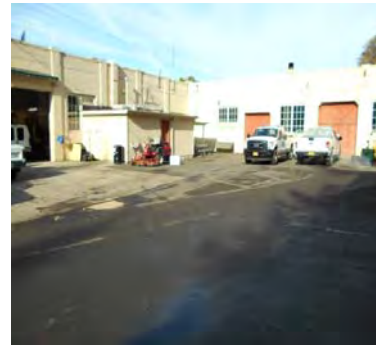
Basin 2 Run 8 Leak 2 B

Comments: 3 catch basins in city shop parking

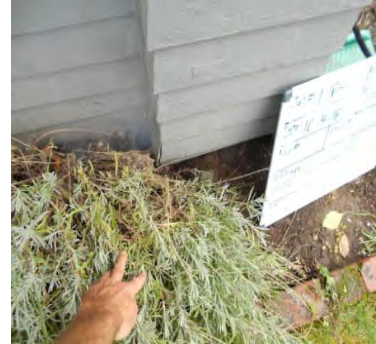
Basin 3 Run 12 Leak 1 B

Comments: Broken CB at corner of house

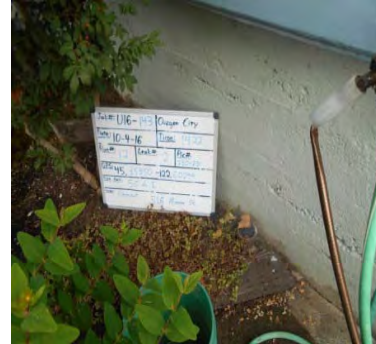
Basin 3 Run 12 Leak 2 A

Comments: Leaking cleanout

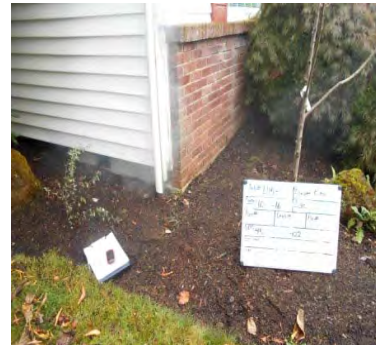
Basin 3 Run 22 Leak 1 A

Comments: Leak-downspout at front corner of house.

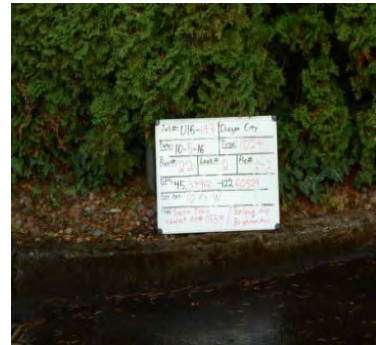
Basin 3 Run 22 Leak 2 A

Comments: Storm drain near MH 11554

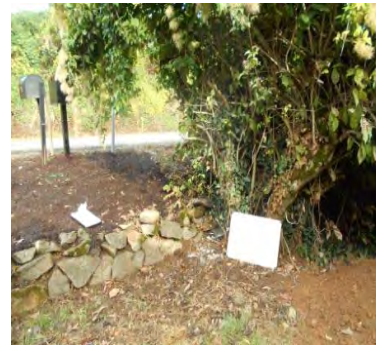
Basin 3 Run 24 Leak 1 B

Comments: Leak #1 was actually found during run #26, but is located within run #24. Leak suspected to be from "T" in the main getting replaced.

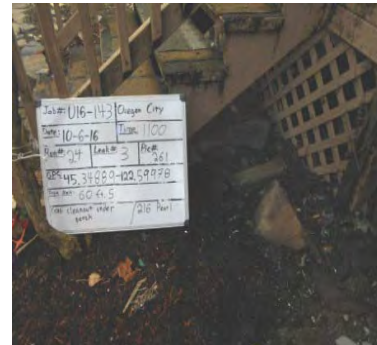
Basin 3 Run 24 Leak 3 A

Comments: Cleanout under front porch smoking

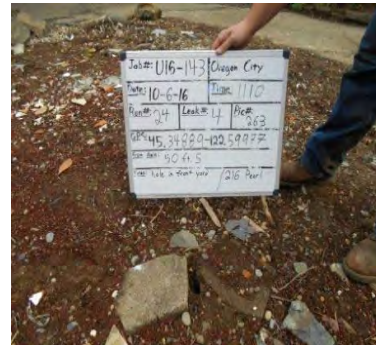
Basin 3 Run 24 Leak 4 A

Comments: Smoke from hole in front yard. Unknown Source

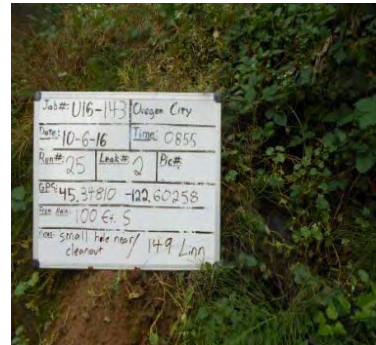
Basin 3 Run 25 Leak 1 B

Comments: Smoke from hole in flower bed + crack in walkway. Unknown Source

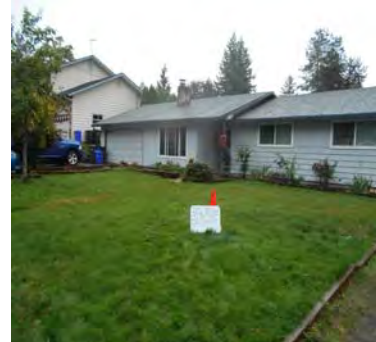
Basin 4 Run 6 Leak 1 B

Comments: Smoke coming from hole in yard.

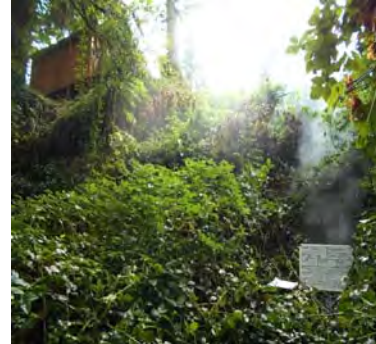
Basin 4 Run 12 Leak 1 B

Observations: Heavy smoke, blackberry bushes

Comments: In the valley of a drainage ravine that runs down to Electric St.

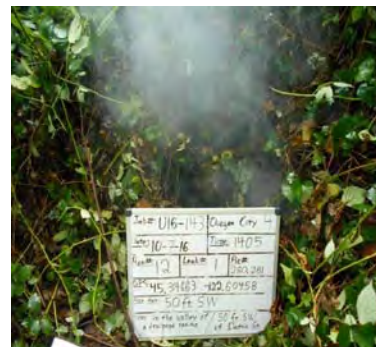
Basin 4 Run 12 Leak 1 A

Observations: Heavy smoke, blackberry bushes

Comments: In the valley of a drainage ravine that runs down to Electric St.

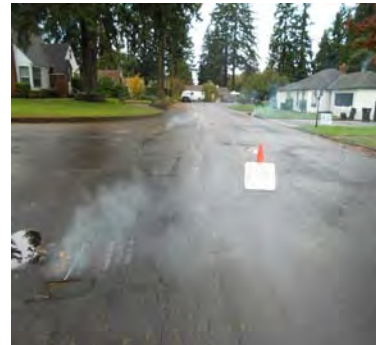
Basin 4 Run 13 Leak 1 B

Observations: Heavy smoke

Comments: 3 storm drains

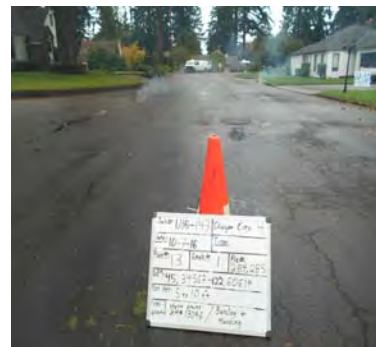
Basin 4 Run 13 Leak 1 A

Observations: Heavy smoke

Comments: 3 storm drains

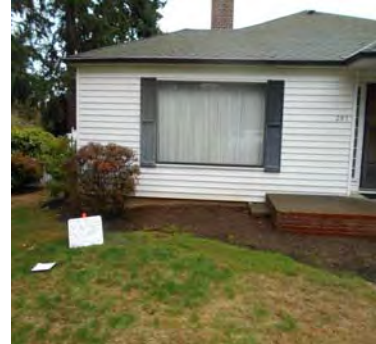
Basin 4 Run 13 Leak 2 B

Observations: Light smoke

Comments: Holes in ground in front yard.

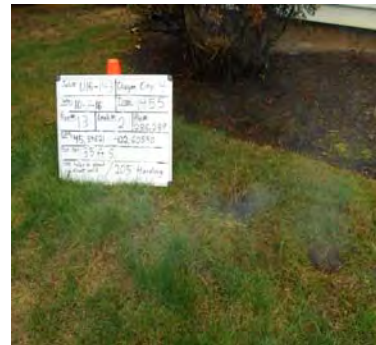
Basin 4 Run 13 Leak 2 A

Observations: Light smoke

Comments: Holes in ground in front yard.

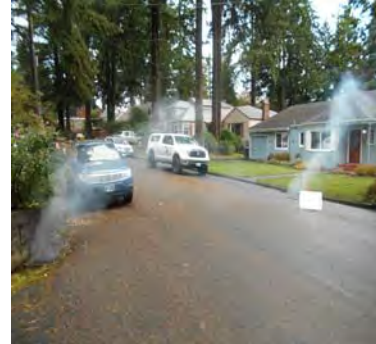
Basin 4 Run 13 Leak 3 B

Observations: Heavy smoke

Comments: 2 storm drains near MH 13045

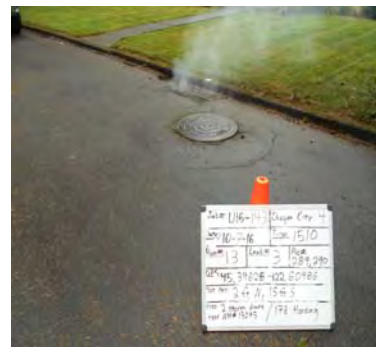
Basin 4 Run 13 Leak 3 A

Observations: Heavy smoke

Comments: 2 storm drains near MH 13045

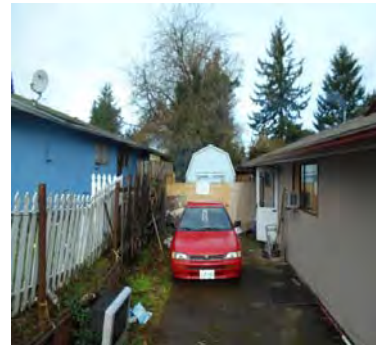
Basin 5 Run 2 Leak 1 B

Comments: 11291 480 Hilltop Ave 45.33647 122.58922. Leak: unable to access leak-behind fence, no one home. Possibly a cleanout.

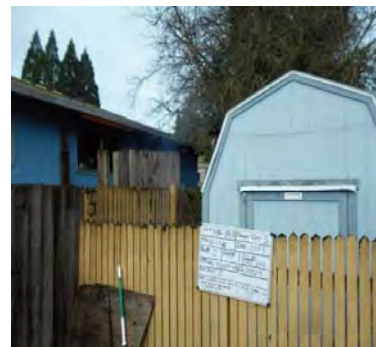
Basin 5 Run 2 Leak 1 A

Comments: 11291 480 Hilltop Ave 45.33647 122.58922. Leak: unable to access leak-behind fence, no one home. Possibly a cleanout.

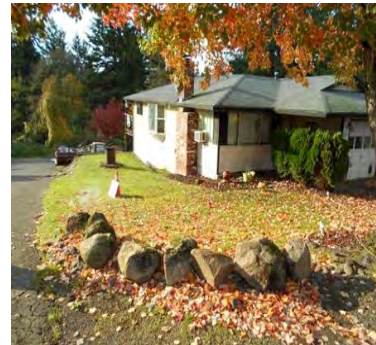
Basin 6 Run 4 Leak 1 B

Comments: Old broken capped pipe.

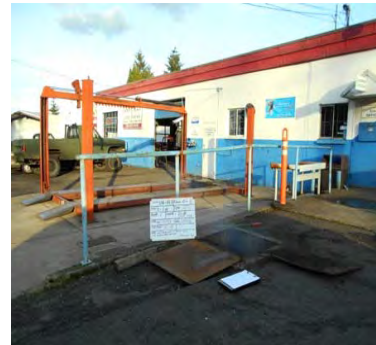
Basin 6 Run 7 Leak 1 B

Comments: Smoke from Grease trap

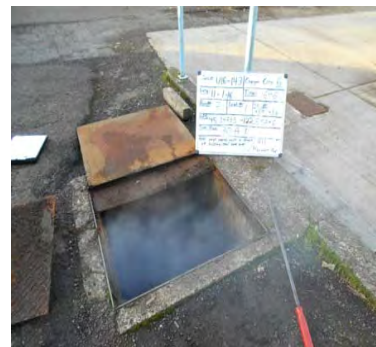
Basin 6 Run 7 Leak 1 A

Comments: Smoke from Grease trap

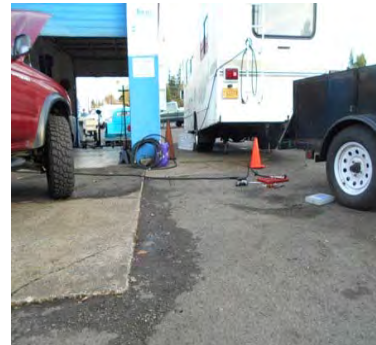
Basin 6 Run 7 Leak 2 B

Comments: Smoke from Wash drain

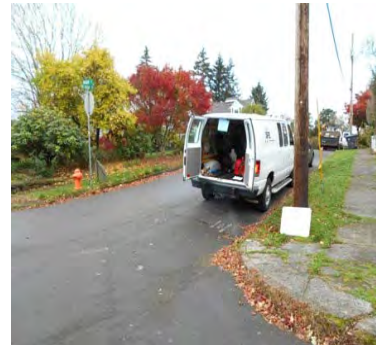
Basin 6 Run 10 Leak 1 B

Comments: Heavy smoke from this Storm Drain. Could not locate upstream manhole.

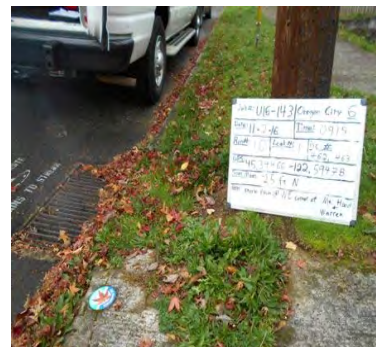
Basin 6 Run 10 Leak 1 A

Comments: Heavy smoke from this Storm Drain. Could not locate upstream manhole.

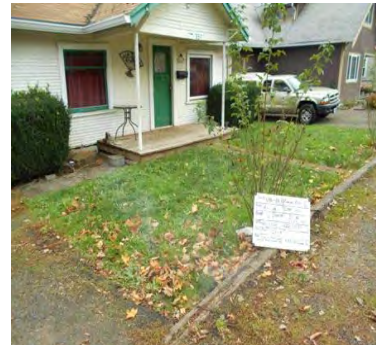
Basin 6 Run 12 Leak 1 B

Comments: Holes in front yard. Unknown Source

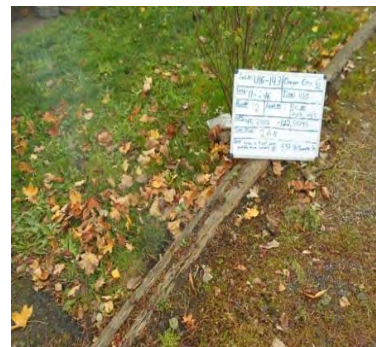
Basin 6 Run 12 Leak 1 A

Comments: Holes in front yard. Unknown Source

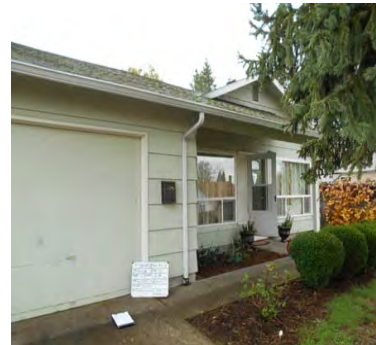
Basin 6 Run 12 Leak 2 B

Comments: Smoke from downspouts at this house

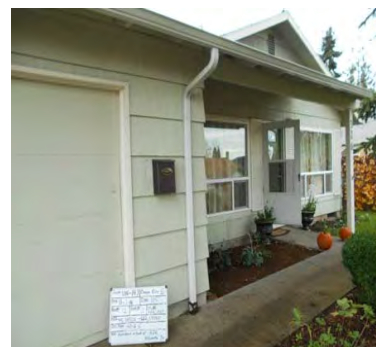
Basin 6 Run 12 Leak 2 A

Comments: Smoke from downspouts at this house

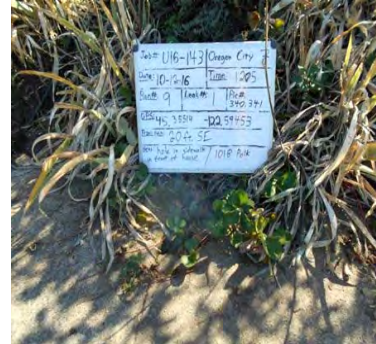
Basin 7 Run 9 Leak 1 A

Comments: Hole in sidewalk, possibly a lateral.

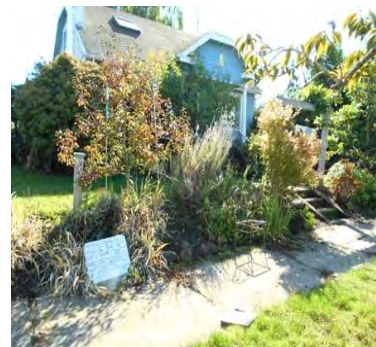
Basin 7 Run 9 Leak 1 B

Comments: Hole in sidewalk, possibly a lateral.

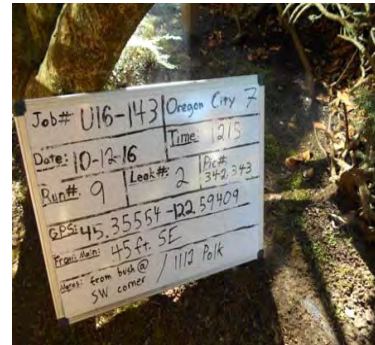
Basin 7 Run 9 Leak 2 A

Comments: Smoke from under bush at SW corner.

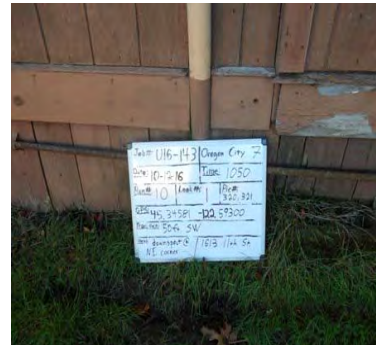
Basin 7 Run 10 Leak 1 A

Comments: Smoke from Downspout and from ground near mailbox.

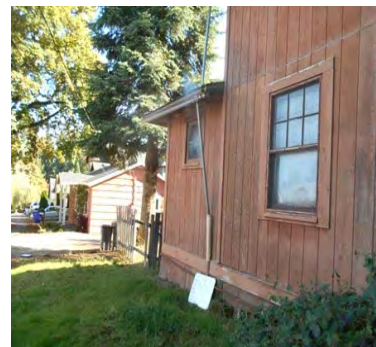
Basin 7 Run 10 Leak 1 B

Comments: Smoke from Downspout and from ground near mailbox.

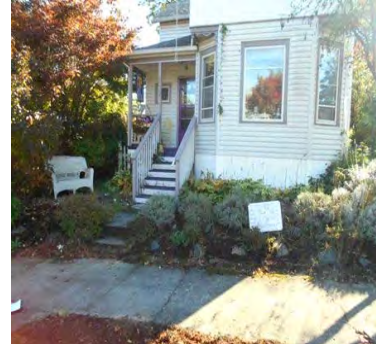
Basin 7 Run 10 Leak 2 B

Comments: Landscaping at front of house on both sides of sidewalk.

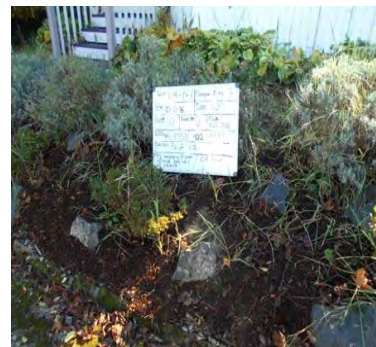
Basin 7 Run 10 Leak 2 A

Comments: Landscaping at front of house on both sides of sidewalk.

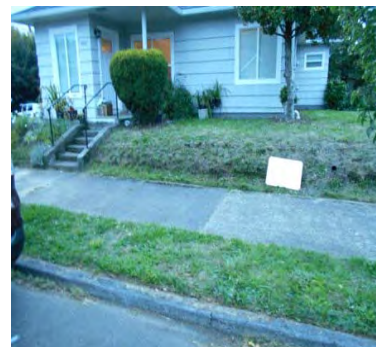
Basin 7 Run 14 Leak 1 B

Comments: Smoke from open pipe, unsure if it is a lateral or some sort of cleanout.

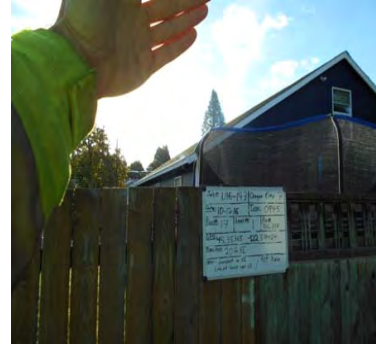
Basin 7 Run 17 Leak 1 A

Comments: Downspout at NE corner of house.

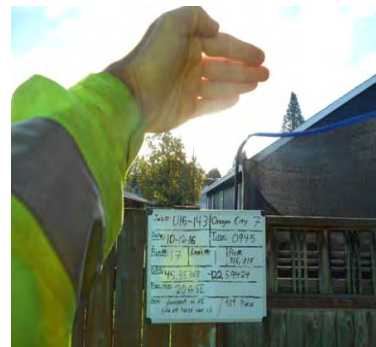
Basin 7 Run 17 Leak 1 B

Comments: Downspout at NE corner of house.

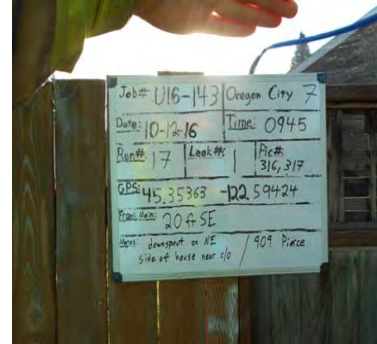
Basin 7 Run 17 Leak 1 C

Comments: Downspout at NE corner of house.

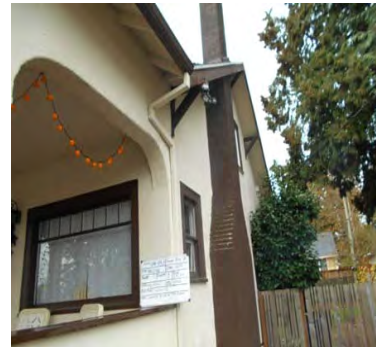
Basin 7 Run 18 Leak 1 A

Comments: Downspout at SW side of house.

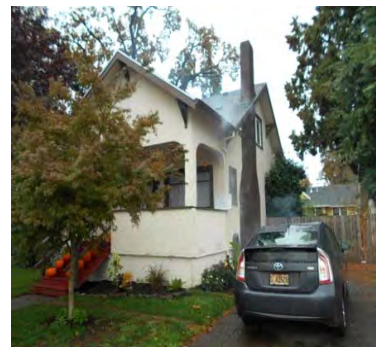
Basin 7 Run 18 Leak 1 B

Comments: Downspout at SW side of house.

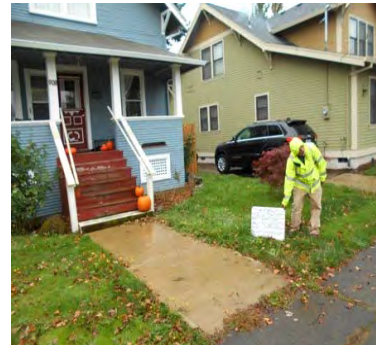
Basin 7 Run 19 Leak 1 B

Comments: Smoke from ground in line with service lateral.

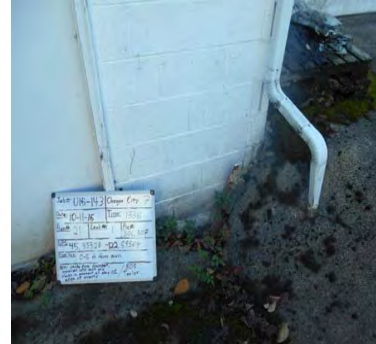
Basin 7 Run 21 Leak 1 A

Comments: Several issues going on in this section. Downspout and catch basin cross connected.

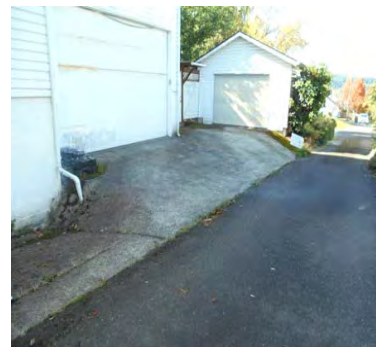
Basin 7 Run 21 Leak 1 B

Comments: Several issues going on in this section. Downspout and catch basin cross connected.

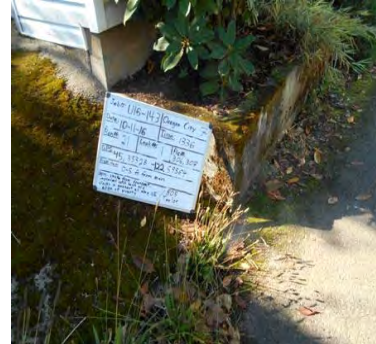
Basin 7 Run 21 Leak 2 A

Comments: Smoke from cracks between road and wall.

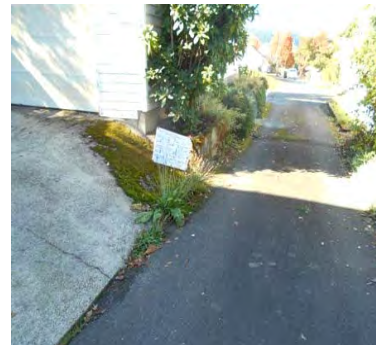
Basin 7 Run 21 Leak 2 B

Comments: Smoke from cracks between road and wall.

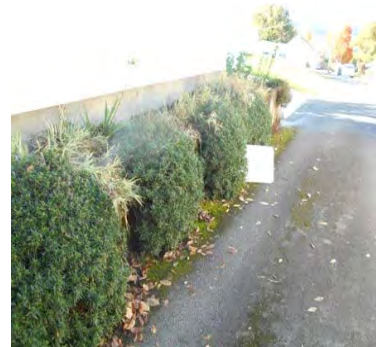
Basin 7 Run 21 Leak 3 A

Comments: Smoke from bushes and edge of wall.

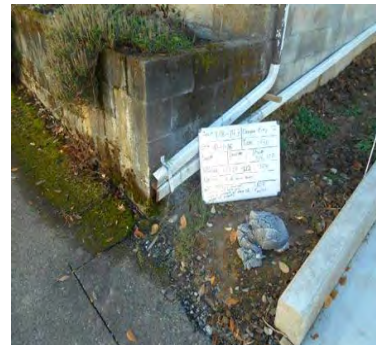
Basin 7 Run 21 Leak 3 B

Comments: Smoke from bushes and edge of wall.

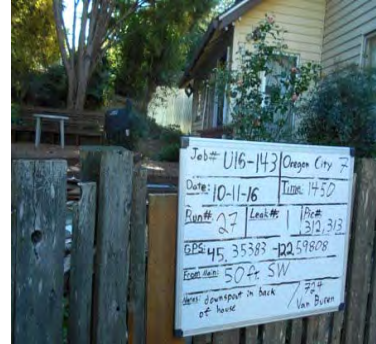
Basin 7 Run 27 Leak 1 A

Comments: Downspouts appear to be cross connected

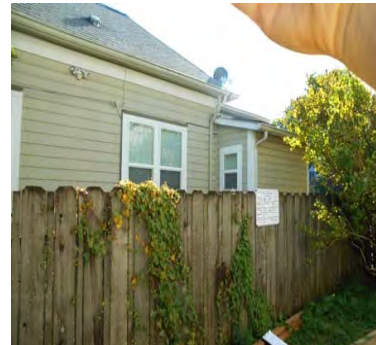
Basin 7 Run 29 Leak 1 B

Comments: Downspouts appear to be cross connected

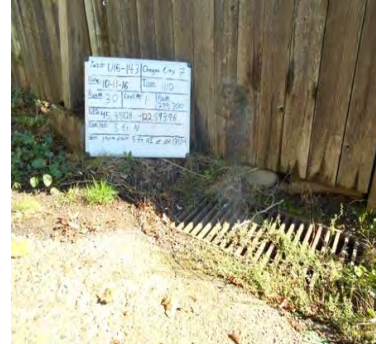
Basin 7 Run 30 Leak 1 A

Comments: Storm drain NE of MH 13109.

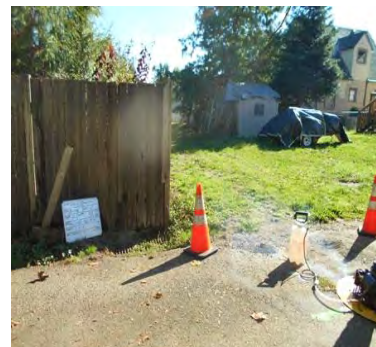
Basin 7 Run 30 Leak 1 B

Comments: Storm drain NE of MH 13109.

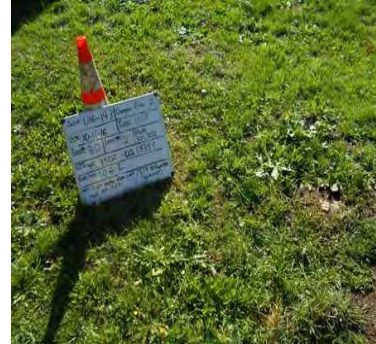
Basin 7 Run 30 Leak 2 A

Result: Positive **Leak Source:** Smoking Ground

Comments: Smoke from yard. Unknown source

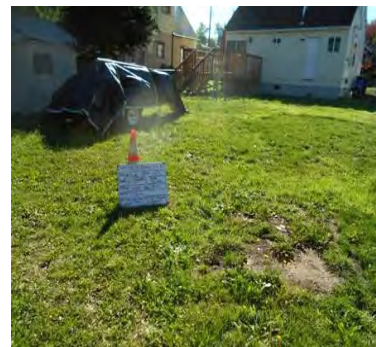
Basin 7 Run 30 Leak 2 B

Result: Positive **Leak Source:** Smoking Ground

Comments: Smoke from yard. Unknown source

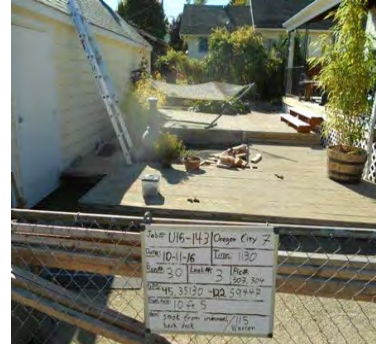
Basin 7 Run 30 Leak 3 A

Result: Positive **Leak Source:** Smoking Ground

Comments: Smoke from underneath new deck. Possibly a covered manhole?

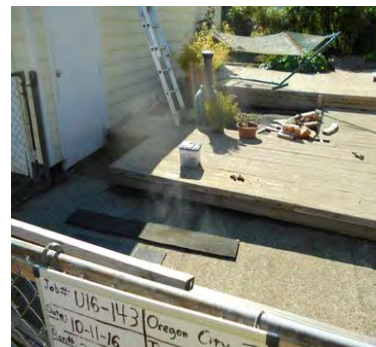
Basin 7 Run 30 Leak 3 B

Result: Positive **Leak Source:** Smoking Ground

Comments: Smoke from underneath new deck. Possibly a covered manhole?

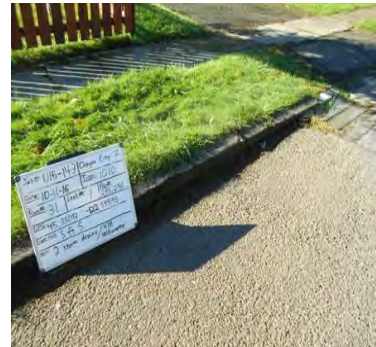
Basin 7 Run 31 Leak 1 A

Leak Source: Storm Drain

Comments: Smoke from catch basins. Cross connection observed

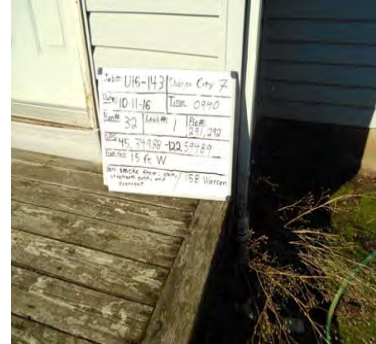
Basin 7 Run 32 Leak 1 A

Leak Source: Downspout

Comments: Smoke from drain, porch and downspout.

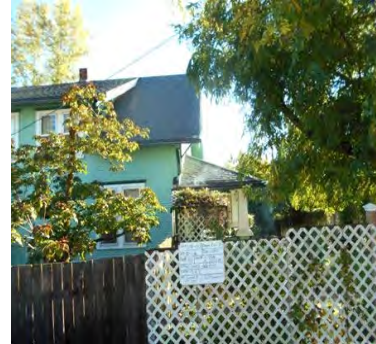
Basin 7 Run 32 Leak 2 B

Result: Positive **Leak Source:** Downspout

Comments: Downspout at SW corner.

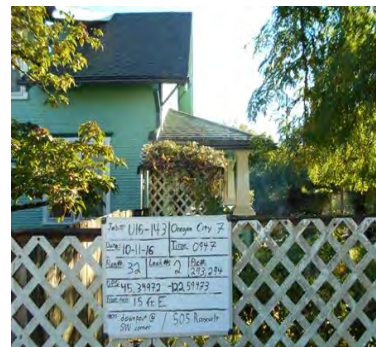
Basin 7 Run 32 Leak 2 A

Result: Positive **Leak Source:** Downspout

Comments: Downspout at SW corner.

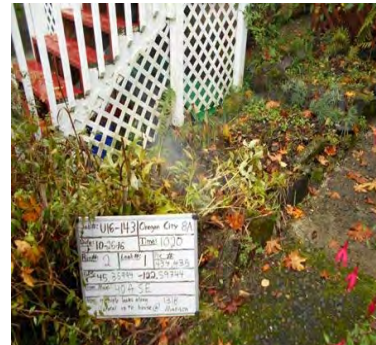
Basin 8a Run 2 Leak 1 B

Leak Source: Service Lateral

Comments: Multiple leaks along lateral.

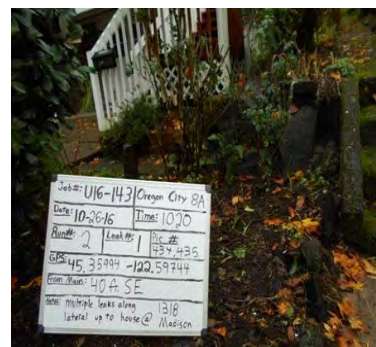
Basin 8a Run 2 Leak 1 A

Leak Source: Service Lateral

Comments: Multiple leaks along lateral.

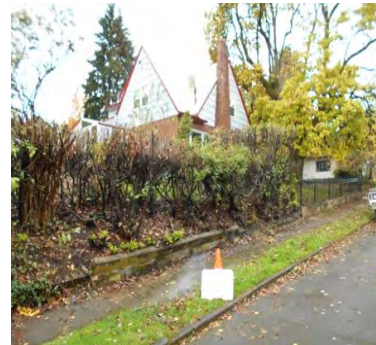
Basin 8a Run 4 Leak 1 B

Leak Source: Cracked Concrete

Comments: Unknown type, coming from sidewalk.

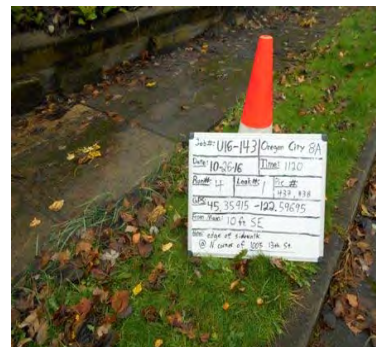
Basin 8a Run 4 Leak 1 A

Leak Source: Cracked Concrete

Comments: Unknown type, coming from sidewalk.

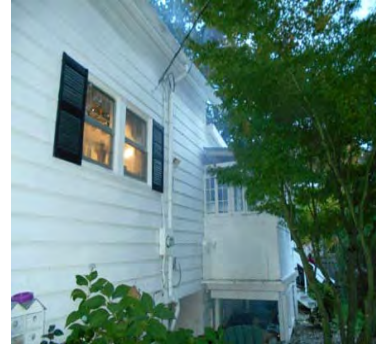
Basin 8a Run 5 Leak 1 B

Leak Source: Downspout

Comments: Downspout on SW side of 1511 JQ Adams

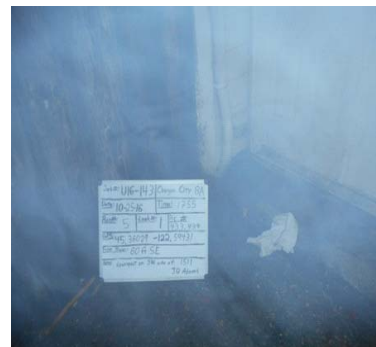
Basin 8a Run 5 Leak 1 A

Leak Source: Downspout

Comments: Downspout on SW side of 1511 JQ Adams

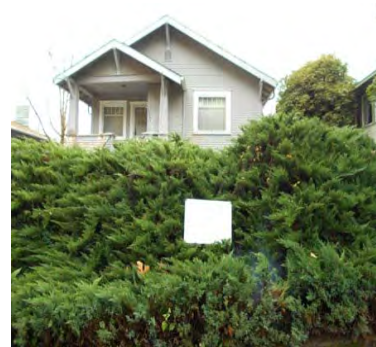
Basin 8a Run 6 Leak 1 B

Leak Source: N/A

Comments: Unknown type and source, smoke coming from holes inground under bushes

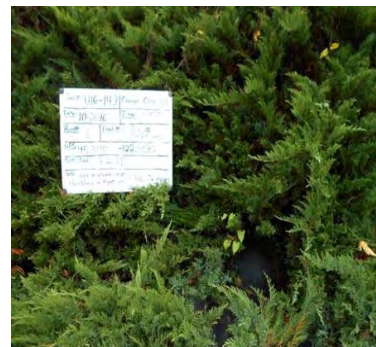
Basin 8a Run 6 Leak 1 A

Leak Source: N/A

Comments: Unknown type and source, smoke coming from holes inground under bushes

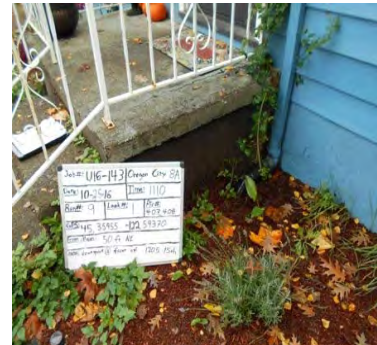
Basin 8a Run 9 Leak 1 A

Leak Source: Downspout

Comments: Downspout located at front of house (front door)

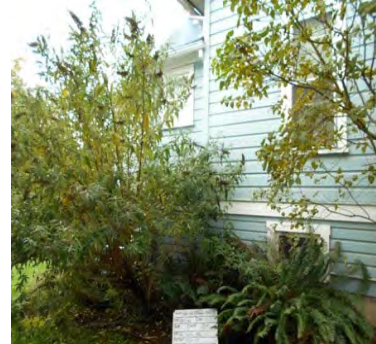
Basin 8a Run 10 Leak 1 B

Result: Positive **Leak Source:** Downspout

Comments: Smoke from Downspout at NE side.

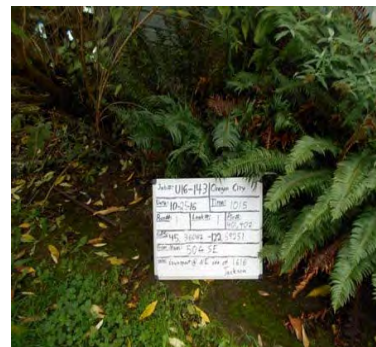
Basin 8a Run 10 Leak 1 A

Result: Positive **Leak Source:** Downspout

Comments: Smoke from Downspout at NE side.

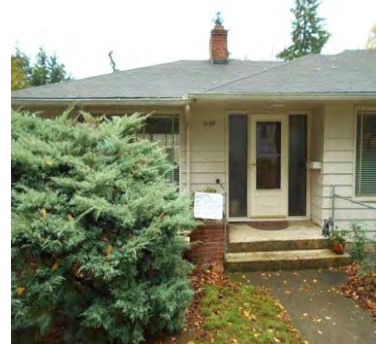
Basin 8a Run 10 Leak 2 B

Leak Source: Downspout

Comments: Downspouts on front of house and on SW side of house both smoking.

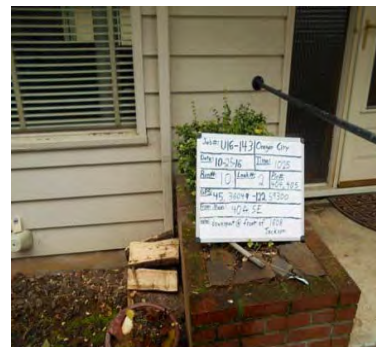
Basin 8a Run 10 Leak 2 A

Leak Source: Downspout

Comments: Downspouts on front of house and on SW side of house both smoking.

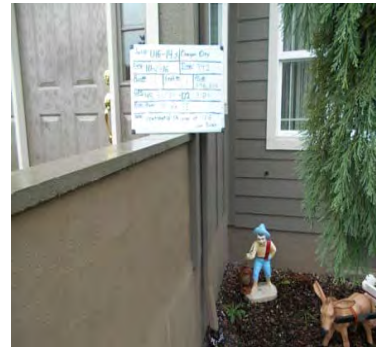
Basin 8a Run 11 Leak 1 A

Result: Negative **Leak Source:** N/A

Comments: No smoke from 13732 to 12913 possible sump pump system.

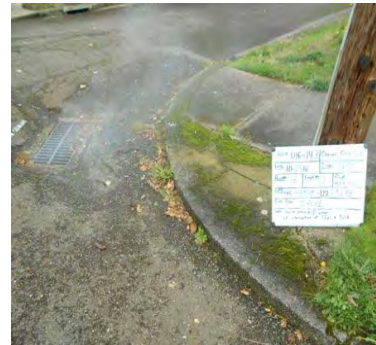
Basin 8a Run 18 Leak 1 A

Leak Source: Storm Drain

Comments: Storm drain at E corner of intersection.

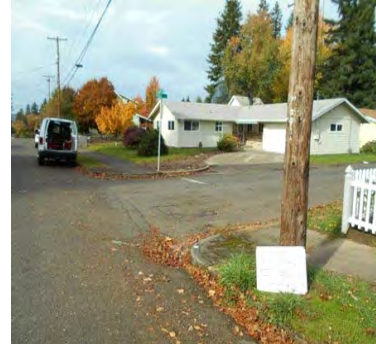
Basin 8a Run 19 Leak 1 B

Leak Source: Storm Drain

Comments: Storm drain at E corner of 16th + Pierce.

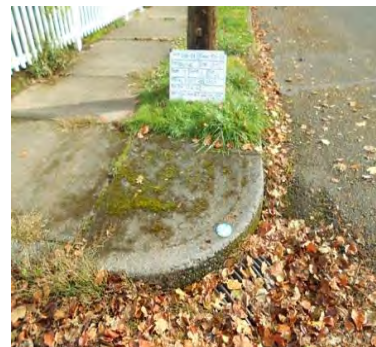
Basin 8a Run 19 Leak 1 A

Leak Source: Storm Drain

Comments: Storm drain at E corner of 16th + Pierce.

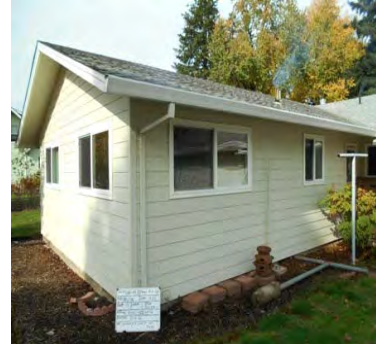
Basin 8a Run 19 Leak 2 B

Leak Source: Downspout

Comments: Downspout at S corner of 1611 Pierce.

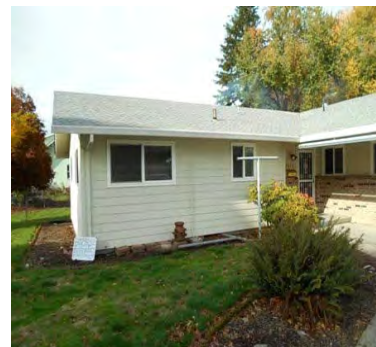
Basin 8a Run 19 Leak 2 A

Leak Source: Downspout

Comments: Downspout at S corner of 1611 Pierce.

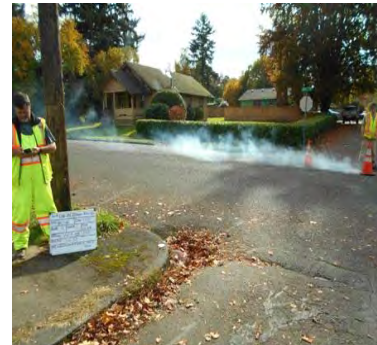
Basin 8a Run 19 Leak 3 B

Leak Source: Cracked Concrete

Comments: Sidewalk crack at E corner of 16th + Pierce. Unknown Source

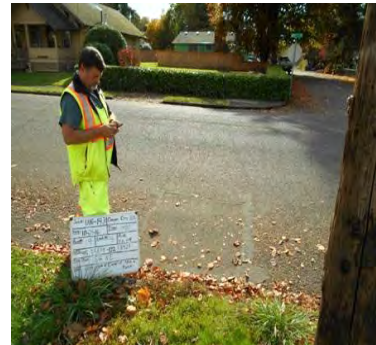
Basin 8a Run 19 Leak 4 B

Leak Source: Cracked Concrete

Comments: Sidewalk crack at E corner of 16th + Pierce. Unknown Source

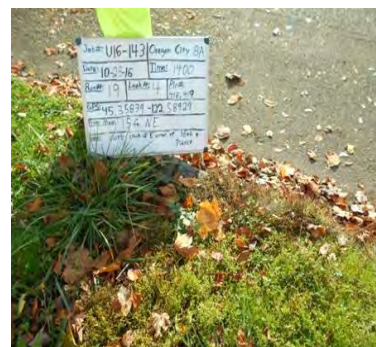
Basin 8a Run 19 Leak 4 A

Leak Source: Cracked Concrete

Comments: Sidewalk crack at E corner of 16th + Pierce. Unknown Source

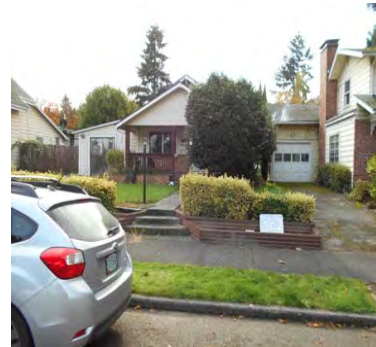
Basin 8a Run 19 Leak 5 B

Leak Source: Service Lateral

Comments: Suspected service lateral smoking.

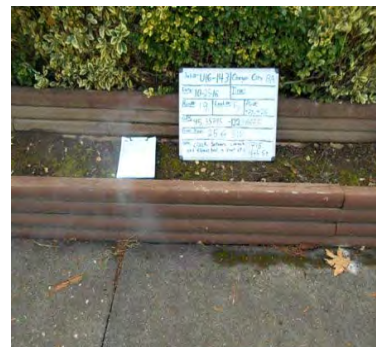
Basin 8a Run 19 Leak 5 A

Leak Source: Service Lateral

Comments: Suspected service lateral smoking.

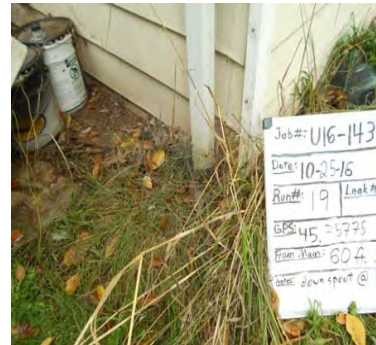
Basin 8a Run 19 Leak 6 A

Leak Source: Downspout

Comments: Smoke from Downspout

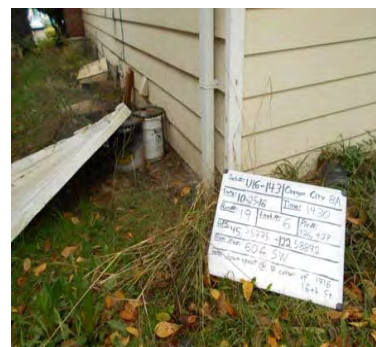
Basin 8a Run 19 Leak 6 B

Leak Source: Downspout

Comments: Smoke from Downspout

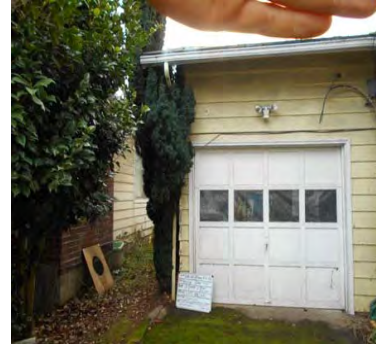
Basin 8a Run 19 Leak 7 A

Leak Source: Downspout

Comments: Smoke from downspout

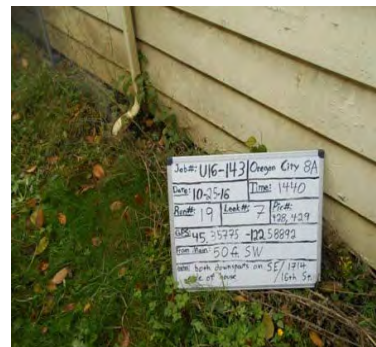
Basin 8a Run 19 Leak 7 B

Leak Source: Downspout

Comments: Smoke from downspout

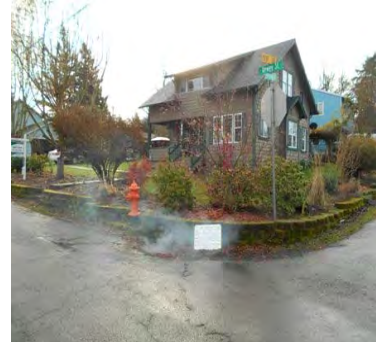
Basin 8B Run 1 Leak 1 B

Leak Source: Catch Basin

Comments: Catch basin at SE corner of Dewey St. + Irving St.

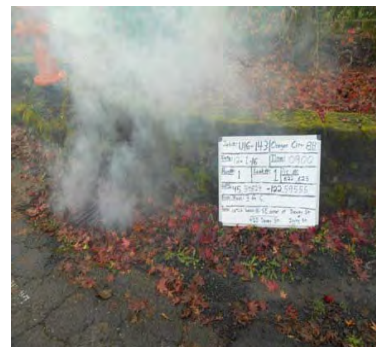
Basin 8B Run 1 Leak 1 A

Leak Source: Catch Basin

Comments: Catch basin at SE corner of Dewey St. + Irving St.

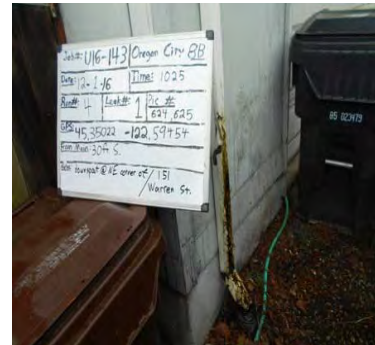
Basin 8B Run 4 Leak 1 A

Comments: Downspout at NE corner of house.

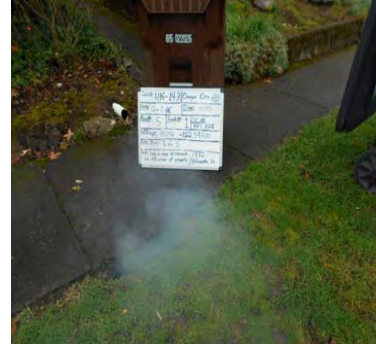
Basin 8B Run 5 Leak 1 A

Comments: Hole on edge of sidewalk at NE corner of property. Unknown Source

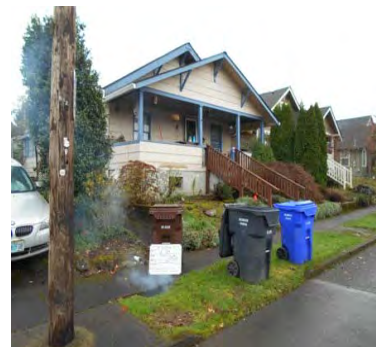
Basin 8B Run 5 Leak 1 B

Comments: Hole on edge of sidewalk at NE corner of property. Unknown Source

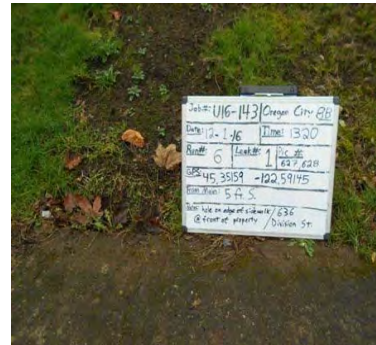
Basin 8B Run 6 Leak 1 A

Comments: Smoke from ground, Unknown Source. Likely service lateral

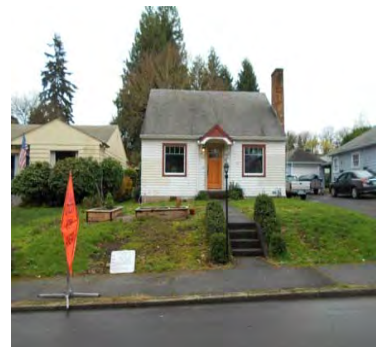
Basin 8B Run 6 Leak 1 B

Comments: Smoke from ground, Unknown Source. Likely service lateral

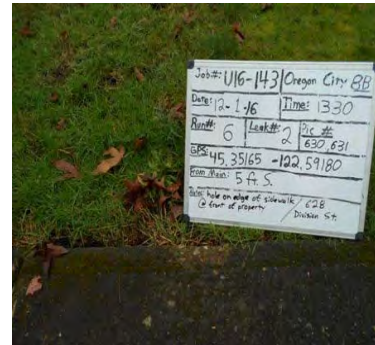
Basin 8B Run 6 Leak 2 A

Comments: Smoke from ground, Unknown Source. Likely service lateral

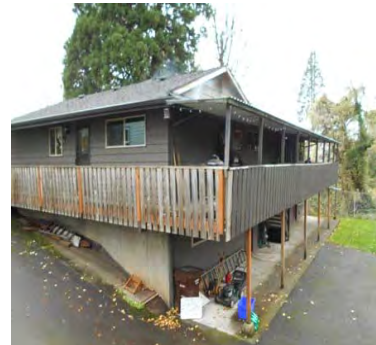
Basin 8B Run 7 Leak 1 B

Comments: Downspout at E corner.

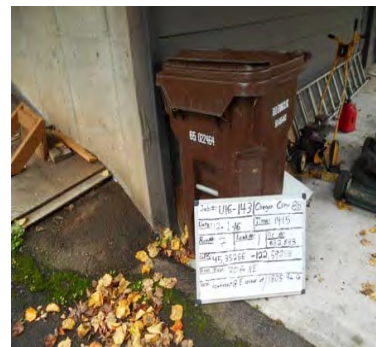
Basin 8B Run 7 Leak 1 A

Comments: Downspout at E corner.

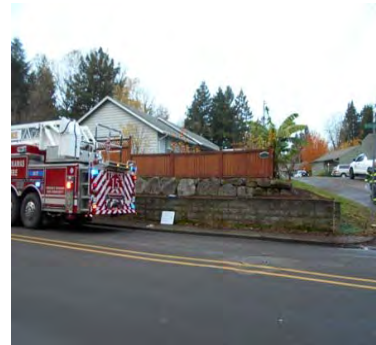
Basin 8B Run 8 Leak 1 B

Comments: Water meter access panel.

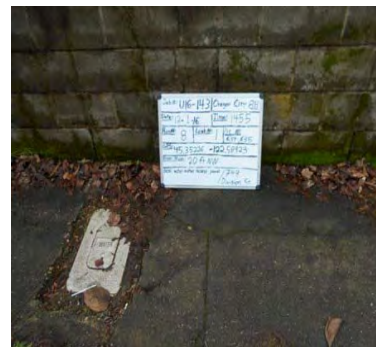
Basin 8B Run 8 Leak 1 A

Comments: Water meter access panel.

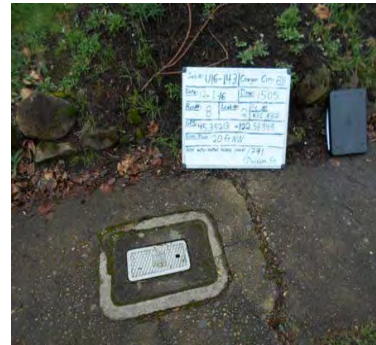
Basin 8B Run 8 Leak 2 A

Comments: Water meter access panel.

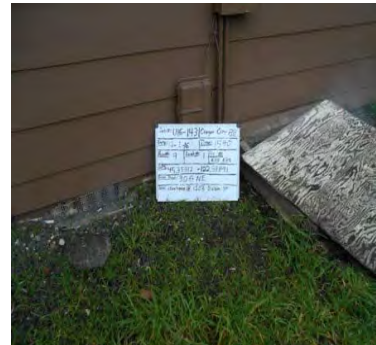
Basin 8B Run 9 Leak 1 A

Comments: Smoke coming from crawl space.

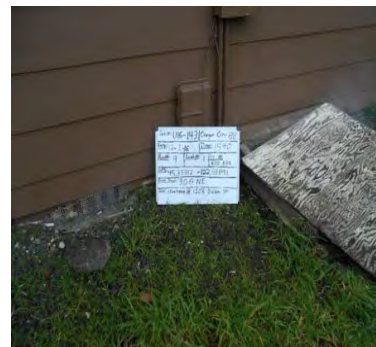
Basin 8B Run 9 Leak 1 A

Comments: Smoke coming from crawl space.

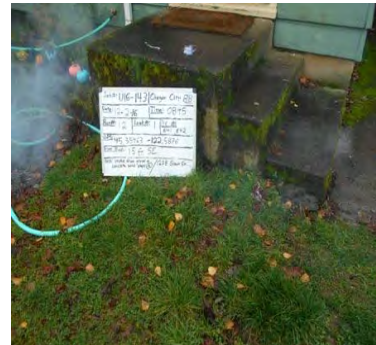
Basin 8B Run 12 Leak 1 A

Comments: Smoke from ground, Unknown Source.

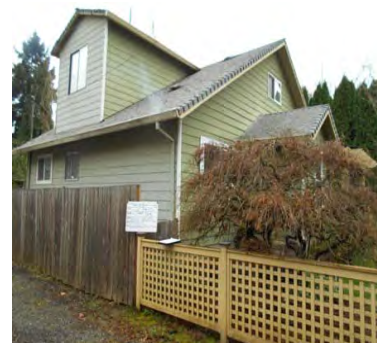
Basin 8B Run 14 Leak 1 B

Comments: Smoke from Downspouts

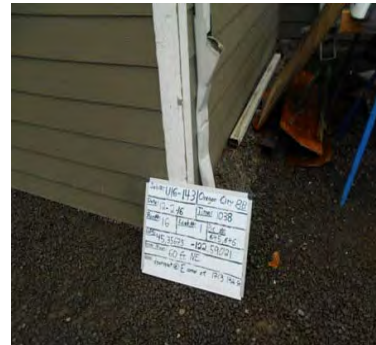
Basin 8B Run 16 Leak 1 A

Comments: Smoke from Downspouts

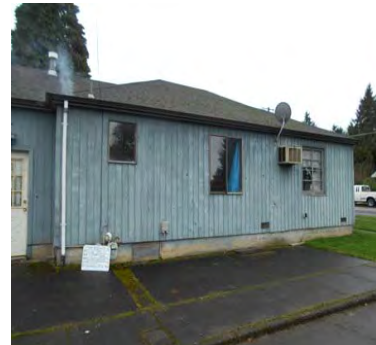
Basin 8B Run 17 Leak 1 B

Comments: Smoke from Downspouts

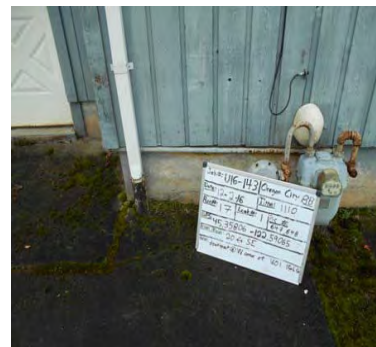
Basin 8B Run 17 Leak 1 A

Comments: Smoke from Downspouts

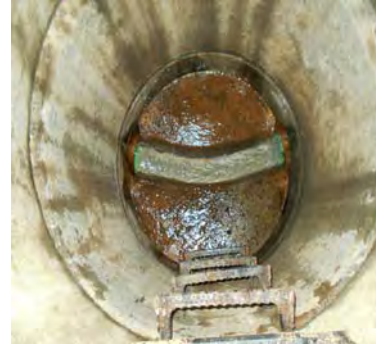
Basin 9 Run 14 Leak 1 B

Comments: MH 10325 has visible infiltration, leak source from ground water.

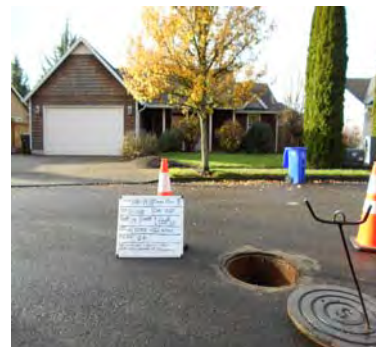
Basin 9 Run 14 Leak 1 A

Comments: MH 10325 has visible infiltration, leak source from ground water.

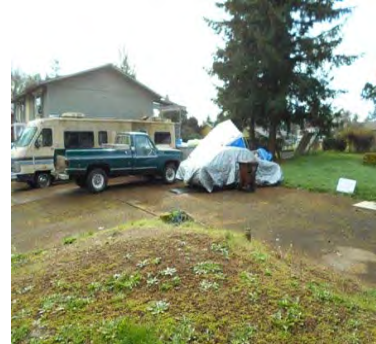
Basin 10 Run 3 Leak 1 B

Comments: Two pipes in cement slab parking area NW of house.

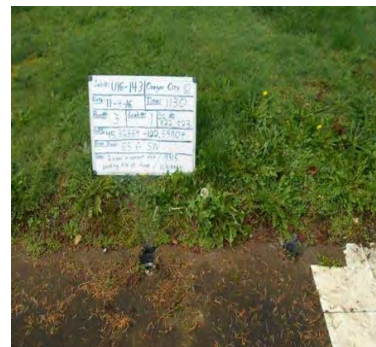
Basin 10 Run 3 Leak 1 A

Comments: Two pipes in cement slab parking area NW of house.

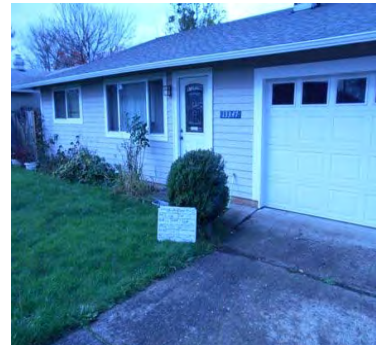
Basin 10 Run 14 Leak 1 B

Comments: Old downspout connection in front yard near driveway + walkway.
